Re: Notice of Violation  
EOLM Construction & Demolition Debris  
Landfill  
Allen County

September 14, 2009

On June 3, 2009, I, representing the Ohio Environmental Protection Agency (Ohio EPA) accompanied Bill Kelly with the Allen County Health Department on an inspection of EOLM Construction and Demolition Debris Landfill (Facility). Tyler Madeker with Ohio EPA was also present during this inspection. During the inspection we spoke with Eric Hefner from the Facility.

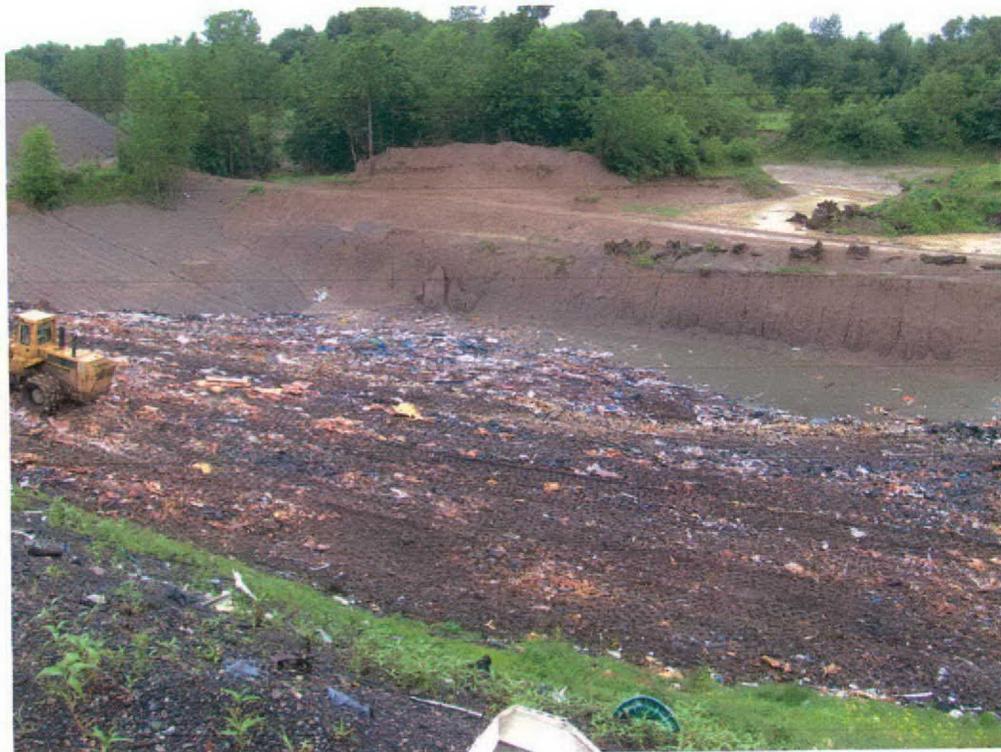
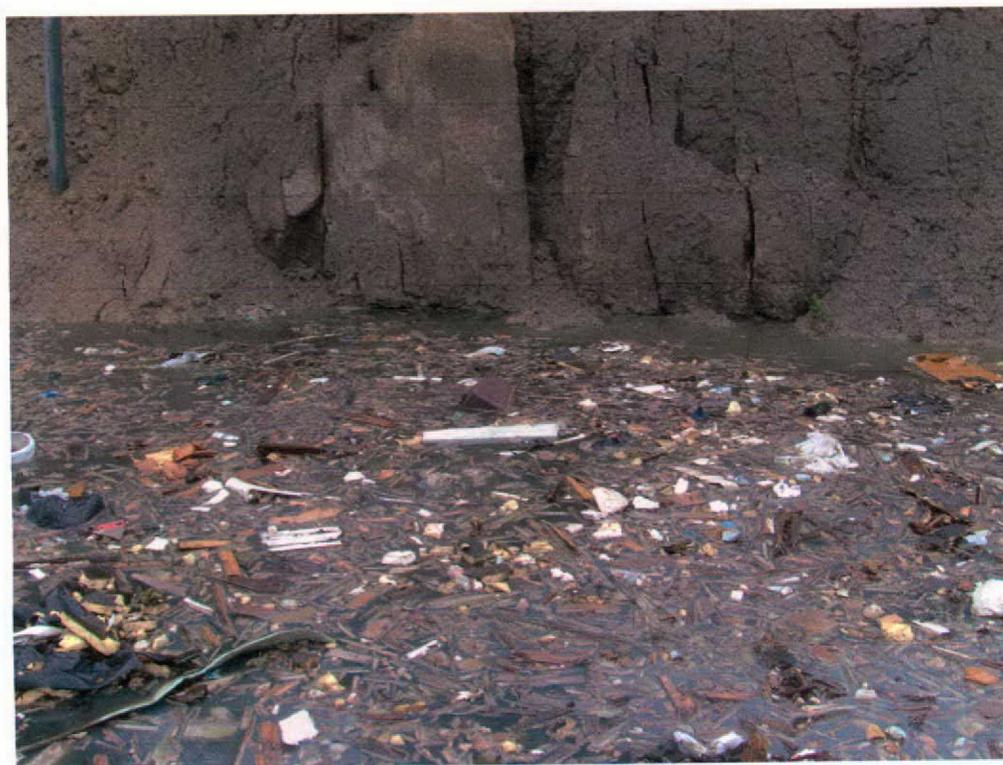
During the inspection a very large area of ponded leachate was observed along the western limits of Cell 3 (Photos 1 and 2). Upon closer inspection of the ponded area of leachate, it was estimated that the depth of the area of ponding ranged from two to four feet above the one foot of drainage layer. A very strong hydrogen sulfide odor was observed in areas surrounding the ponded leachate. Areas of erosion could be observed along the western limit of Cell 3 indicating the intrusion of surface water into the cell (Photo 3). Based upon the amount of leachate observed within Cell 3, it does not appear that the leachate collection system is functioning properly.

The leachate collection system was not effectively maintaining less than one foot of head over the *in situ* liner at the Facility, in fact up to four feet over the one foot of drainage layer was observed in some areas of Cell 3. There are likely multiple contributing factors for this situation, one of which is the fact that there is only one sump area servicing two cells. Additionally, there are no plans for adding additional sump areas as additional cells are added. Based on the current observations of conditions at the Facility it does not appear that the design of a single sump system is sufficient for two cells, let alone additional cells that are proposed to be added. **The owner/operator is in violation of OAC Rule 3745-400-07(F)(5)(c)(ii) for not designing a leachate collection system capable of maintaining less than one foot depth of leachate over the *in situ* liner.**

The document representing Tab 5 of the license application states, "Leachate will only accumulate to of depth of greater than 1 foot in the immediate area of the sump." As previously stated leachate was observed to be accumulated at depths between two and four feet above the one foot of drainage layer. Significant accumulation of leachate was observed in areas greater than 400-feet from the leachate sump. **The owner/operator is in violation of OAC Rule 3745-400-11(B)(1) for not conducting operations at the Facility in strict compliance with the license.**

As previously stated leachate was observed to be accumulated at depths between two and four feet above the one foot of drainage layer (three to five feet above the *in situ* liner). **The owner/operator is in violation of OAC Rule 3745-400-11(P)(1) for not operating the leachate collection system to maintain no more than one foot of head anywhere in the *in situ* liner.**

**Photo 1**-Ponded leachate along western limit of Cell 3. Photo taken June 3, 2009 by Brent Goetz.

**Photo 2**-Ponded leachate along western limit of Cell 3. Photo taken June 3, 2009 by Brent Goetz.

- The owner/operator shall fully and adequately investigate why the leachate collection system is not functioning properly, this investigation shall include a visual inspection of the entire leachate collection system piping network (camera, jet rod, etc.).
- Once the cause of the significant accumulation of leachate is determined the owner/operator shall respond in writing to Ohio EPA and the Allen County Health Department, as to what the contributing factors were, how they were corrected, and how a reoccurrence of this issue will be avoided during future operations in Cell 3.

- The owner/operator shall analyze conditions leading to the failure of the current leachate collection system and address the inadequacies in the design of leachate collection systems in future cell construction.
- The owner/operator shall either submit justification to Ohio EPA and the Allen County Health Department of how a single sump system is sufficient for the entire planned Facility, or submit a redesigned plan in the 2010 license application, which will include a sufficient number of sump systems for the entire planned Facility.

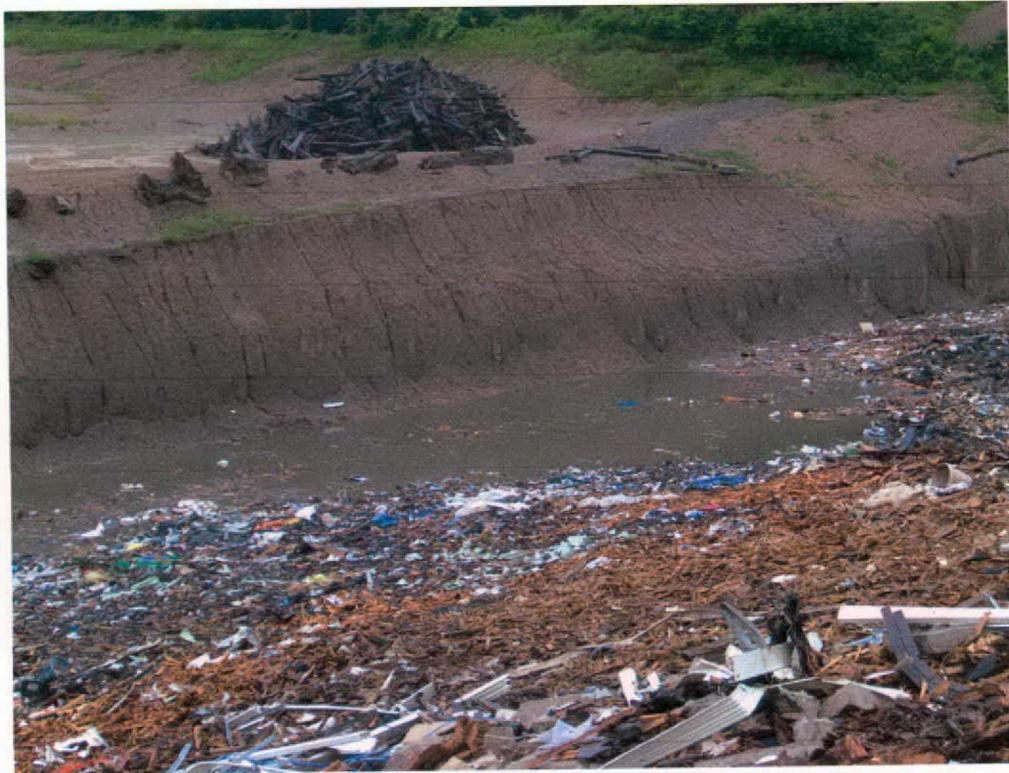
Erosion rills where surface water was actively flowing from west of Cell 3 into the cell could be observed along the western cell wall. This surface water was likely contributing to the generation of leachate in Cell 3 that was ponding along the western cell wall. **The owner/operator is in violation of OAC Rule 3745-400-11(Q)(1) for not diverting surface water from the active and inactive licensed disposal areas of the facility.**

**Photo 3-** Erosion from surface water flowing into Cell 3. Photo taken June 3, 2009 by Brent Goetz.

- The owner/operator shall respond in writing to Ohio EPA and the Allen County Health Department, as to how surface water will be managed in the area to the west of Cell 3 in order to prevent surface water from flowing into the active licensed disposal area.

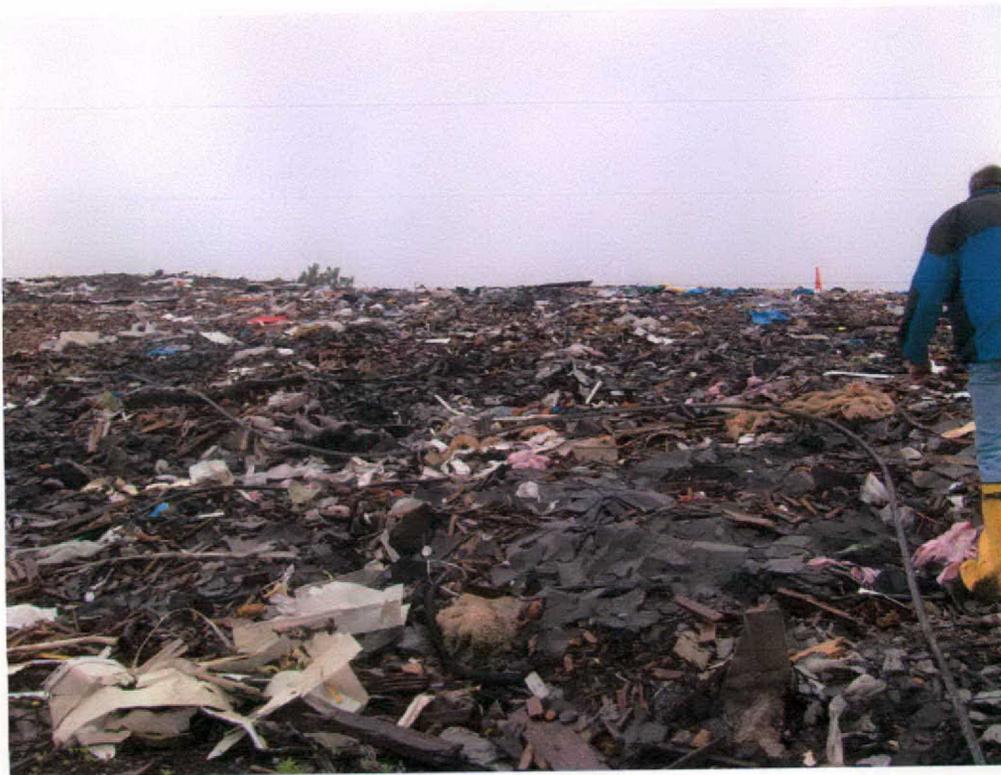
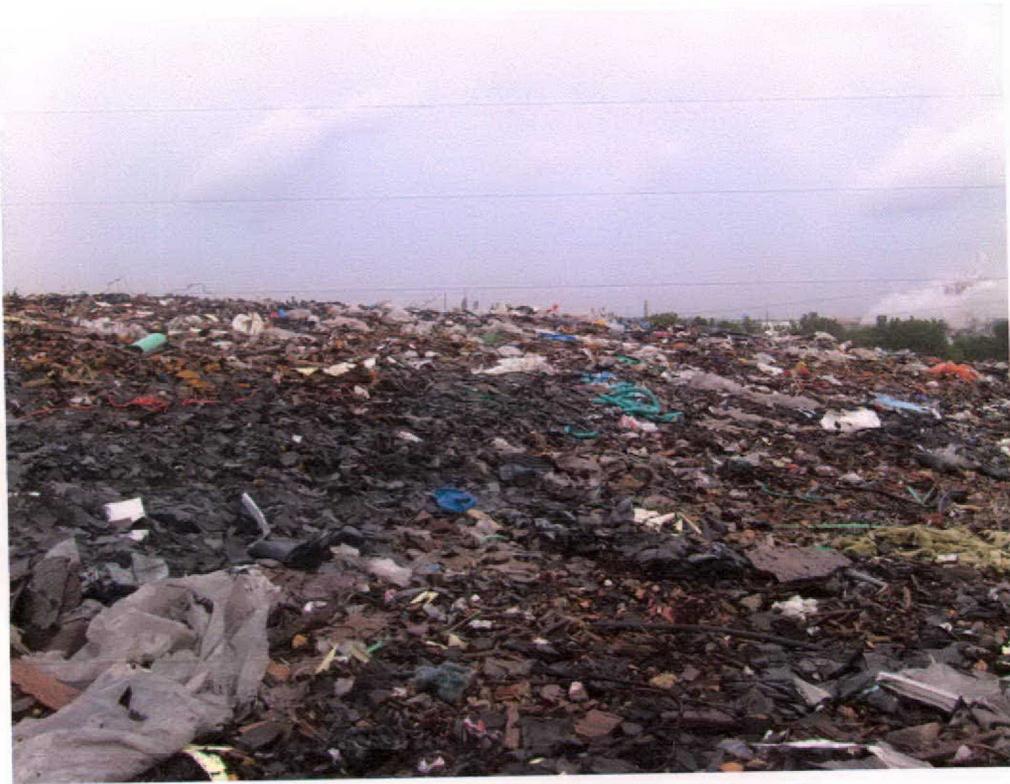
During the inspection it was observed that large areas of both Cells 2 and 3 were not covered (Photos 4 and 5). Many of these areas have never been covered, or have not been covered in years, as documented by previous Allen County Health Department inspection letters and observations made during inspections where Ohio EPA accompanied the Allen County Health Department. Areas that were covered are covered with foundry ash. Significant areas of erosion and flagging waste due to scoured cover material, were observed throughout the covered areas, indicating less than adequate cover (Photos 6 and 7). Below are the violations related to these issues:

Many of the areas of Cell 2 have never been covered or have not been covered in years, as documented by previous Allen County Health Department inspection letters and observations made during inspections where Ohio EPA accompanied the Allen County Health Department. **The owner/operator is in violation of OAC Rule 3745-400-11(H)(2) for not applying monthly cover of noncombustible cover.**

**Photo 4-** Portions of Cell 2 containing no monthly cover. Photo taken June 3, 2009 by Brent Goetz.

**Photo 5**-Portions of Cell 2 containing no monthly cover. Photo taken June 3, 2009 by Brent Goetz.

- The owner/operator shall respond in writing to Ohio EPA and the Allen County Health Department, indicating how operations will be adjusted to insure that monthly cover is applied.

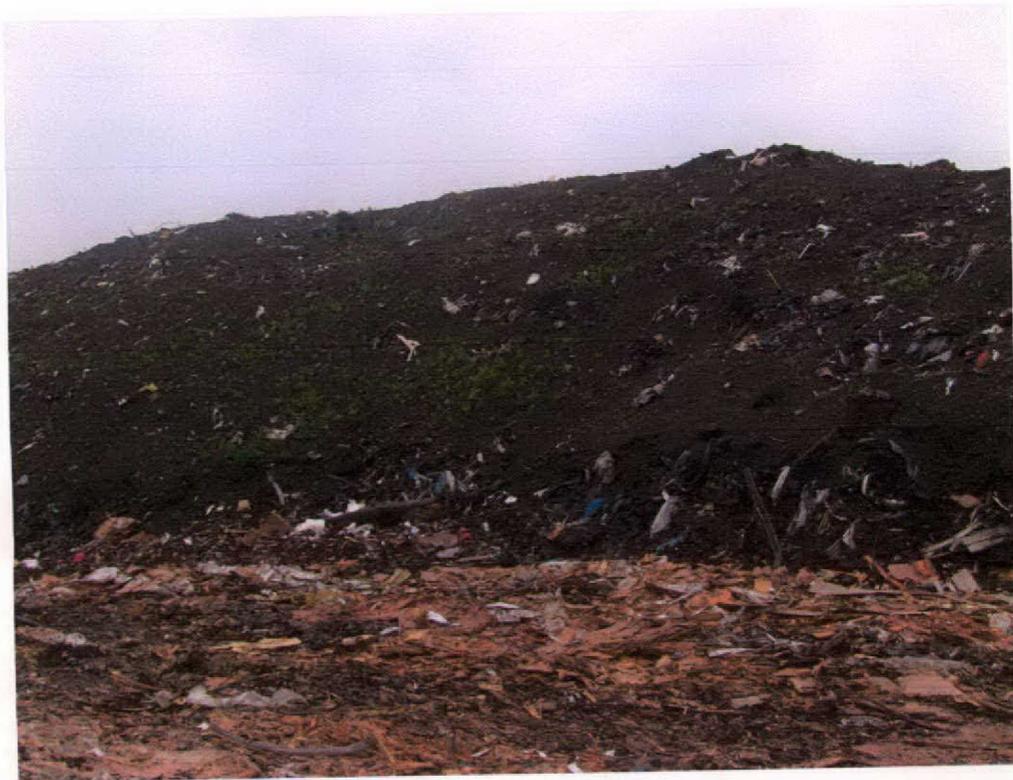
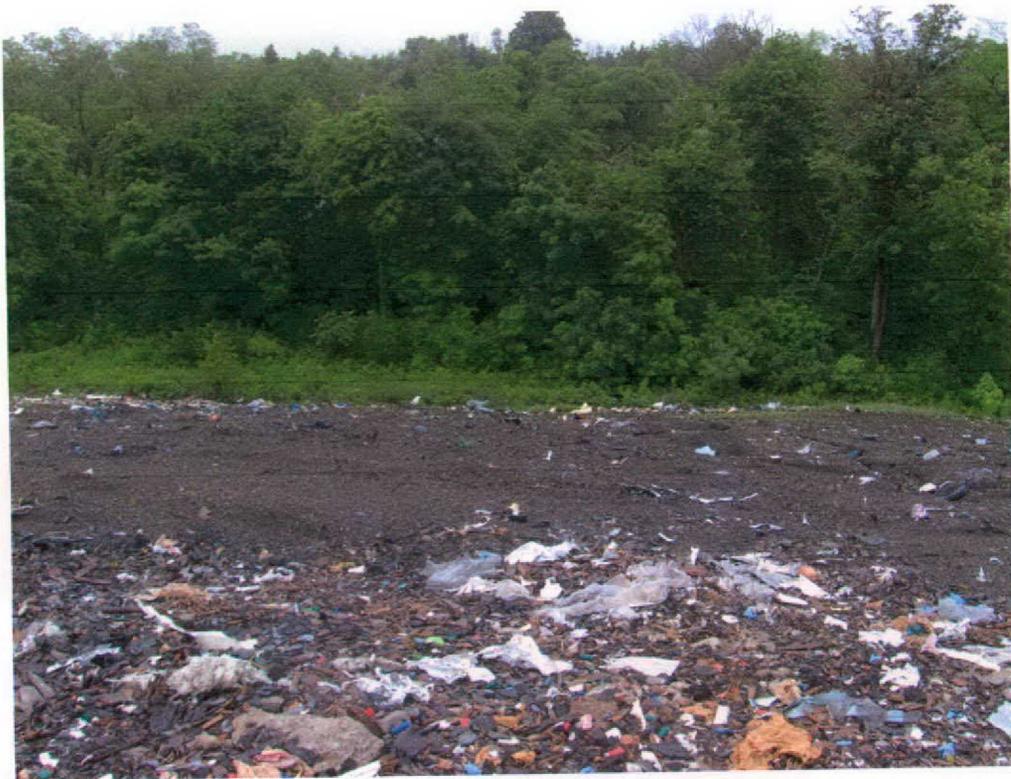
Inadequate grading and drainage system were evident through observations of areas of erosion and/or stripped cover. These areas, in addition to the questionable ability of the cover material itself to withstand erosion and scouring on the steep slopes, were not ensuring minimal infiltration of water through the cover. **The owner/operator is in violation of OAC Rule 3745-400-11(Q)(2) for not grading the Facility and providing drainage systems to insure minimal infiltration of water through the cover material.**

**Photo 6**-Flagging waste in area of inadequate monthly cover. Photo taken June 3, 2009 by Brent Goetz.

**Photo 7-**Flagging waste in area of inadequate monthly cover. Photo taken June 3, 2009 by Brent Goetz.

- The owner/operator shall respond in writing to Ohio EPA and the Allen County Health Department, indicating how current areas of erosion will be corrected, and how future areas of erosion will be corrected in a prompt manner.
- The owner/operator shall respond in writing to Ohio EPA and the Allen County Health Department, indicating how areas of future erosion will be prevented, as to insure minimal infiltration of water through the cover. As part of this response the owner/operator should consider the utilization of a more suitable cover material that will better withstand erosion and scouring on the steep slopes, or adjust the grade of the slopes and drainage to be more accommodating for the foundry ash cover.

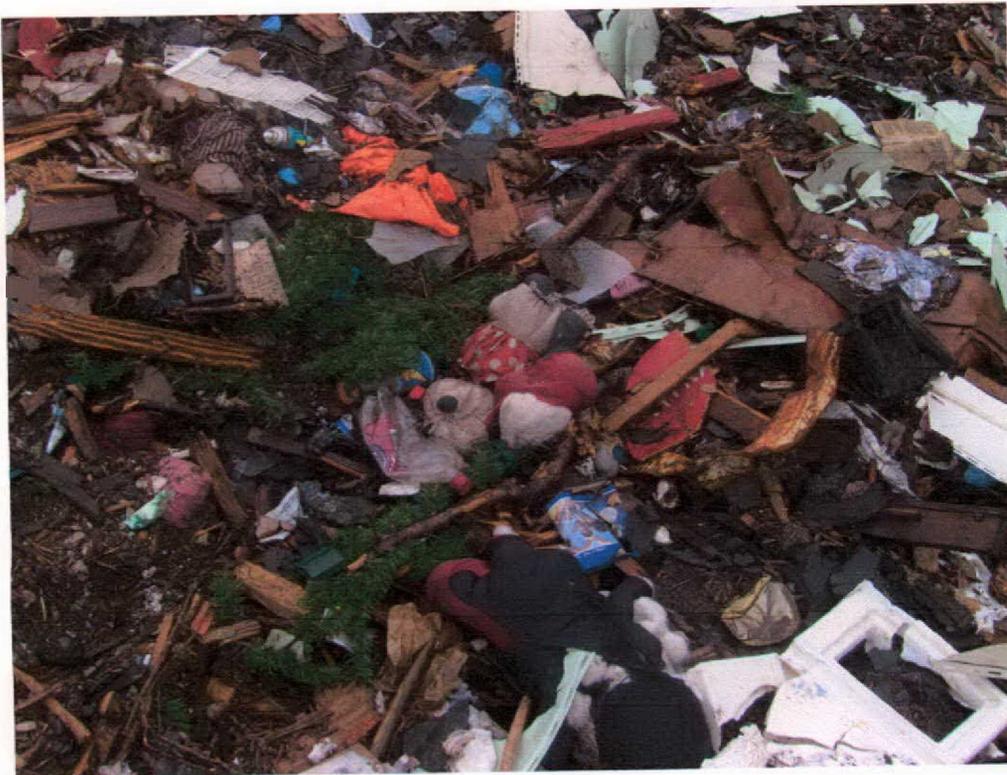
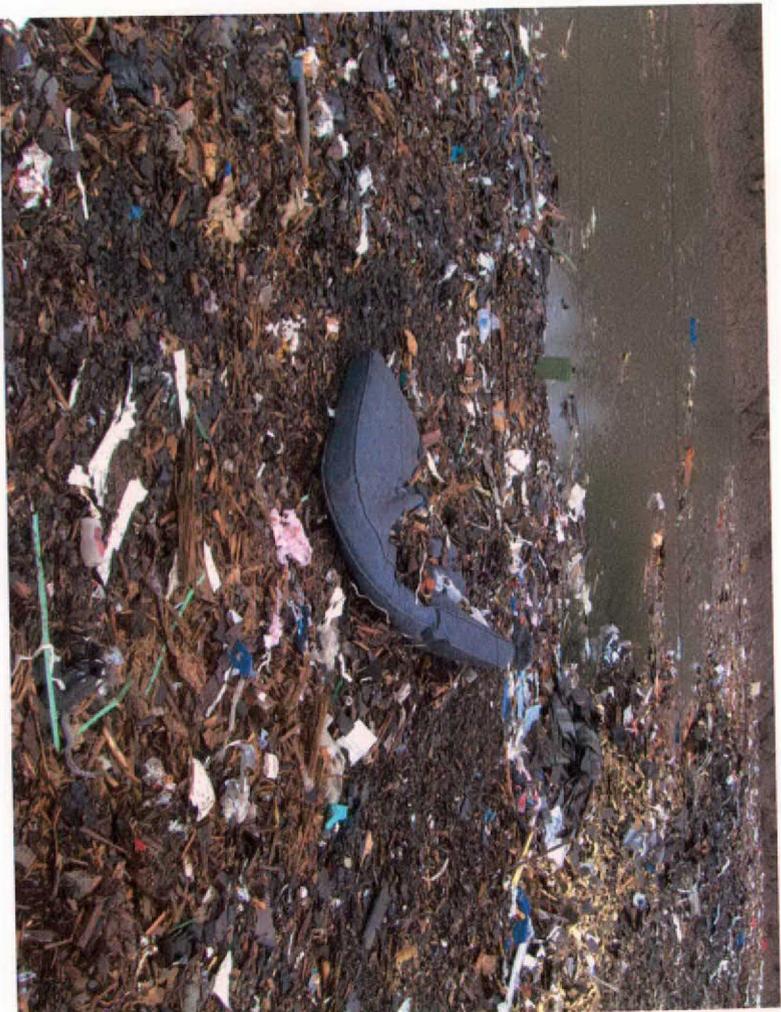
Observations made of unloading areas, as well as uncovered areas, indicated various amounts of disposed solid waste, such as Christmas decorations, stuffed animals, clothing, non-construction demolition packaging (food wrappers, drink containers, etc.), mattresses, toys, and other miscellaneous solid waste (Photos 8 and 9). Additionally, during the inspection a load containing mostly solid waste was allowed pass the front office and dump into Cell 3; however, upon discovery of the solid waste the load was placed back into the truck and rejected by the Facility (Photo 10). Below are the violations related to these issues:

Observations made of unloading areas as well as uncovered areas indicated various amounts of disposed solid waste, such as Christmas decorations, stuffed animals, clothing, non-construction demolition packaging (food wrappers, drink containers, etc.), mattresses, toys, and other miscellaneous solid waste. **The owner/operator is in violation of OAC Rule 3745-400-11(F)(2) for disposing of solid waste.**

**Photo 8-** Disposed solid waste. Photo taken June 3, 2009 by Brent Goetz.

**Photo 9 -** Disposed solid waste. Photo taken June 3, 2009 by Brent Goetz.

- The owner/operator must submit in writing to Ohio EPA and Allen County Health Department, a statement indicating how Facility operations will be altered to insure that all solid waste is removed through the pre-acceptance screening process, prior to disposal. Additionally, the owner operator shall remove and properly dispose of all visible solid waste throughout all active areas of the Facility.

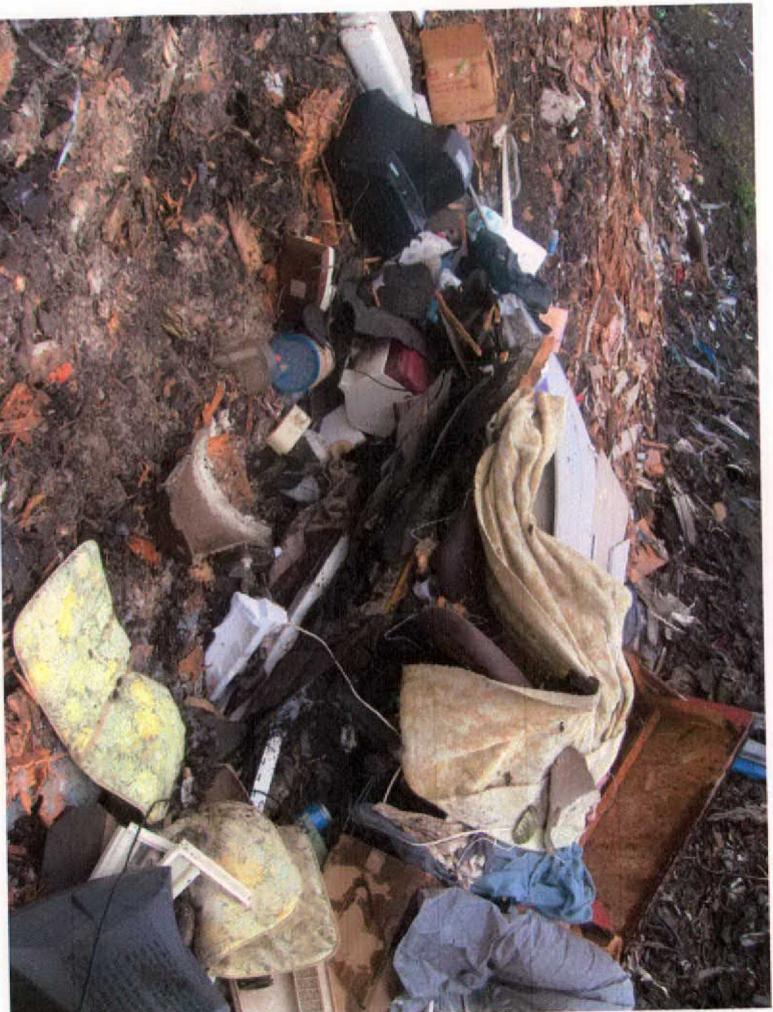
**Photo 10 -** Load dumped, but latter rejected. Photo taken June 3, 2009 by Brent Goetz.
