Re: Meadow Grove Estates, Sec. 3, Franklin County

This letter is written regarding the storm water inspection I conducted of the construction activities at the project located at Meadow Grove Estates, Sec. 3, located near Buckeye Parkway, on September 16, 2011. I understand this site is currently covered under the General Storm Water Permit Associated with Construction Activities. Based on my site inspection and the conditions set forth in the General Permit, the following items must be addressed:

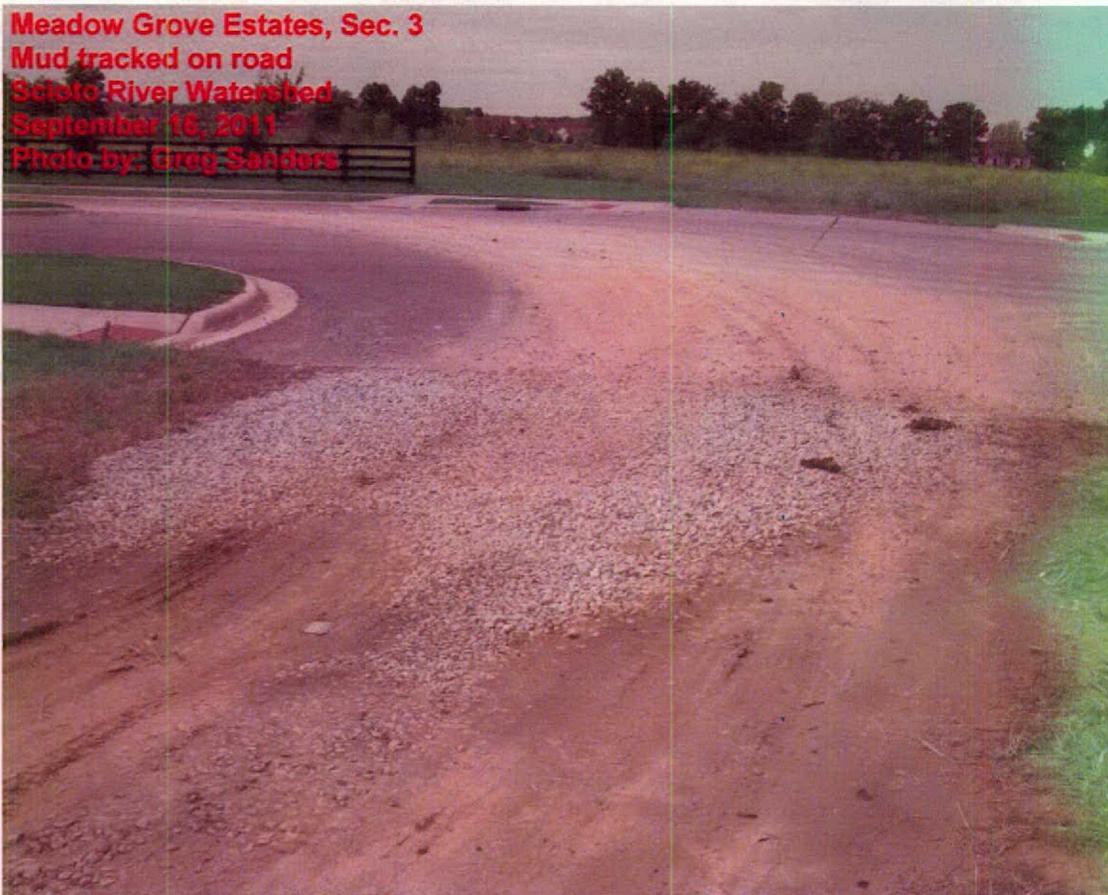
The project site had a barren area consisting of a dirt stockpile that did not have erosion controls. Mud was being tracked on to Buckeye Parkway. Please see attached picture.

Meadow Grove Estates, Sec. 3
Mud tracked on road
Scioto River Watershed
September 16, 2011
Photo by: Greg Sanders

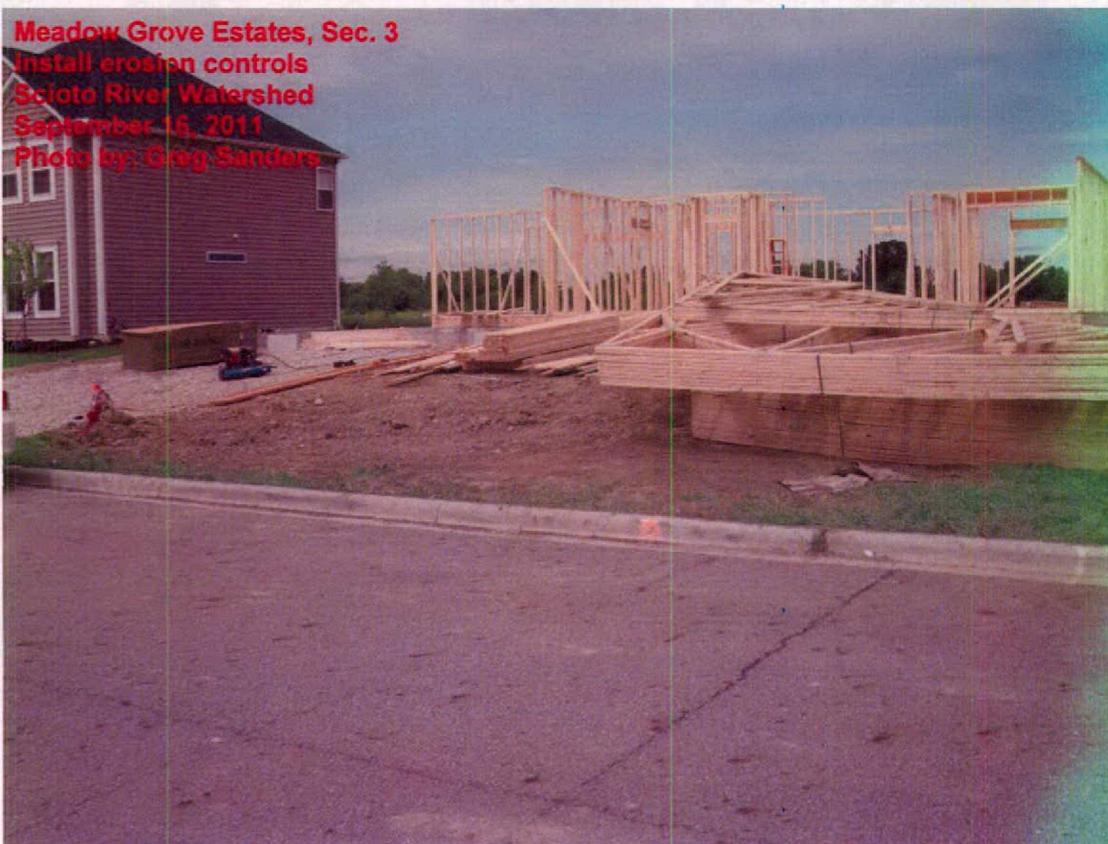
There were a few active construction sites that did not have erosion controls. Please install and maintain silt fence or straw waddles around the perimeter of the barren areas at the active construction sites. Please see attached picture.

Meadow Grove Estates, Sec. 3
Install erosion controls
Scioto River Watershed
September 16, 2011
Photo by: Greg Sanders
