State of Ohio Environmental Protection Agency

April 25, 2007

**Re: Wilmington Landfill, Clinton County
Notice of Violation**

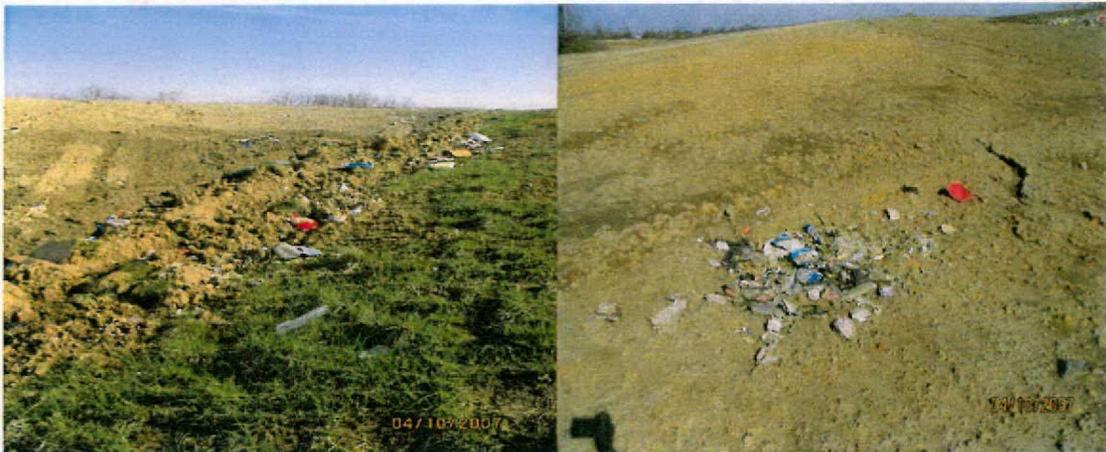
1. Flagger waste was observed along the southeastern portion of the west expansion area (see Figure 1). The operator's failure to maintain daily cover was also documented in Ohio EPA Notice of Violation letters dated December 6, 2006 and April 17, 2007. The operator's failure to maintain daily cover is a violation of Ohio Administrative Code (OAC) Rule 3745-27-19(F) which states in part:

The Facility addressed the use of daily cover in the PTI Narrative, section 6.2 (page 34). **Therefore, the failure to cover exposed waste for greater than forty-eight (48) hours is in violation of the PTI, which states in part:**

Figure 1: Flagging waste on the southeast portion of the west expansion area

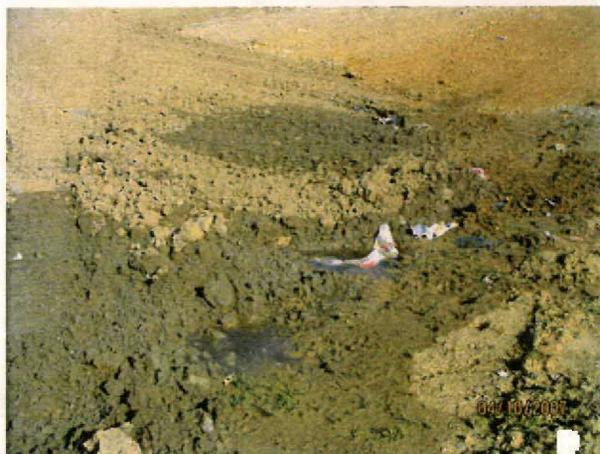
2. Ponding was observed on the southeastern portion of the west expansion area (see Figure 2). The operator's failure to correct the conditions causing the ponding and maintain adequate surface water structure diverting surface water from areas of waste placement is a violation of OAC Rule 3745-27-19(J)(3) which states in part:

Ponding was also documented in a Notice of Violation letter dated April 17, 2007, from Ohio EPA. During this inspection the operator indicated that more soil would be placed in this area to improve grading to prevent ponding.

Figure 2: Ponding on the southeast portion of the west expansion area

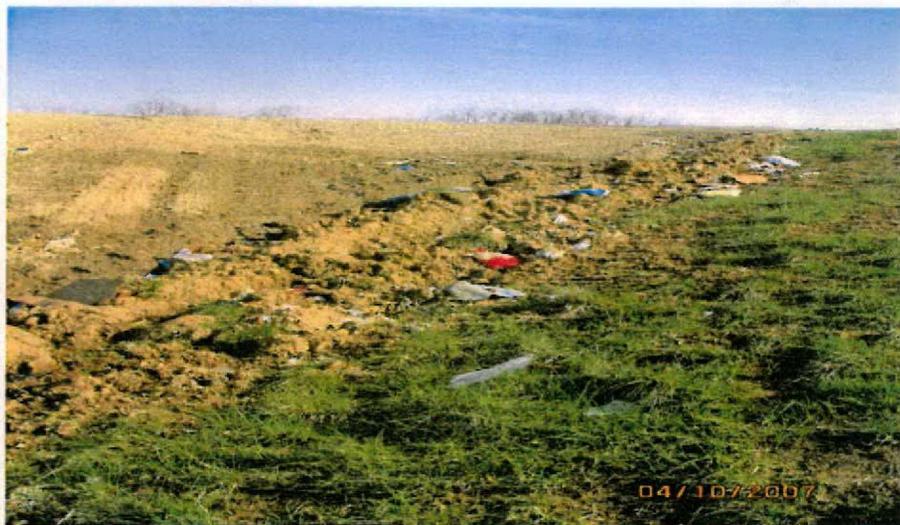
3. Blowing litter and flagging waste were observed along the eastern boundary of the West Expansion Area (see Figure 3). This violation was documented in Notice of Violation letters, dated December 6, 2006 and April 17, 2007. The operators failure to employ reasonable measures to collect, properly contain and dispose of scattered litter is a violation of OAC Rule 3745-27-19(E)(9) which states in part:

The operator’s failure to control scattered litter is also a violation of OAC Rule 3745-27-19(F) which states in part:

Figure 3: Scattered litter along the eastern boundary of the west expansion area

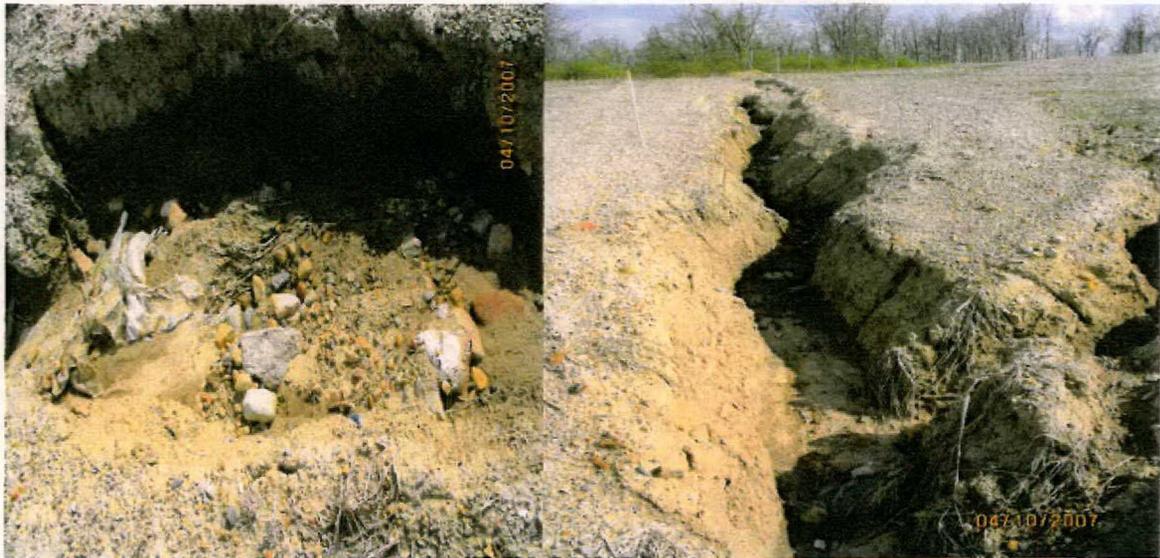
4. Large erosion ruts between twelve (12) to eighteen (18) inches in depth were observed along the west side of the west expansion and solid waste was flagging in the ruts (see Figure 4). The operator’s failure to maintain surface water structures ensuring minimal erosion and infiltration of water through the minimizing the cover material and cap system is a violation of OAC Rule 3745-27-19(J)(3) which states in part:

Figure 4: Erosion rut and exposed waste along the west side of the west expansion area

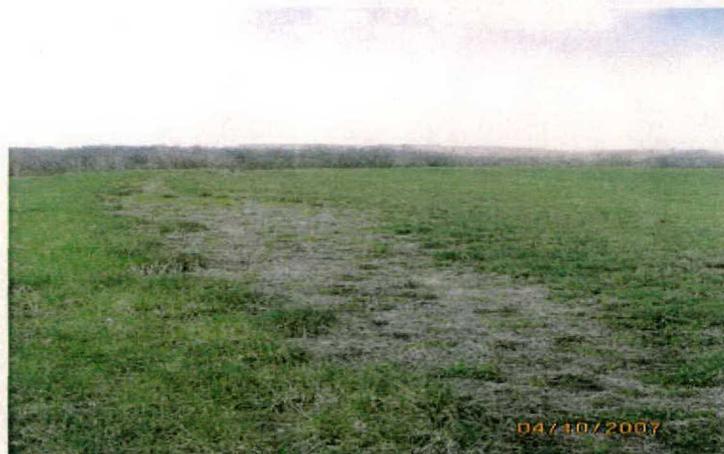
5. On the closed portion of the landfill there were areas of dead vegetative cover on the cap (see Figure 5). As outlined in OAC Rule 3745-27-08 (B)(1)(f)(iv), the cap protection layer is an engineered component. The operator's failure to maintain the integrity of the engineered component is in violation of OAC Rule 3745-27-19(E)(1)(c) which states in part:

The cap was constructed in 2001 and certified in accordance with OAC Rule 3745-27-08(D)(26)(e)(ii) which states:

Figure 5: Dead vegetation on closed portion of the landfill

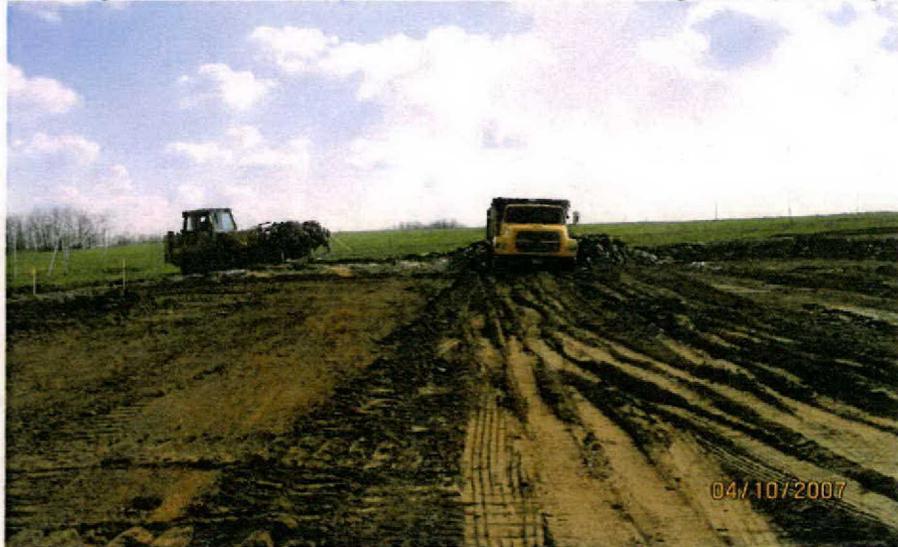
6. Materials from the over fill along the northeast section of the west expansion were being excavated and placed within the working face (see Figure 6).

Figure 6: Excavation of NE corner of West Expansion Area
