RE: LORAIN COUNTY
BLACK RIVER WATERSHED
CITY OF ELYRIA
ELYRIA HIGH SCHOOL

NOTICE OF VIOLATION

ELYRIA HIGH SCHOOL
City of Elyria Lorain County

Photos Taken: September 10, 2010
By: Dan Bogoevski, DSW, NEDO

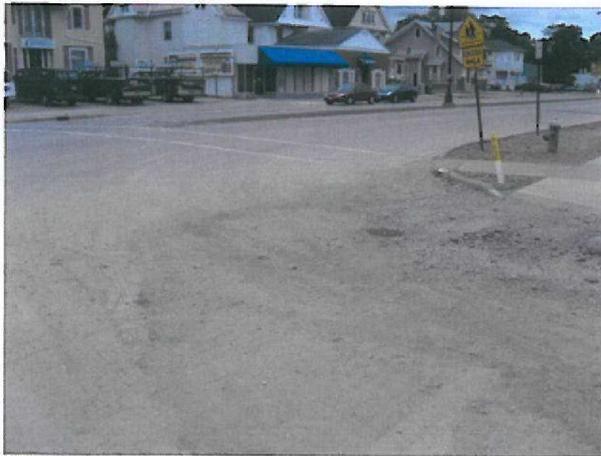
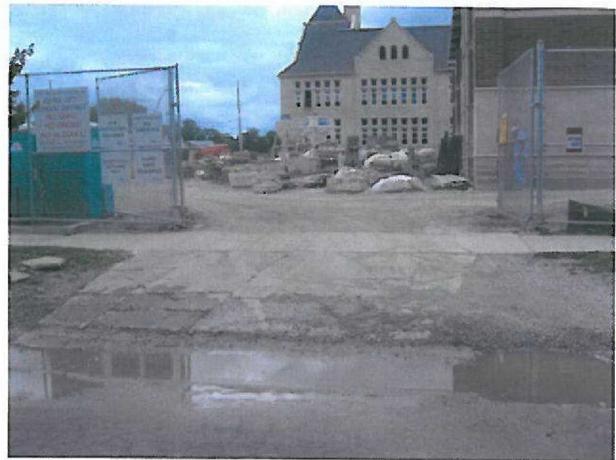
Fig 1 & 2. Off site tracking onto Middle Ave (LEFT) and 5th Street (RIGHT). Note the lack of a rock construction entrance and failure to implement good housekeeping practices to keep aprons clean.

- **Provide rock construction entrances at all points where vehicles access disturbed areas of the site.** Although contractors are using existing concrete aprons, the aprons do not extend at least 70 feet into the site. Further, concrete does not have a rough surface capable of capturing or dislodging sediment adhered to vehicle tires. Please install rock construction entrances per the specifications contained in Rainwater and Land Development, Ohio's Standards for Stormwater Management, Land Development and Urban Stream Protection (Ohio Department of Natural Resources, 2006) available on-line at <http://www.dnr.state.oh.us/tabid/9186/default.aspx>. **NOTE:** You may continue to use the concrete apron as a portion of the rock construction entrance, but rock over geotextile should extend beyond such that the total length is 70 feet or greater. In addition, you may need to sweep the concrete or redress the non-paved portion with stone. Water bars may be required to divert flows away from adjacent streets where the drive slopes toward the street. Runoff should be diverted to an appropriate sediment control.

- **Sweep adjacent streets with a vacuum sweeper.** Some off-site tracking will inevitably occur even if the above on-site controls are implemented. Sediment which is tracked off-site must be swept up and removed from adjacent streets. Currently, the contractor is using a rotating brush sweeper. These methods are not acceptable. Rotating brush sweepers simply disperse and redistribute dust. They do not collect dirt. Regency indicated that streets are wetted before sweeping to aid in dirt collection. My observation of the operation indicated that too much water is being used to wet streets. In essence, the contractor is simply washing sediment into the City of Elyria municipal separate storm sewer system (MS4). This practice must cease. A vacuum sweeper will collect dirt more efficiently and not create an illicit discharge to the MS4.

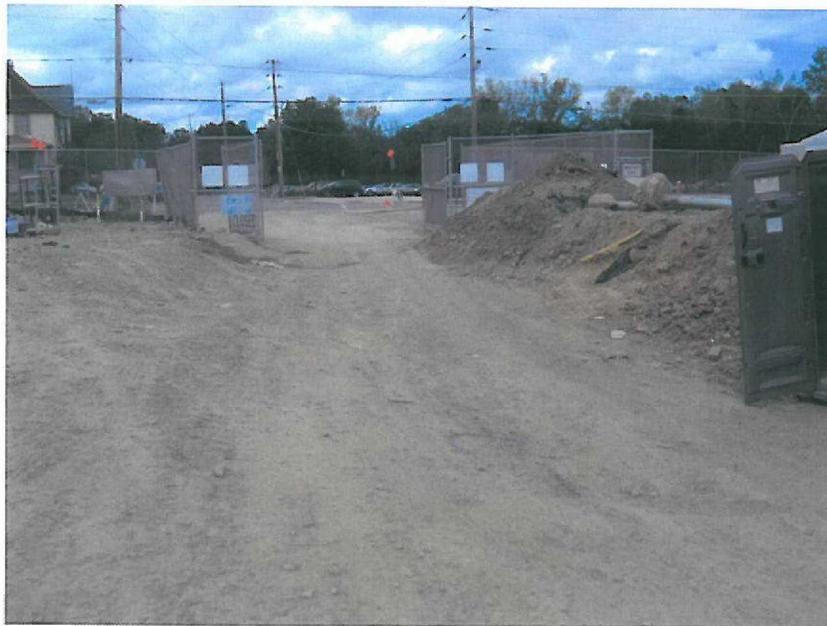
Fig 3. View toward West Ave. Although you may use existing aprons for a portion of the entrance drive, two-inch diameter stone over geotextile should extend beyond the existing aprons such that the total entrance drive is at least 70 feet long.

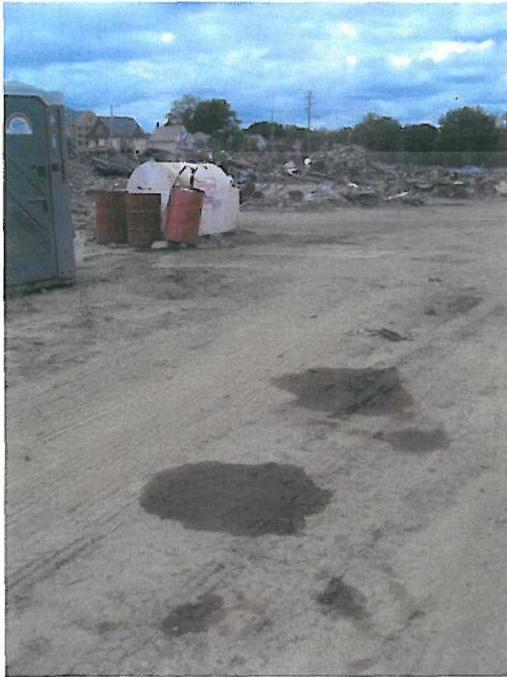
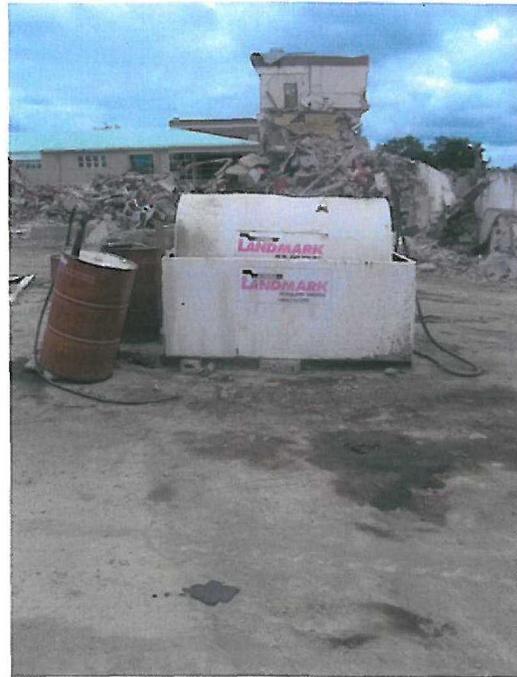
- Fluid spillage was noted in the vicinity of the diesel fuel tanks. No actions were taken to clean up soils contaminated by fluid spillage. Further, no signage or spill kit was available near the fuel tanks to encourage proper spill response.

Fig 4 & 5. Soil contamination due to spills and leaks. Contaminated soils must be removed and properly disposed. 55-gallon drums are not stored within secondary containment.

- 55-gallon drums, 5-gallon buckets and fuel cans are not properly stored. Containers with chemicals, fuels or vehicle fluids should be stored in a locker, within secondary containment structures or on containment trays when not actively being used.
- The trash dumpster was not covered with a tarp or lid. Dumpsters containing municipal solid waste or construction and demolition debris must be covered to prevent the generation and discharge of leachate. The NPDES permit does not authorize the discharge of wastewater.

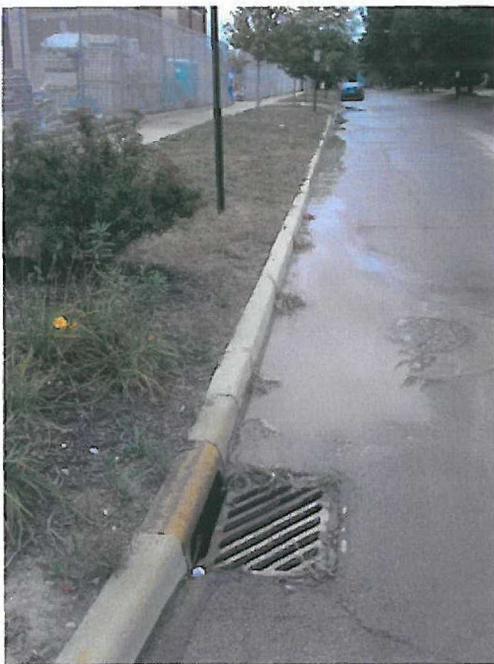
Fig 6 (LEFT). 5th Street after it has been “wetted” to aid in street sweeping. Note that this procedure flushes sediment into unprotected storm drains.

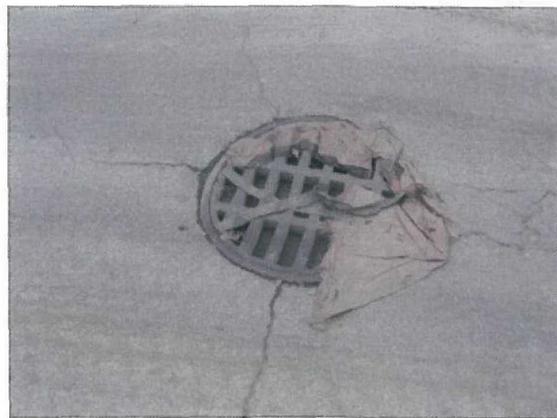
Fig 7 (RIGHT). Inlet protection has ripped and requires replacement.

- **Failure to install storm drain inlet protection.** This is a violation of Part III.G.2.d.iv of the NPDES permit and ORC 6111.04 and 6111.07. On the date of inspection, there were several existing storm drain inlets still actively connected to the City of Elyria MS4. Some had no protection at all and some required replacement due to tears in the geotextile fabric. Please install and repair storm drain inlet protection on all catch basins which are still actively connected to off-site drainage systems and any new storm sewer catch basins that have been installed.

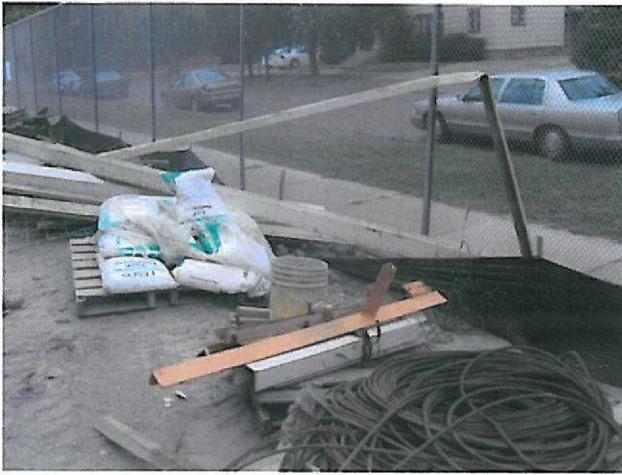
Fig 8 (LEFT). Construction materials have been placed on top of silt fence along 5th Street, compromising its function.

- **Failure to maintain silt fence in a functional condition.** This is a violation of Part III.G.2.h of the NPDES permit and ORC 6111.04 and 6111.07. The silt fence along 5th Street requires maintenance. Construction materials have been placed on top of some sections of silt fence and other sections are down, ripped or otherwise require repair. Please repair silt fence immediately.

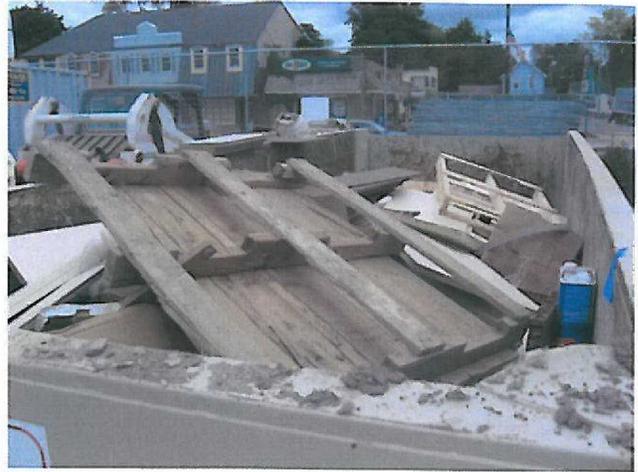
Fig 9 (RIGHT). Trash dumpsters are not covered to prevent the creation of leachate. Tarping is suggested.

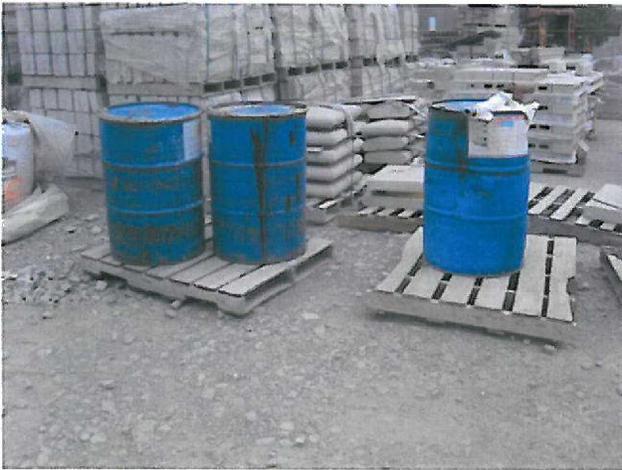
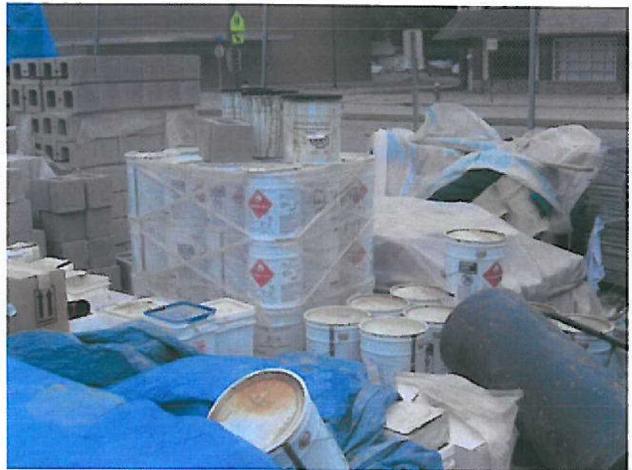
Fig 10 & 11. Storage containers for fuels and chemical materials used on the construction site are not stored within secondary containment or within a storage locker when not in use.

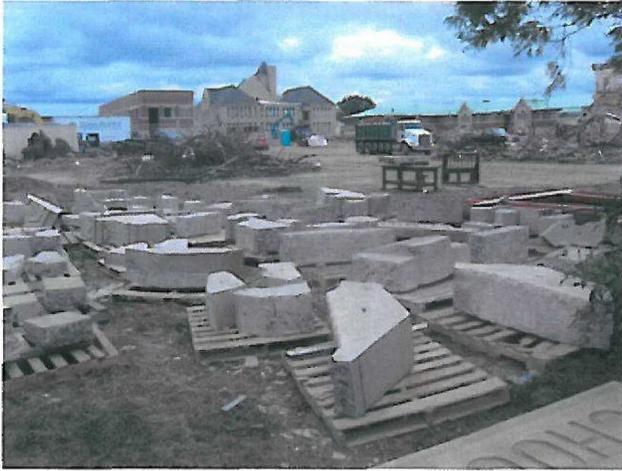
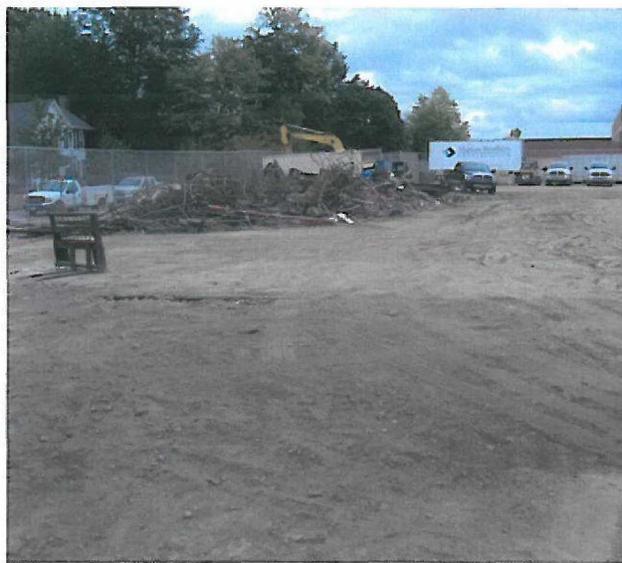
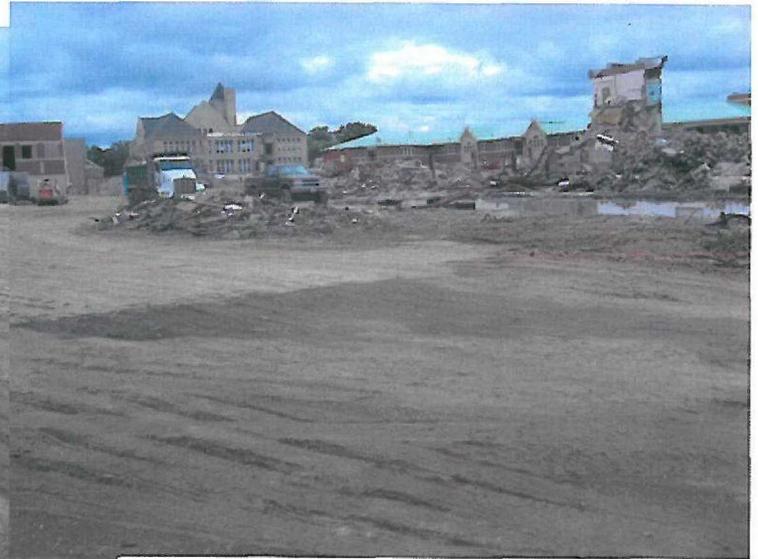
Fig 12 - 14. The sediment trap scheduled for the corner of 5th Street and West Ave (LEFT) has not been installed, yet the drainage area (BELOW) has been disturbed by construction activity.

- **Failure to install sediment ponds within 7 days of first grubbing and prior to grading.** This is a violation of Part III.G.2.d.i of the NPDES permit and Ohio Revised Code (ORC) 6111.04 and 6111.07. The construction drawings show that sediment traps are to be installed in the NE and NW corner of the site. These traps were not installed on the date of inspection and must be installed immediately. Please review specific sizing and elevations with the project engineer. Also, please review where discharges from these traps are to be directed with the project engineer. Be sure that the runoff discharging from these traps does not create a public safety issue or does not traverse over disturbed soils and become re-impacted by sediment. It may be more prudent to provide piped outlet structures typical of sediment basins rather than sediment traps. Diversions may be required along site perimeters to collect runoff and direct it to the appropriate trap. Review drainage areas with the project engineer.

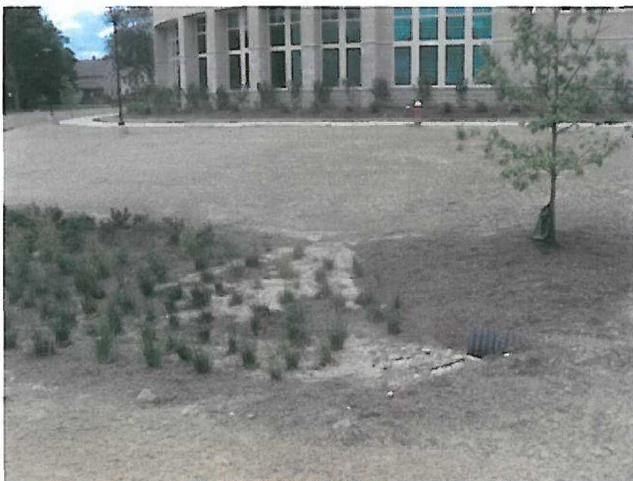
Fig 15 (LEFT). Sediment is washing into the bioretention cell at the corner of 6th Street and Middle Ave. Silt fence should be installed around the cell until the surrounding vegetation establishes.

- I noted that the bioretention cells for the first phase of this project have now been installed and the areas around the bioretention cells have been hydroseeded. However, vegetation has not yet established. As a result, I observed an appreciable amount of sediment washing onto to the surface of the bioretention cell at the SE corner of the site. Please be aware that this may cause the cell to fail prematurely. I recommend that silt fence be installed around the perimeter of the bioretention cells until such time that the vegetation around them establishes to a 70% or greater growth density. Installation of bioretention soil and plantings should be delayed until the areas adjacent to them have been stabilized.
