RE: CUYAHOGA COUNTY
CITY OF BROADVIEW HEIGHTS
GET GO SITE #3088
CONSTRUCTION STORM WATER

NOTICE OF VIOLATION

GET GO SITE #3088

City of Broadview Heights Cuyahoga County
NPDES Permit #3GC05513*AG

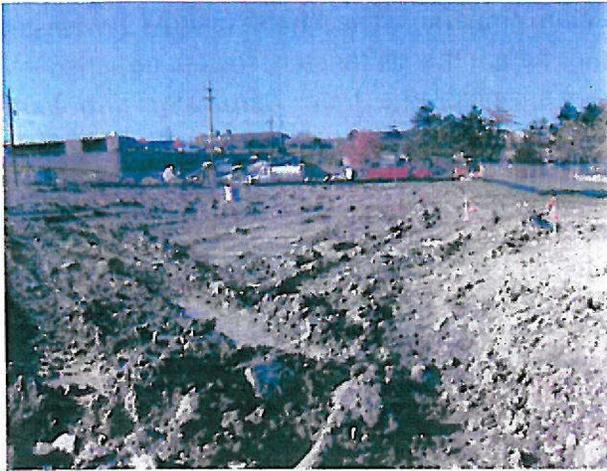
Fig 1 (LEFT). The sediment basin has not been installed. The SWP3 shows it is to be installed in this corner.

- **Failure to install the sediment basin prior to grading and within seven (7) days from the start of grubbing.** This is a violation of Part III.G.2.d.i of the NPDES permit and Ohio Revised Code 6111.04 and 6111.07. The SWP3 shows that a sediment basin is to be installed in the NW corner of the site. Mr. Jays indicated that the basin, as shown on the SWP3, is above existing grade and could not be installed until the grade was raised. However, the drainage area that is supposed to be directed to the sediment basin has been disturbed, graded and is susceptible to erosion. If it is not possible to install the sediment basin shown on the SWP3 and direct construction site runoff through it at this time, you must install a temporary sediment pond or other sediment control in compliance with the NPDES permit that can function until such time that the sediment basin shown on the SWP3 can be established. To address this violation, please install the sediment basin as shown on the SWP3 or amend the plan to provide interim controls. **NOTE:** The approval of interim controls may require review and approval through Cuyahoga SWCD. Please contact Lisa Vavro at (216) 524-6580 ext 12 for further guidance on the SWP3 revision process.

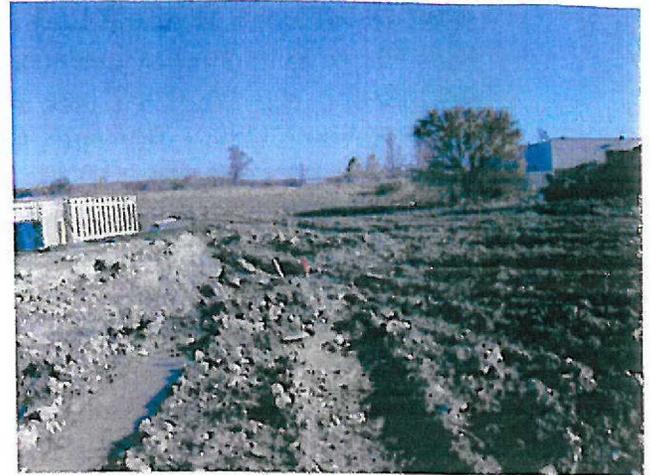
Fig 2 (RIGHT). Currently, the site is graded to drain north onto an adjacent landfill. There is no perimeter control or diversion to a sediment pond to retain sediment on the construction site.

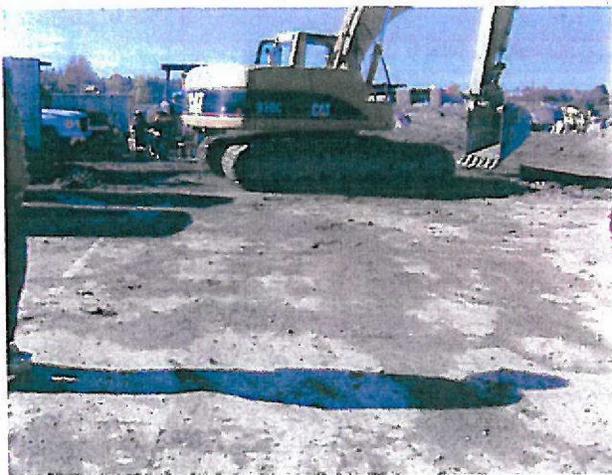
Fig 3 (LEFT). Photo shows off-site tracking of sediment onto an adjacent parking lot on the east side of the project. The SWP3 does not indicate a construction entrance at this location.

- **Additional perimeter controls needed.** Construction crews have been accessing the site from an unauthorized construction entrance on the east side of the site. This has resulted in off-site tracking of sediment onto an adjacent parking lot with active storm drainage. Please discontinue use of the unauthorized construction entrance and establish perimeter sediment controls across the (former) entrance. Perimeter controls are also needed across the north side of the site as shown on the SWP3. Perimeter controls may include silt fence, filter socks or compost filter berms (specifications enclosed).

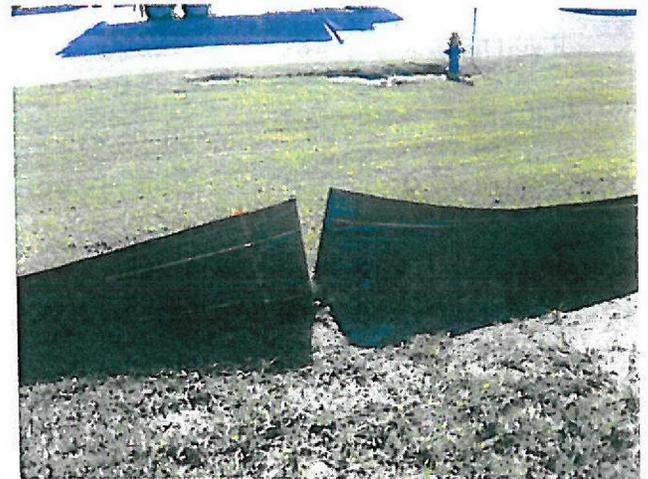
Fig 4 (RIGHT). Perimeter silt fence along SR 82 (Royalton Road) has not been installed properly. The joints between two rolls of silt fence must be twisted together to prevent the formation of gaps.

- **Perimeter silt fence along SR 82 requires maintenance.** The joints between two (2) roles of silt fence have not been connected properly. The stakes should be twisted together so as to create a continuous barrier before the silt fence is staked, trenched into the ground and backfilled (see enclosed specifications from *Rainwater and Land Development, Ohio's Standards for Stormwater Management, Land Development and Urban Stream Protection*, ODNR, 2006). Please repair the silt fence and ensure it is installed per accepted specifications.

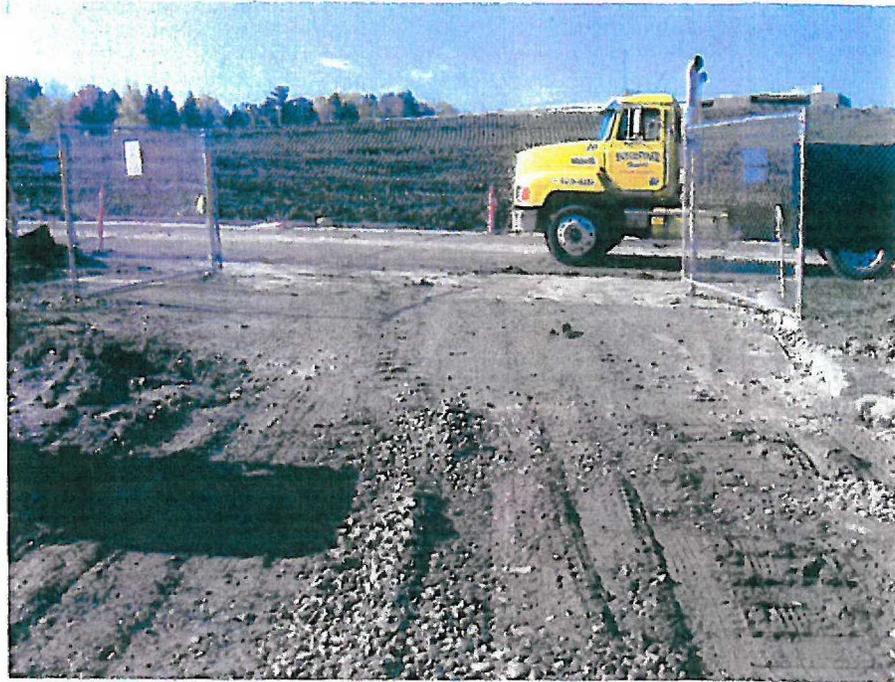
Fig 5. The main rock construction entrance must be redressed with stone to minimize off-site tracking onto Treeworth Blvd. In addition, the paved apron off Treeworth must be swept to remove sediment that has accumulated on it.

- **The rock construction entrance requires maintenance.** Please redress with stone as needed to maintain a clean surface. Sweep the paved apron and roadways if sediment is tracked off-site.
- **The soil stockpile was not stabilized.** Please be aware that any disturbed portions of the construction site, including soil stockpiles, must be temporarily stabilized if they will remain idle for 21 days or longer. Temporary stabilization must be initiated within seven (7) days of most recent earth disturbance in that area. Mr. Jays indicated that soil in the

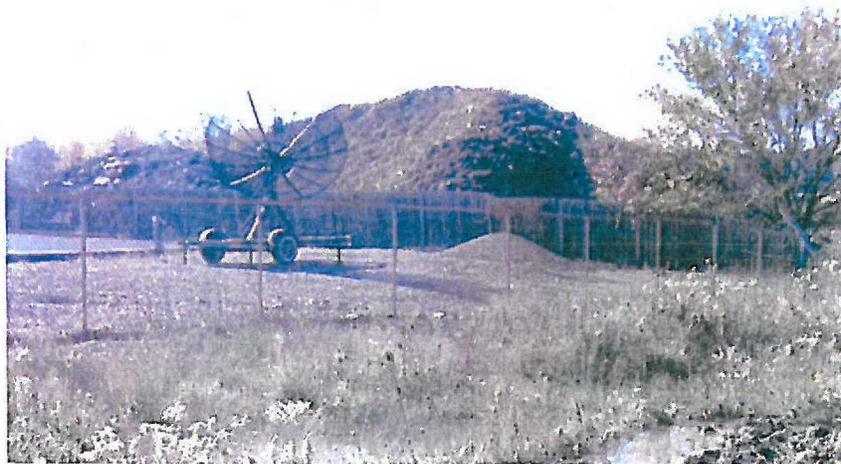
Fig 6. The soil stockpile has not been stabilized. It must be stabilized (seeded, mulched, tarped or covered with erosion control blanket) if it will remain idle for 21 days or longer.

stockpile would be used as fill across the site and that it would not remain idle for 21 days or longer. Please monitor the soil stockpile and other disturbed areas of the site to ensure that you are initiating temporary stabilization as required by the NPDES permit.
