RE: Pretreatment Compliance Inspection and  
Notice of Significant Non-Compliance

# PRETREATMENT INSPECTION REPORT

**Millat Industries Corp. - MPP Division  
7611 Center Point 70 Blvd.  
Huber Heights, OH 45424**

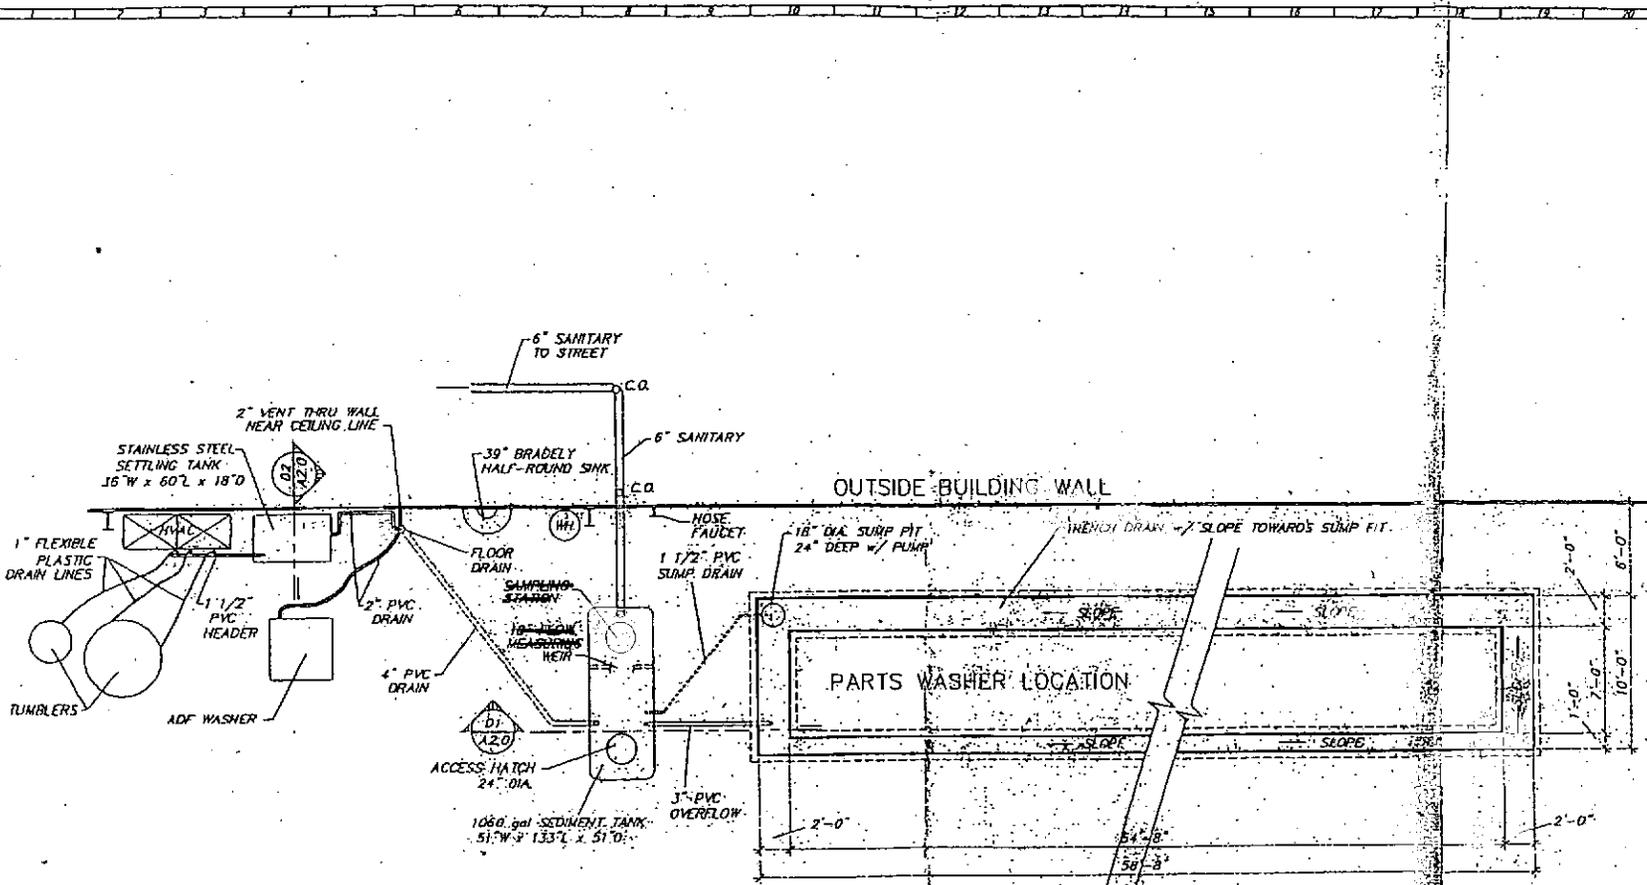
**Floor Plan**

**The system consists of simply a settling tank (including one serving the tumbling operations). During cleanings, the pH of the process wastewater tank dumps is adjusted in the trench that is adjacent to the process line. Solids are retained behind the trench screen and removed.**
