State of Ohio Environmental Protection Agency

Re: Construction Storm Water Inspection at Ohio Eastern Star Home

This letter is written in follow-up to a construction storm water inspection Ryan Griffin and Rachelle Howe, of Ohio EPA, conducted at Ohio Eastern Star Home located at 1451 Gambier Road in Knox County on July 21, 2009. The purpose of the inspection was to evaluate compliance with the General Storm Water Permit Associated with Construction Activities. During the inspection, the following items were noted:

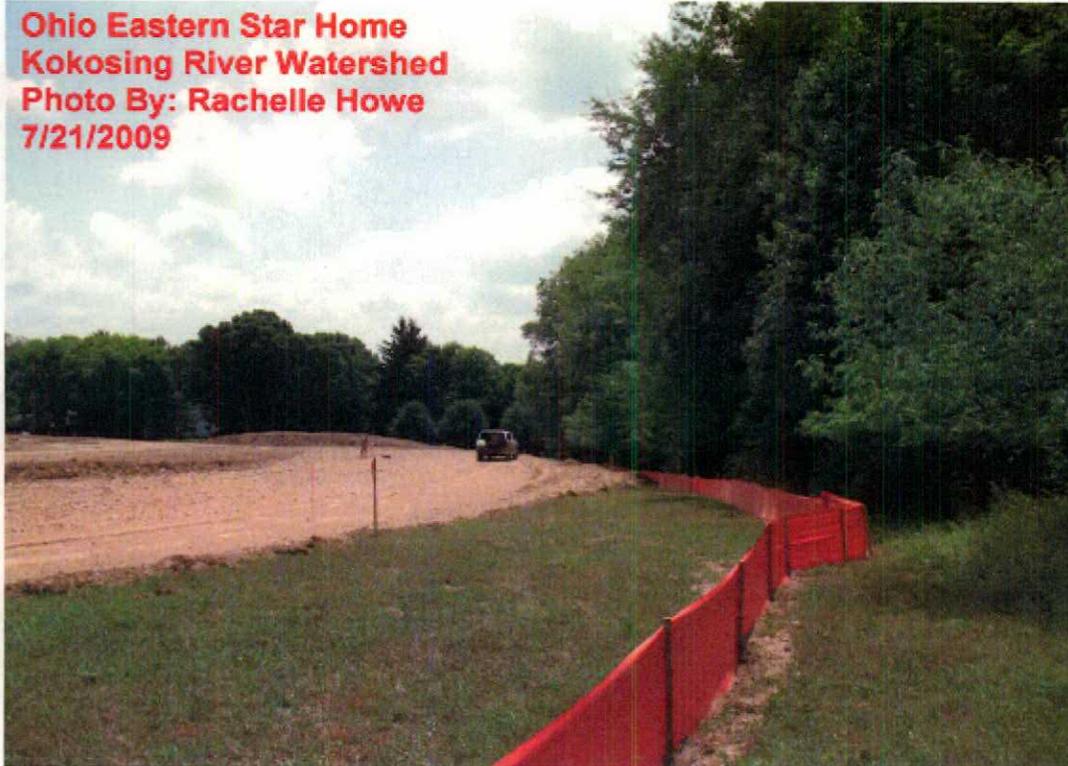
- The silt fence established along the perimeter of the site appears to be functioning as intended (See Figure 1). Please ensure that all sediment controls are inspected and maintained every seven days or within 24 hours of a precipitation event equal to or greater than 0.5 inches as required by the general permit.
- It appears that the centralized sediment basin for this site is currently under construction on the northwest corner of the site (See Figure 2). This basin must be completed within 10 days from receipt of this letter.
- Be aware the General Permit states that all barren areas which remain idle in excess of 21 days must be protected from erosion within seven days of the last earth disturbing activities. In addition, erosion protection must be implemented for all areas of final grade within seven (7) days.

Figure 1 Established Silt Fence Along Western Perimeter

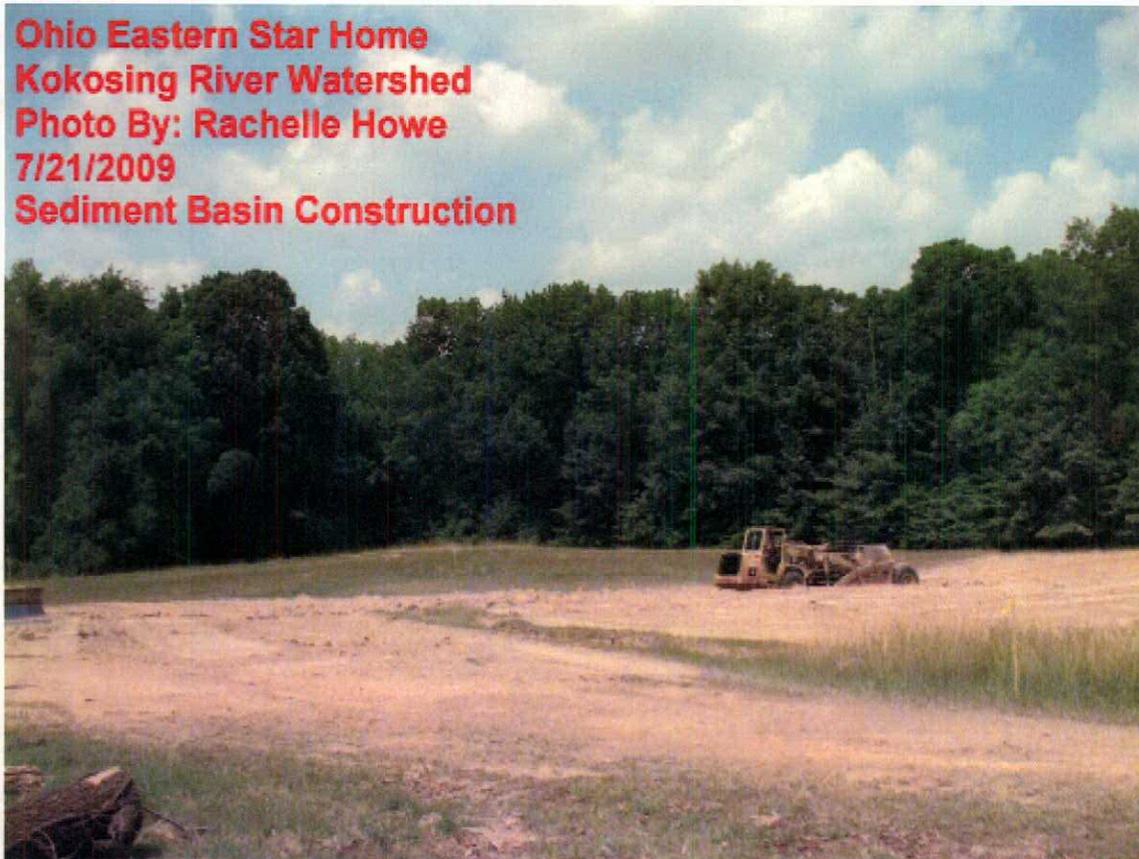
Figure 2 Sediment Basin Construction Located on NW Corner of Site
