JOHNSON TRANSFER AND RECYCLING

March 12, 2010

**Re: Johnson Transfer and Recycling / Frankling County  
Industrial Storm Water Permit 4GR00451\*DG**

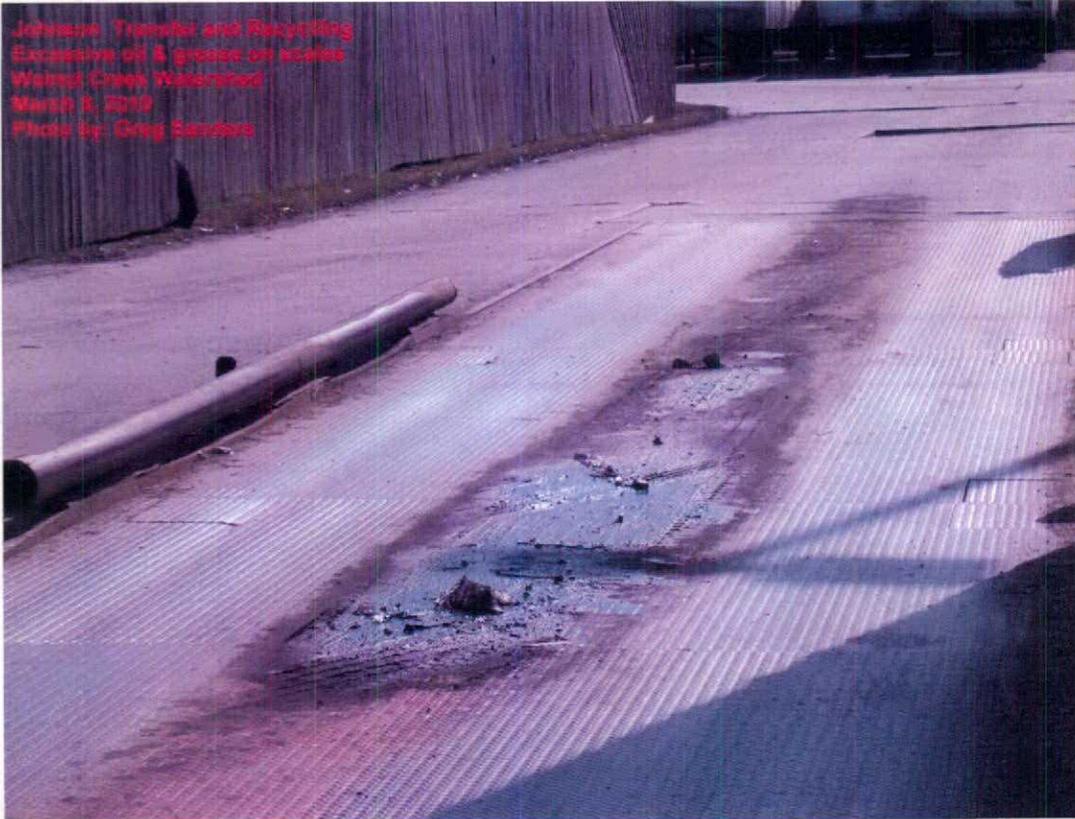
3. There was excessive oil and grease (O&G) on the scales. Please immediately remove O&G from scales and dispose of properly. Please see attached picture.

Johnson Transfer and Recycling  
Excessive oil & grease on scales  
Walnut Creek Watershed  
March 8, 2010  
Photo by: Greg Sanders

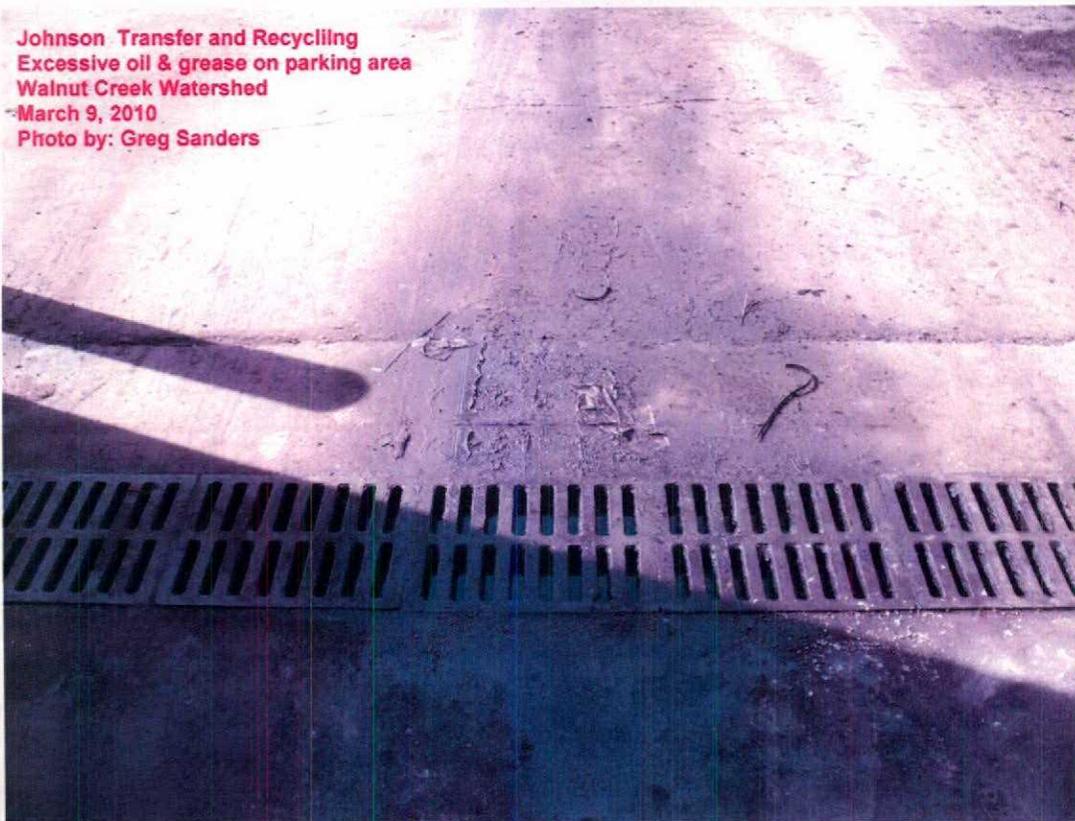
4. There was excessive O&G located on the pavement near the maintenance garage. Please immediately remove O&G from pavement and dispose of properly. Controls must be implemented immediately to prevent O&G from discharging to the storm water drains. Please see attached pictures.

Johnson Transfer and Recycling  
Excessive oil & grease on parking area  
Walnut Creek Watershed  
March 9, 2010  
Photo by: Greg Sanders

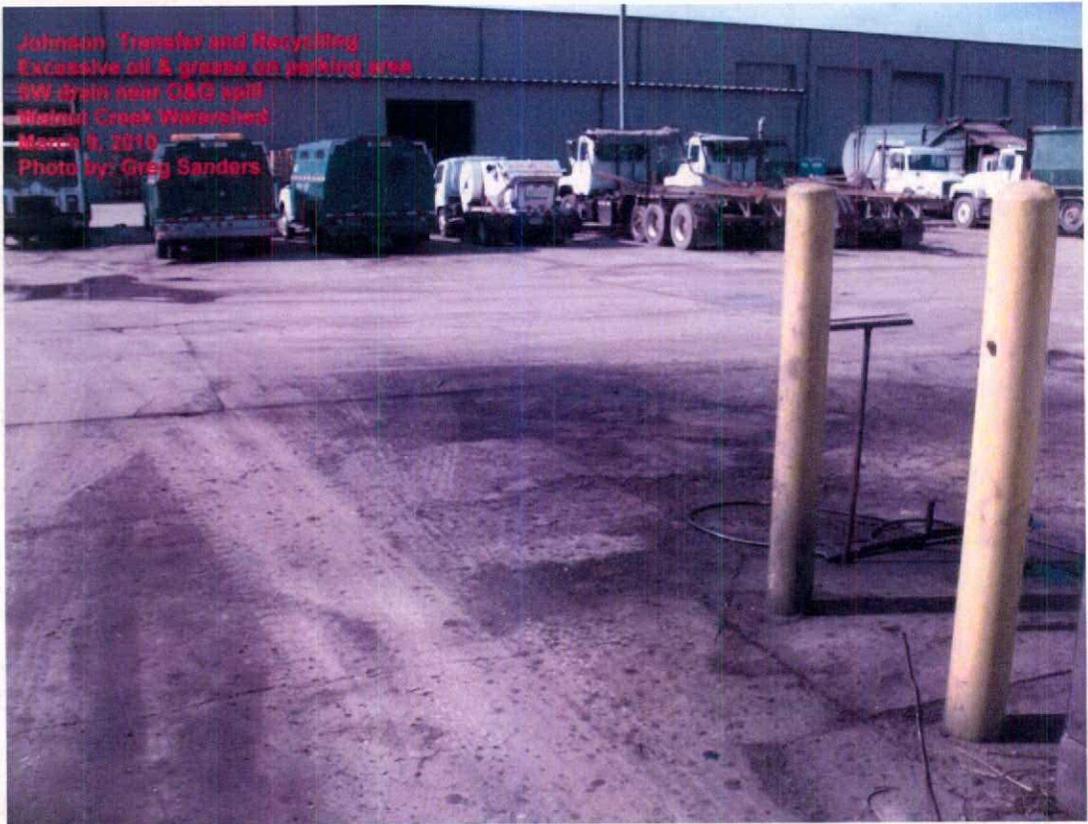
Johnson Transfer and Recycling  
Excessive oil & grease on parking area  
SW drain near O&G spill  
Walnut Creek Watershed  
March 9, 2010  
Photo by: Greg Sanders

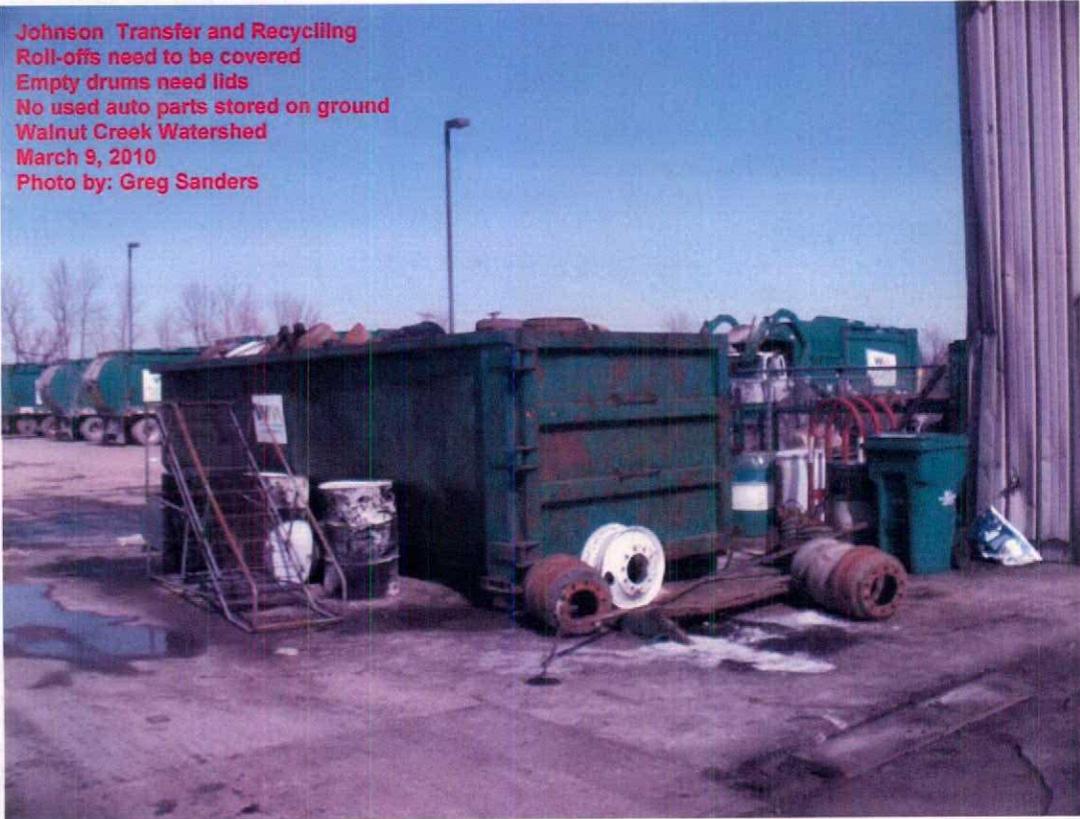
5. There were used truck parts in trash roll-offs without covers. Also the trash roll-offs were not structurally sound and could leak. Please install covers on trash roll-offs. You may also store the truck parts inside. Please see attached pictures.

Johnson Transfer and Recycling  
Roll-offs need to be covered  
Empty drums need lids  
No used auto parts stored on ground  
Walnut Creek Watershed  
March 9, 2010  
Photo by: Greg Sanders

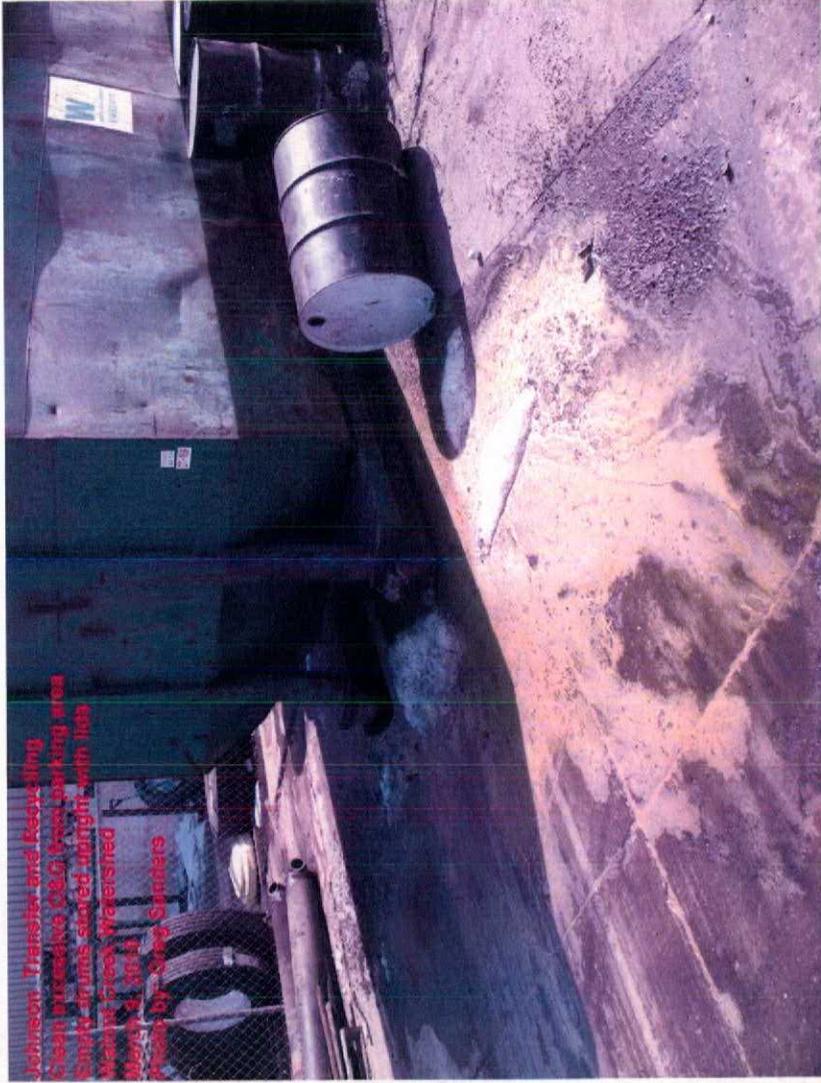
Johnson Transfer and Recycling  
Clean up of 55-gal drum parking area  
Empty drums stored upright with lids  
Walnut Creek Watershed  
March 9, 2010  
Photo by Greg Sanders

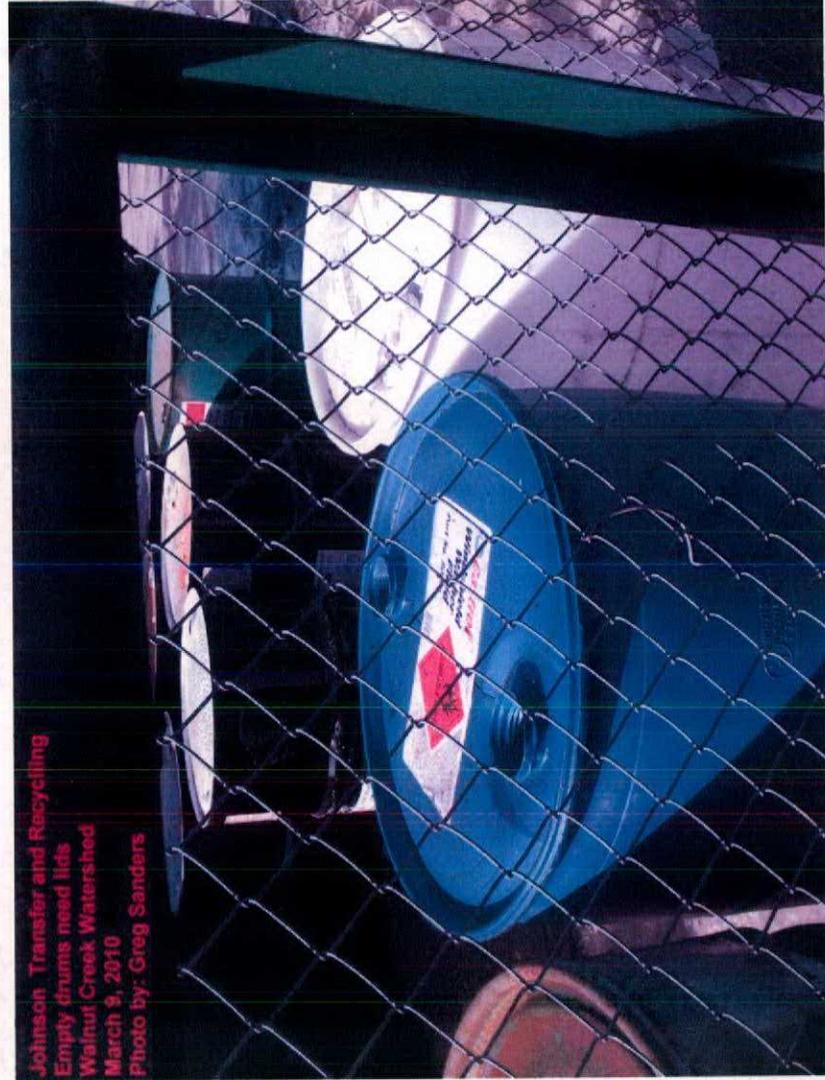
6. There were empty drums laying on their side and without lids. Please store empty drum upright and with lids. Please see attached pictures.

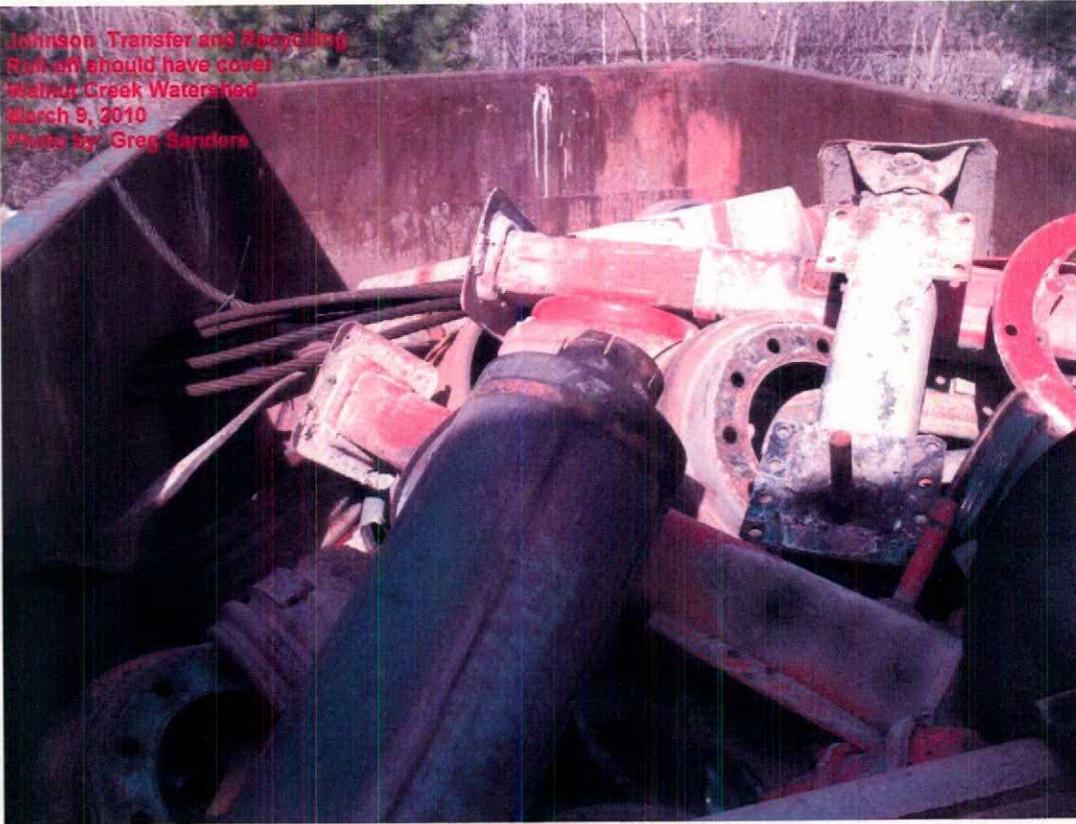
Johnson Transfer and Recycling  
Rin off should have cover  
Walnut Creek Watershed  
March 9, 2010  
Photo by: Greg Sanders

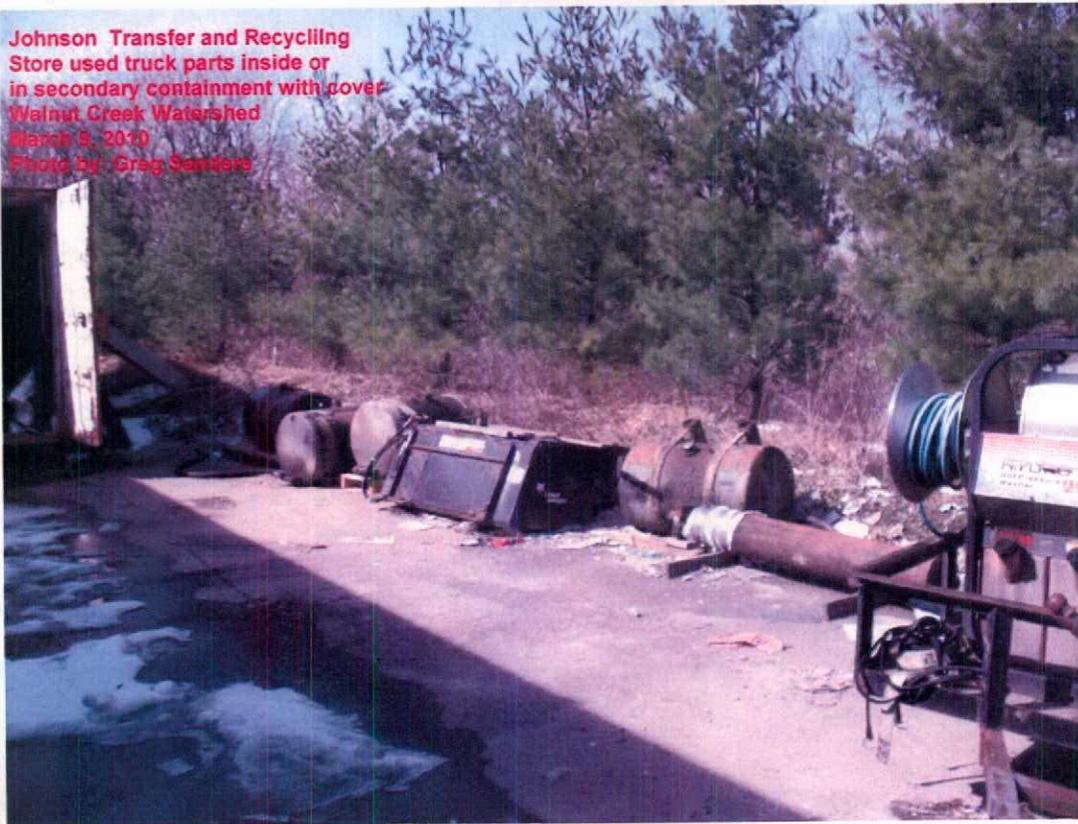
7. There were used truck parts (gas/diesel tanks and used brakes) stored on pavement. These tanks and used brakes must be stored inside or in secondary containment and under roof. Please see attached pictures.
8. The diesel fueling station needs to have a spill kit located near the fueling station.
9. Trucks appeared to be repaired outside. The oil and filter were leaking badly from the repairs. Please repair inside and prevent leaks to outside pavement. Please see attached picture.
10. Drums of used oil were stored outside without secure lids and secondary containment. Please install tight lids and put drums in secondary containment or store drums inside building. Please see attached picture.

Johnson Transfer and Recycling  
Store used truck parts inside or  
in secondary containment with cover  
Walnut Creek Watershed  
March 9, 2010  
Photo by: Greg Sanders

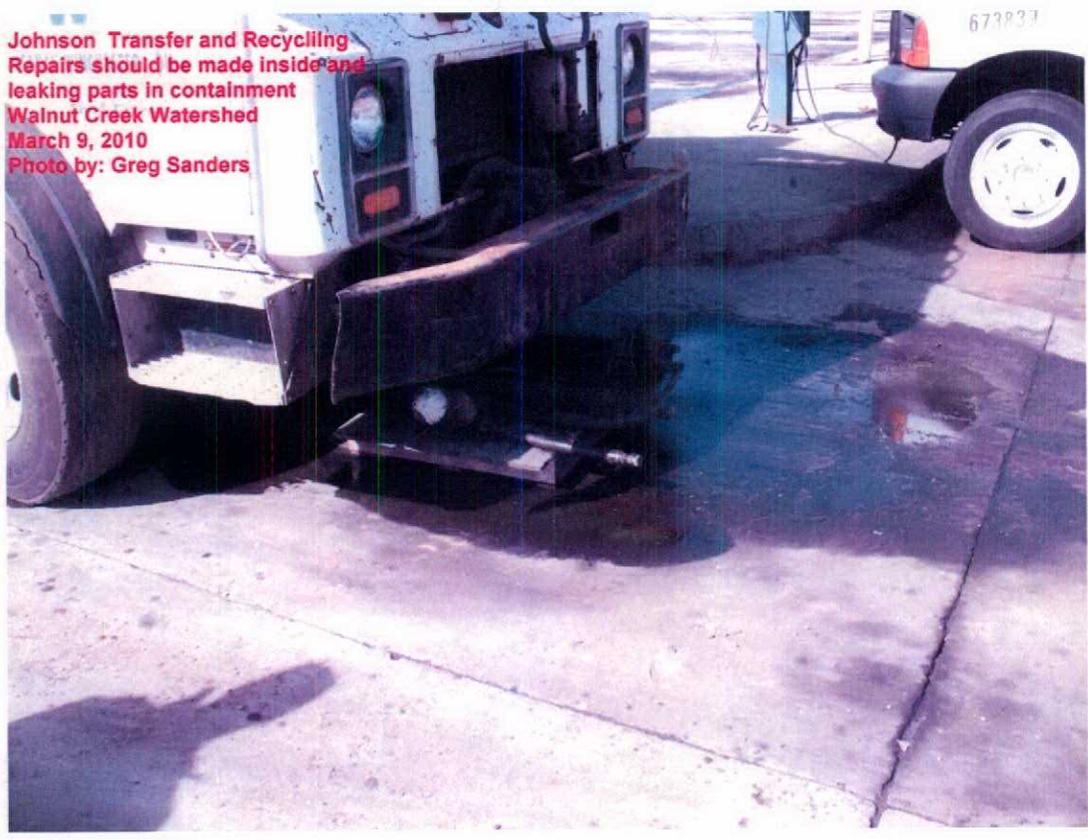
Johnson Transfer and Recycling  
Repairs should be made inside and  
leaking parts in containment  
Walnut Creek Watershed  
March 9, 2010  
Photo by: Greg Sanders

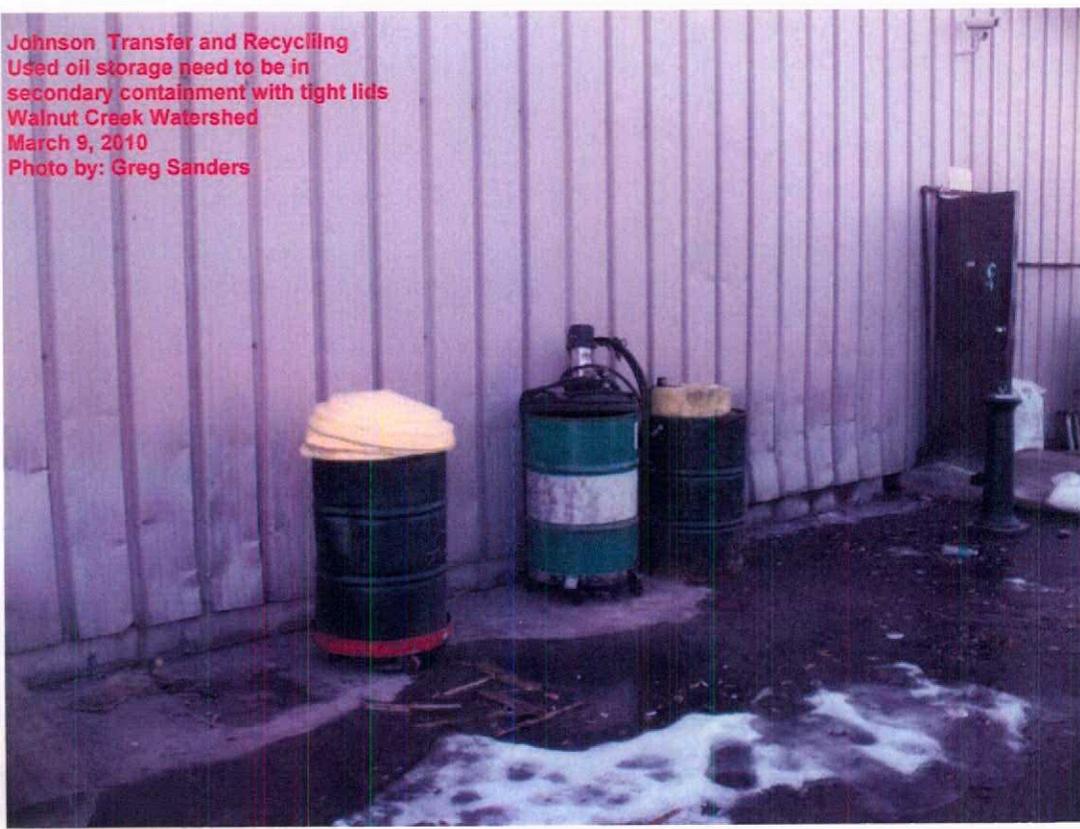
Johnson Transfer and Recycling  
Used oil storage need to be in  
secondary containment with tight lids  
Walnut Creek Watershed  
March 9, 2010  
Photo by: Greg Sanders
