HOCKING RIVER WETLAND AND STREAM  
RESTORATION

October 6, 2010

**Re: Construction Storm Water Inspection at Hocking River Wetland and Stream  
Restoration / Fairfield County  
Permit Number 4GC03234\*AG**

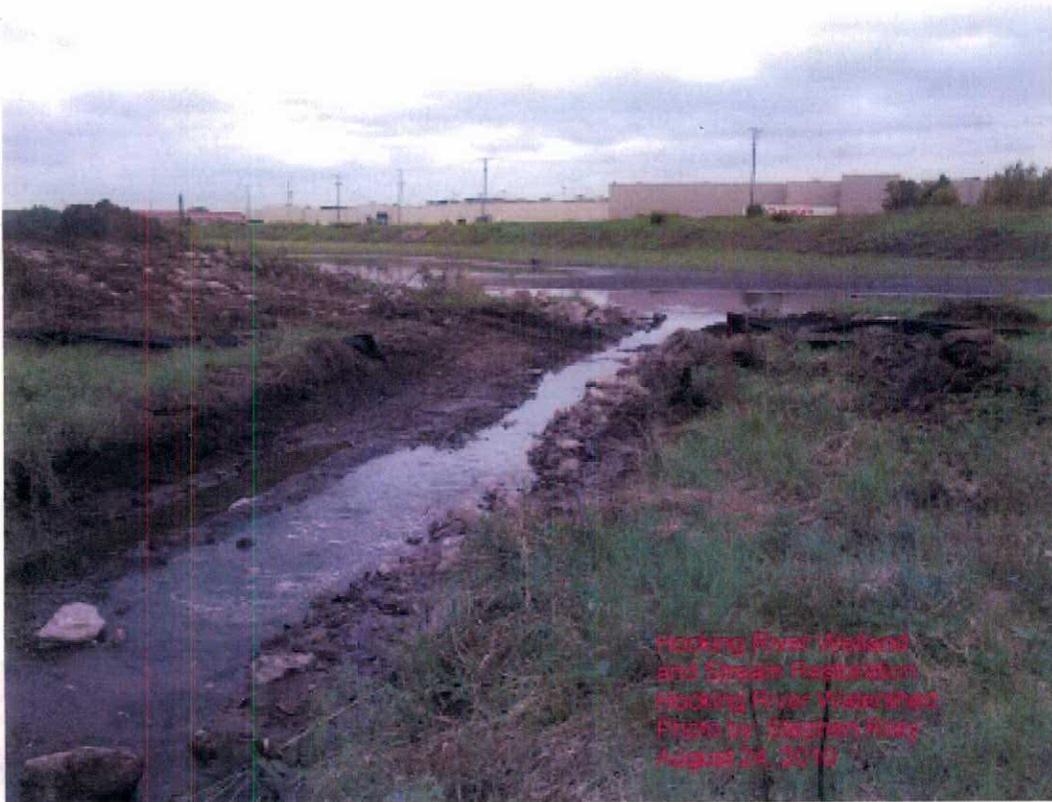
- During the site investigation, it was found that a keyway cut was installed in the side of the retaining wall separating the drainage valley from the Hocking River (Figure 1). The lack of controls on the keyway cut are not acceptable under the General Storm Water Permit Associated with Construction Activities. The addition of a check dam or series of check dams are expected to ensure the sediment laden discharges are minimized.

Figure 1: Keyway dewatering into Hocking River
