**Re: Storm Water Inspection at Delaware Health Village Phase I
Permit #4GC02678*AG**

This letter is written in follow-up to a construction storm water inspection by Amber Miller and Rachelle Howe, of the Ohio EPA, at Delaware Health Village Phase I located East of Glenn Parkway in Delaware County on September 17, 2009. The purpose of the inspection was to ensure continued compliance with the General Storm Water Permit Associated with Construction Activities. During the inspection, the following items were noted:

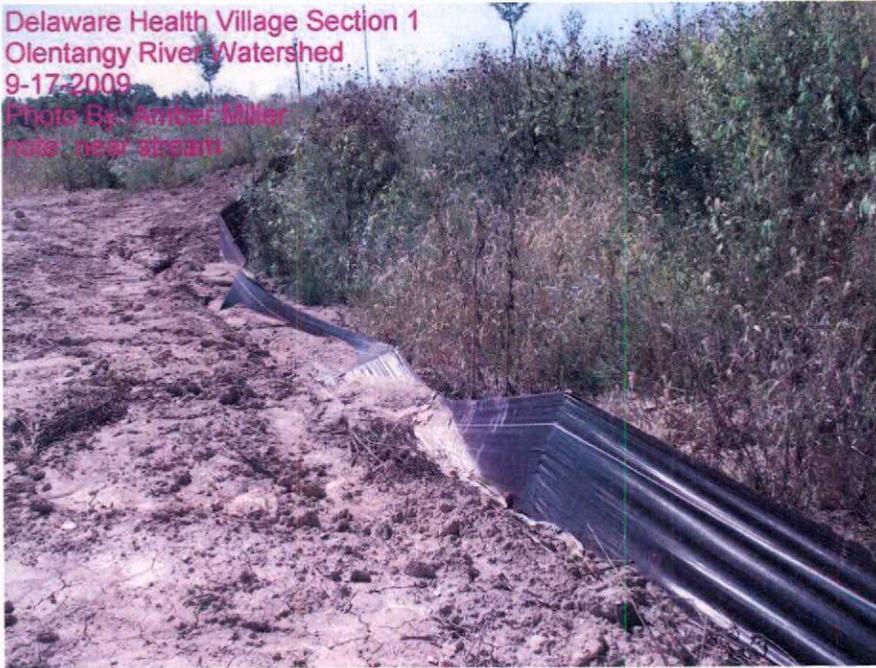
Figure 1

- The silt fence near the stream requires repair or reinstallation to provide adequate protection against sediment entering the stream (See Photo Figure 1).
- Be aware the General Permit states that all barren areas which remain idle in excess of 21 days must be protected from erosion within seven days of the last earth disturbing activities. In addition, erosion protection must be implemented for all areas of final grade within seven (7) days. This is especially important for the area near the stream (See Photo Figure 2).

Delaware Health Village Section 1
Olentangy River Watershed
9-17-2009
Photo By: Amber Miller
note: near stream

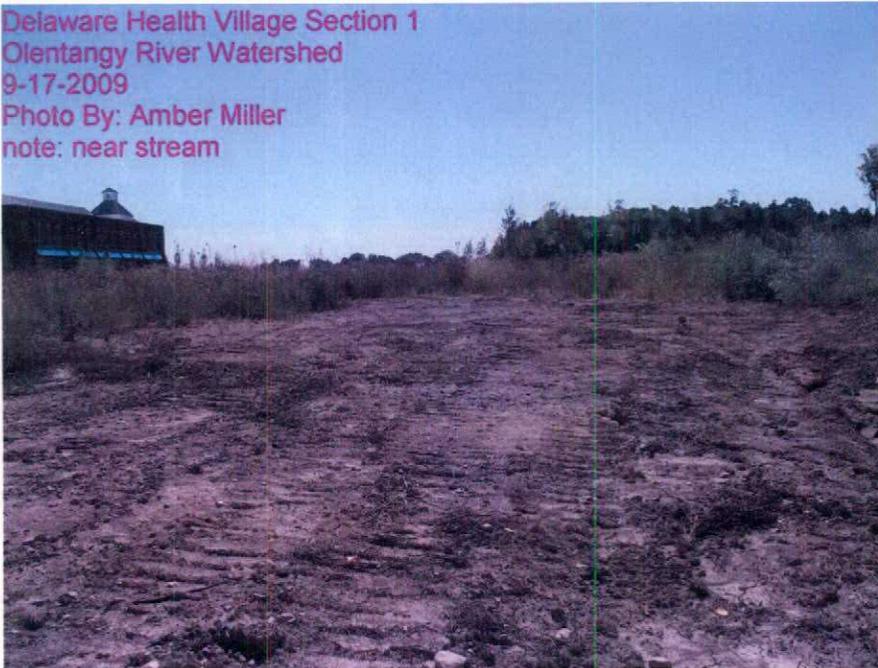
Figure 2

Delaware Health Village Section 1
Olentangy River Watershed
9-17-2009
Photo By: Amber Miller
note: near stream
