Re: Creative Housing XIII, Franklin County

This letter is written in follow-up to a construction storm water inspection that I conducted at the Creative Housing XIII project that is located at the end of Lamplighter Drive, in Grove City, Ohio. The inspection was conducted on June 22, 2011. The purpose of the inspection was to evaluate compliance with the General Storm Water Permit Associated with Construction Activities.

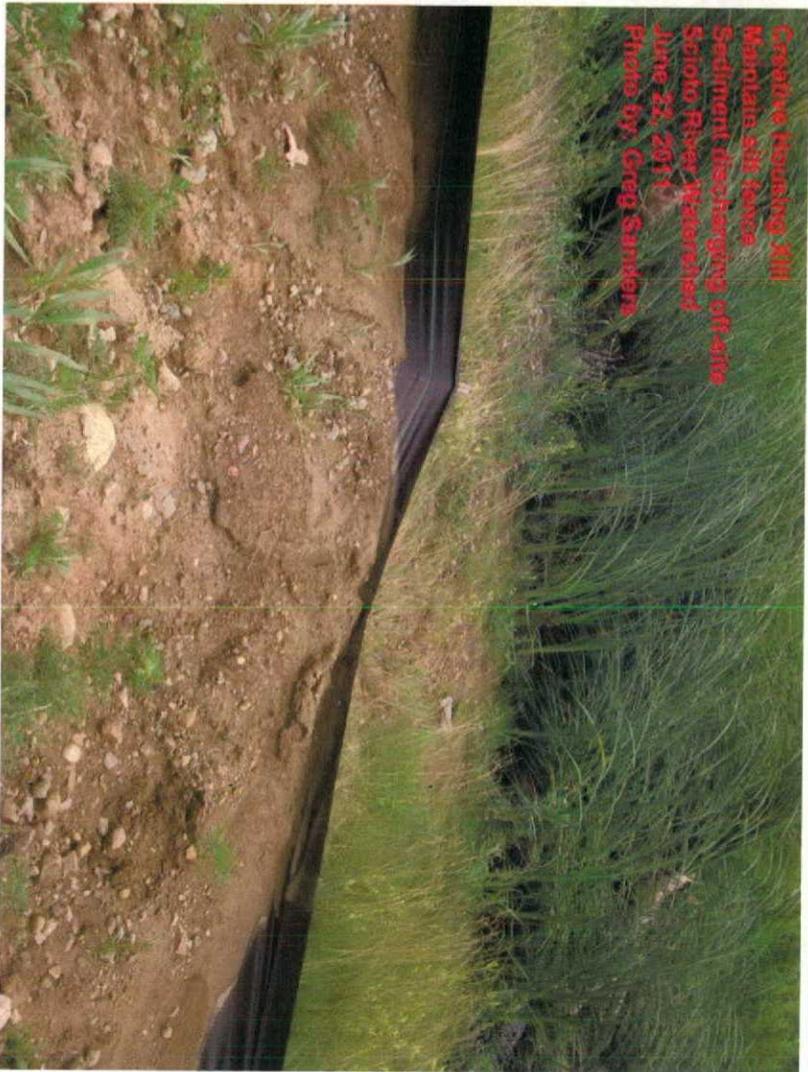
**Creative Housing XIII
Maintain silt fence
Sediment discharging off site
Scioto River Watershed
June 22, 2011
Photo by: Greg Sanders**

Please maintain erosion controls around the perimeter of the site. I noted numerous sections that needed repaired and sediment was discharging off-site. Please see attached pictures.

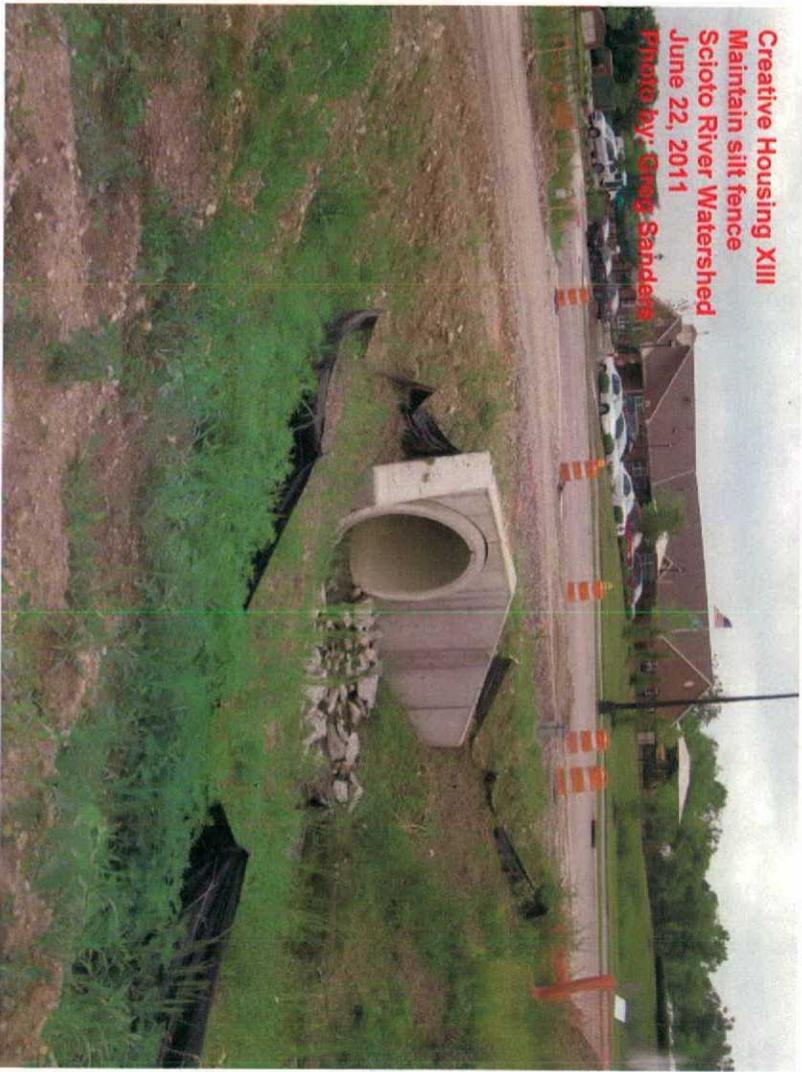
**Creative Housing XIII
Maintain silt fence
Scioto River Watershed
June 22, 2011
Photo by: Greg Sanders**
