GS/nsm Fairfield Union HS, June 9, 2011

FAIRFIELD UNION MIDDLE SCHOOL & US RT 22
WIDENING

Re: Coughlin Automotive - Circleville, Pickaway County

This letter is written regarding the storm water inspection that I conducted at Coughlin Automotive located at 24001 US Route 23 South, in Circleville, Ohio. The inspection was conducted on June 14, 2011. I understand that these construction activities are currently covered under the General Storm Water Permit Associated with Construction Activities. Based on my site inspection and the General Storm Water Permit, the following items must be addressed.

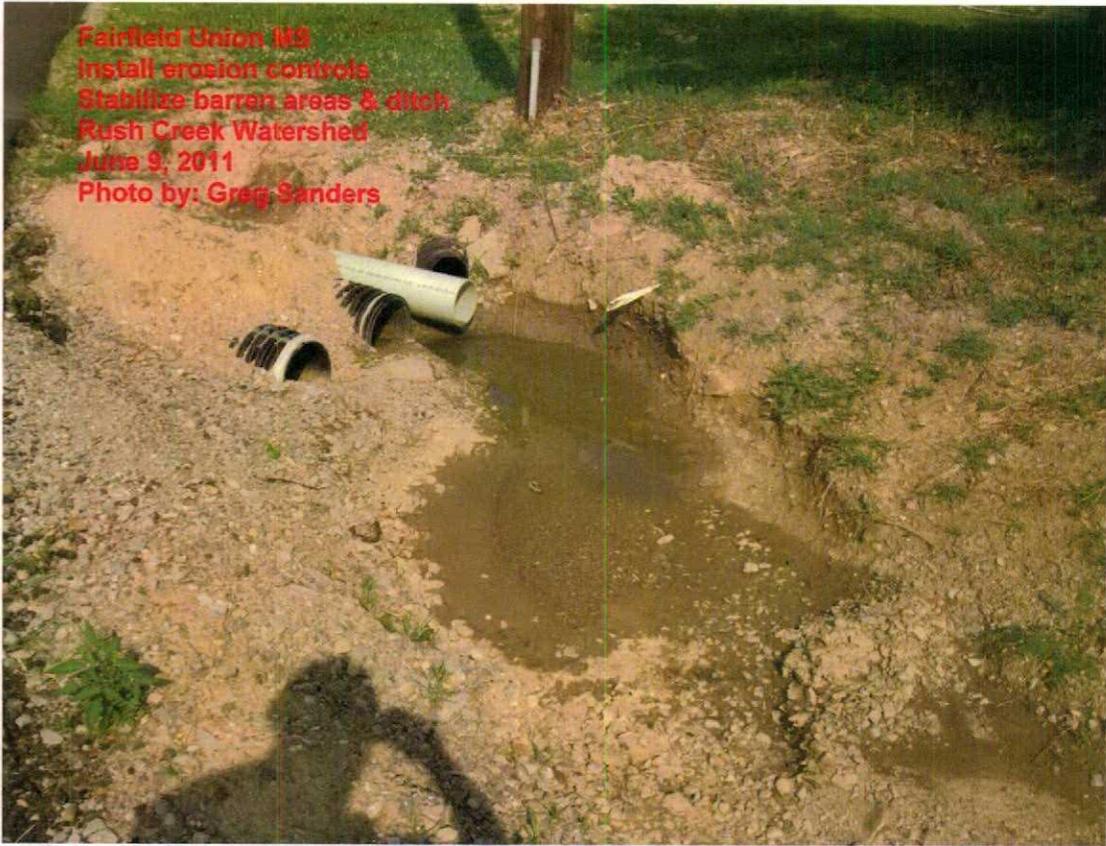
Fairfield Union MS
Install erosion controls
Stabilize barren areas & ditch
Rush Creek Watershed
June 9, 2011
Photo by: Greg Sanders

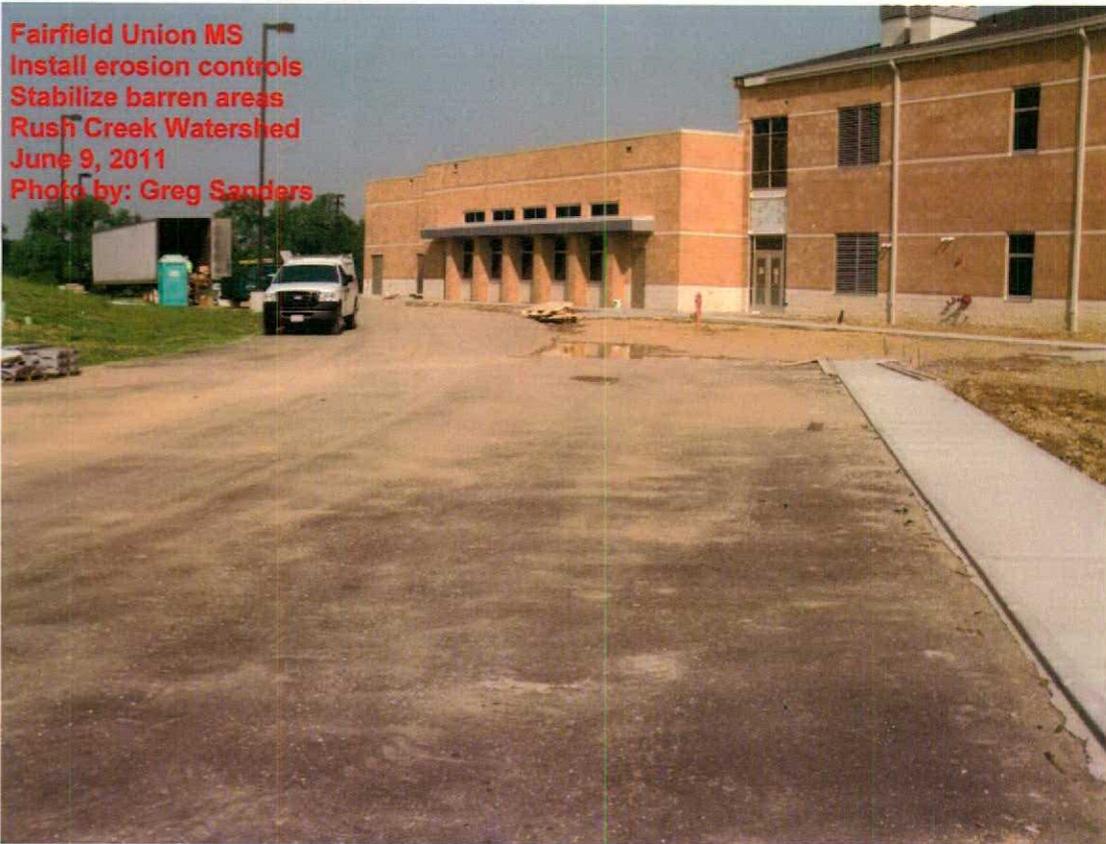
Fairfield Union MS
Install erosion controls
Stabilize barren areas
Rush Creek Watershed
June 9, 2011
Photo by: Greg Sanders

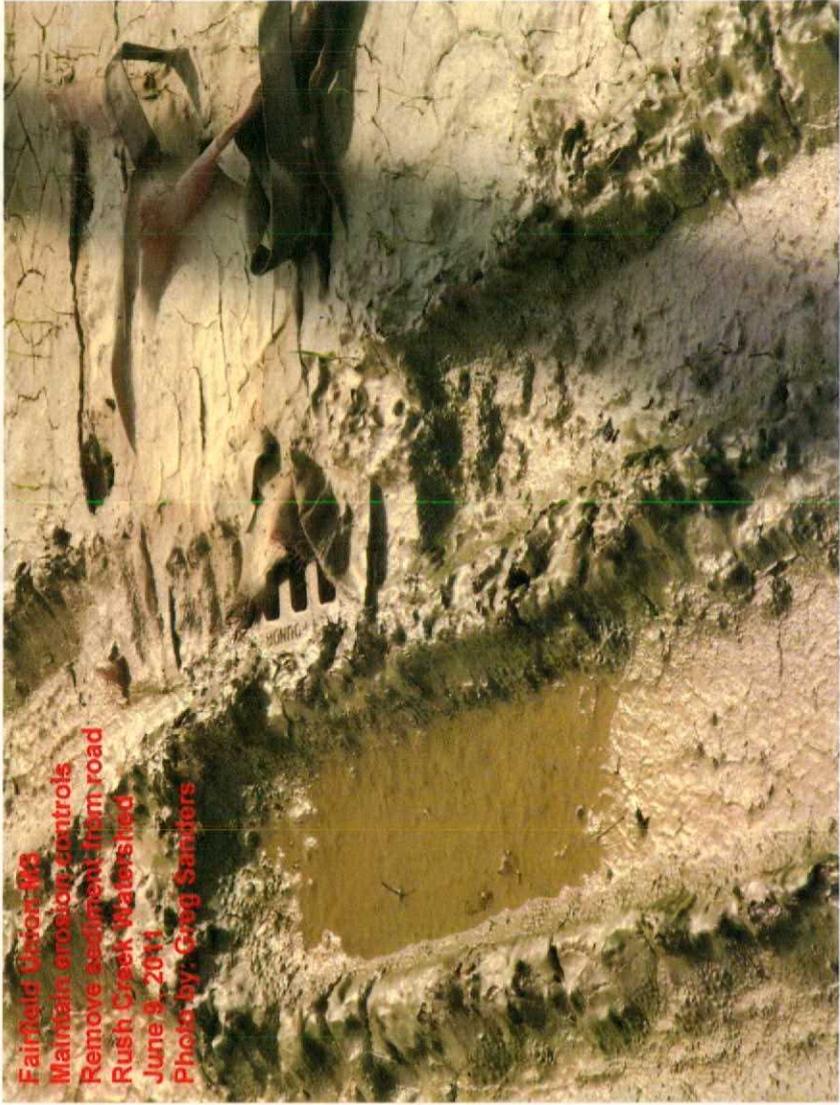
Fairfield Union MS
Maintain erosion controls
Remove sediment from road
Rush Creek Watershed
June 9, 2011
Photo by Greg Sanders

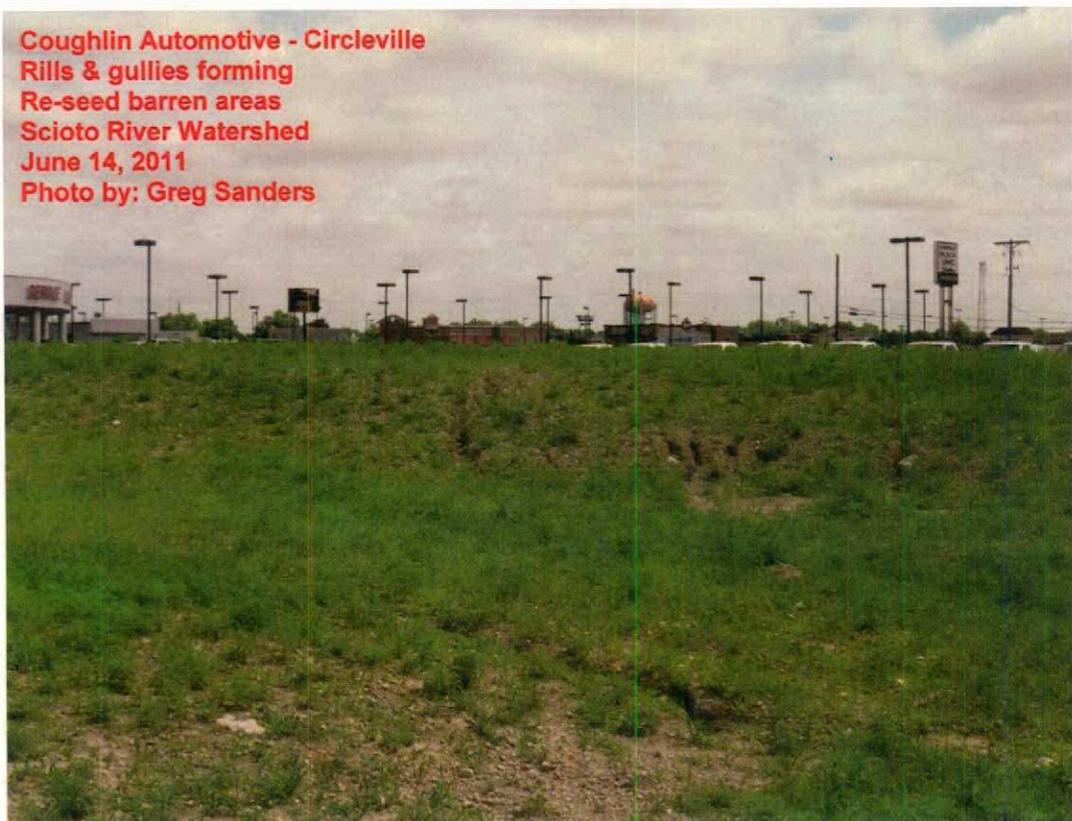
1. Most of the site was stabilized and construction appeared to be completed. However, there are several areas that will need to be re-seeded. There is a lot of sediment discharging to the storm water drains. There are rills and gullies forming which further allow the site to erode. Please re-seed and stabilize barren areas. Please see attached pictures.

Coughlin Automotive - Circleville
Rills & gullies forming
Re-seed barren areas
Scioto River Watershed
June 14, 2011
Photo by: Greg Sanders
