**Environmental
Protection Agency**

May 9, 2011

Re: Fairfield Union Middle School / Fairfield County

This letter is written in follow-up to a construction storm water inspection that I conducted at the Fairfield Union Middle School project along State Route 22. This site is located at 6401 Cincinnati-Zanesville Road near Rushville, Ohio and the inspection was conducted on April 26, 2011. The purpose of the inspection was to evaluate compliance with the General Storm Water Permit Associated with Construction Activities. During the inspection, the following items were noted:

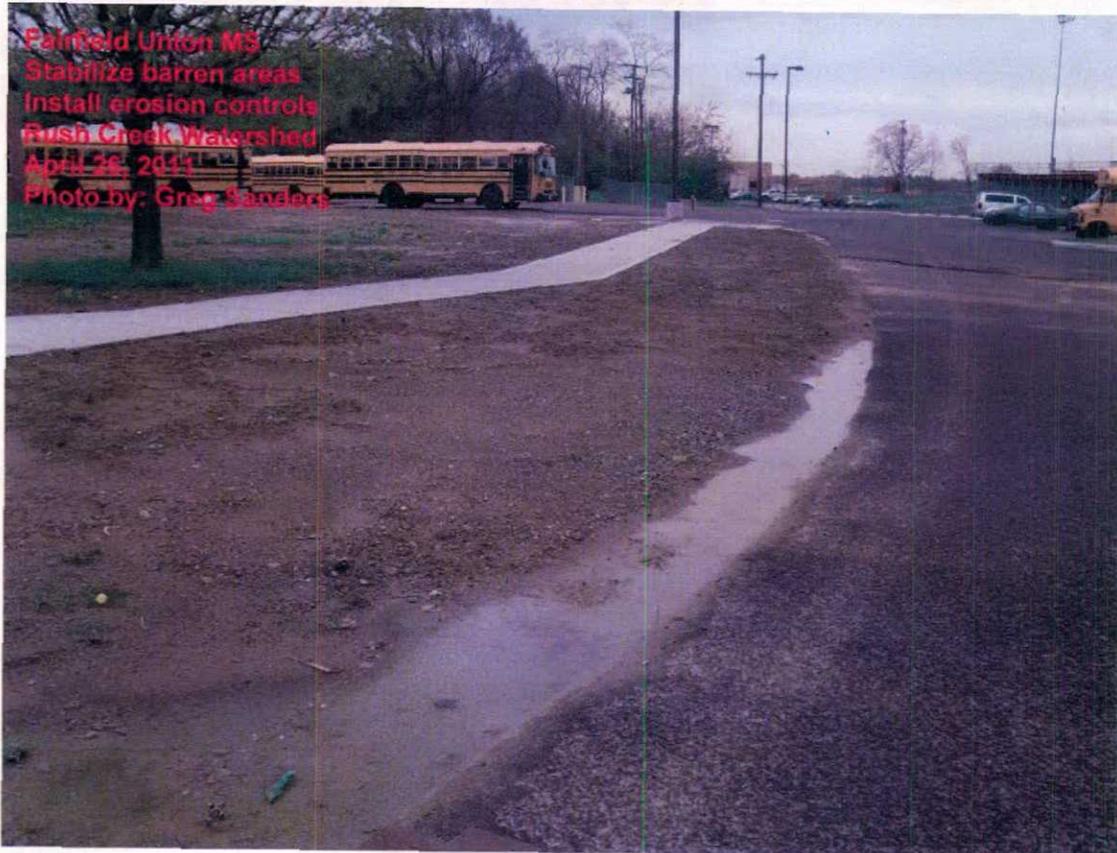
There was an area in the rear of the school that was barren and needed to be stabilized. Also, there were no erosion controls around the barren area and the site was eroding on to the driveway. Please be aware the General Permit states that all barren areas which remain idle in excess of 21 days must be protected from erosion within seven days of the last earth disturbing activities. In addition, erosion protection must be implemented for all areas of final grade within seven (7) days. Please see attached pictures.

Fairfield Union MS
Stabilize barren areas
Install erosion controls
Rush Creek Watershed
April 26, 2011
Photo by: Greg Sanders

Silt fence needs to be installed and maintained around the barren areas in the rear of the middle school.
