Environmental
Protection Agency

Re: Villas at Roxton Ravines, Fairfield County

This letter is written regarding the storm water inspection that I conducted at the Villas at Roxton Ravines located near the intersection of Ety Road and Fair Avenue, in Lancaster, Ohio, on May 2, 2011. I understand that these construction activities are currently covered under the General Storm Water Permit Associated with Construction Activities. Based on my site inspection and the General Storm Water Permit, the following items must be addressed.

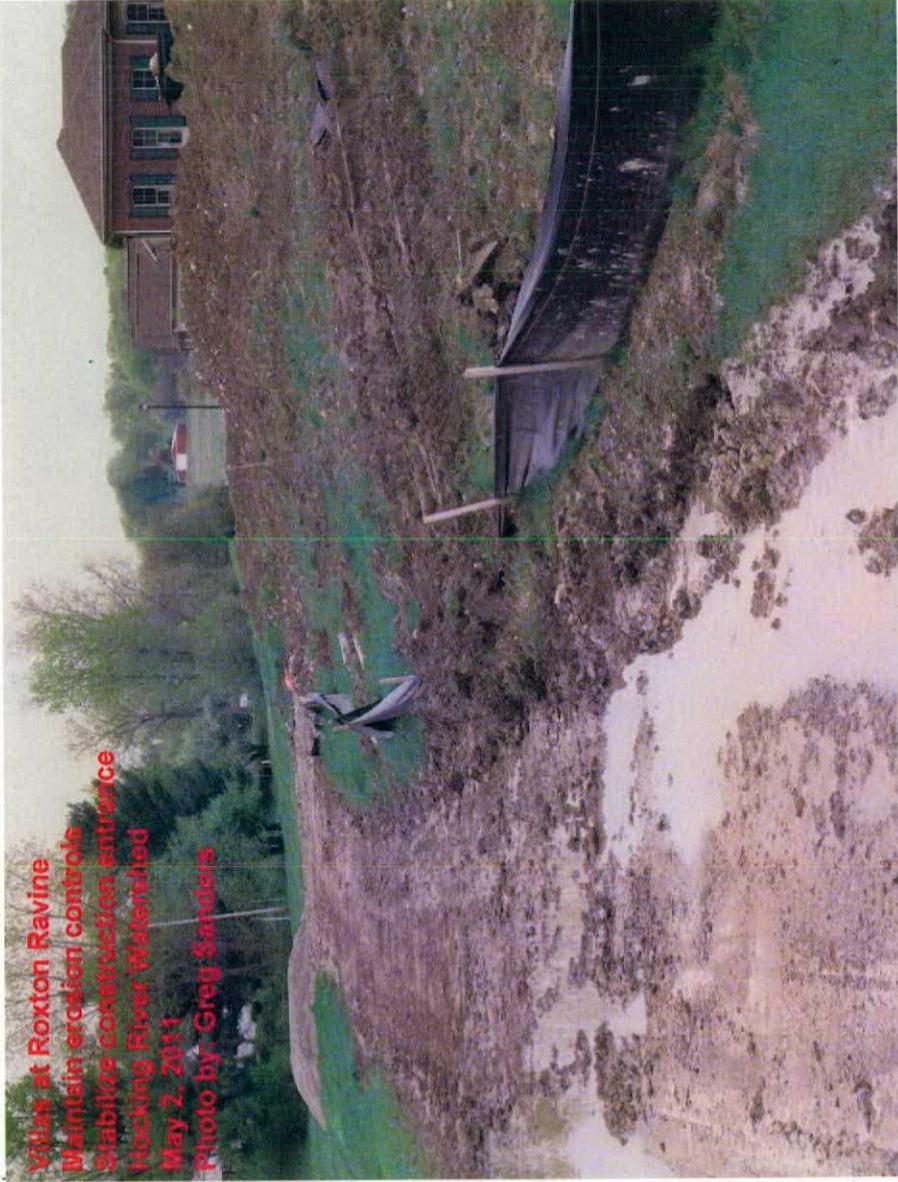
Work at Roxton Ravine
Maintain erosion controls
Stabilize construction entrance
Hocking River Watershed
May 2, 2011
Photo by: Greg Sanders

1. I noted active construction at the site. Most of the site had been stabilized. Please stabilize the construction entrance.
2. Perimeter silt fencing was installed around the active construction at the site, however it needed to be maintained. Please maintain the silt fencing around the construction area. There was a storm drain that needed to have a dandy bag filter. The general permit states that all sediment controls will be inspected and maintained every seven days or within 24 hours of a precipitation event equal to or greater than 0.5 inches. A log of inspection must be maintained on site for the agency to review. Please see attached pictures.

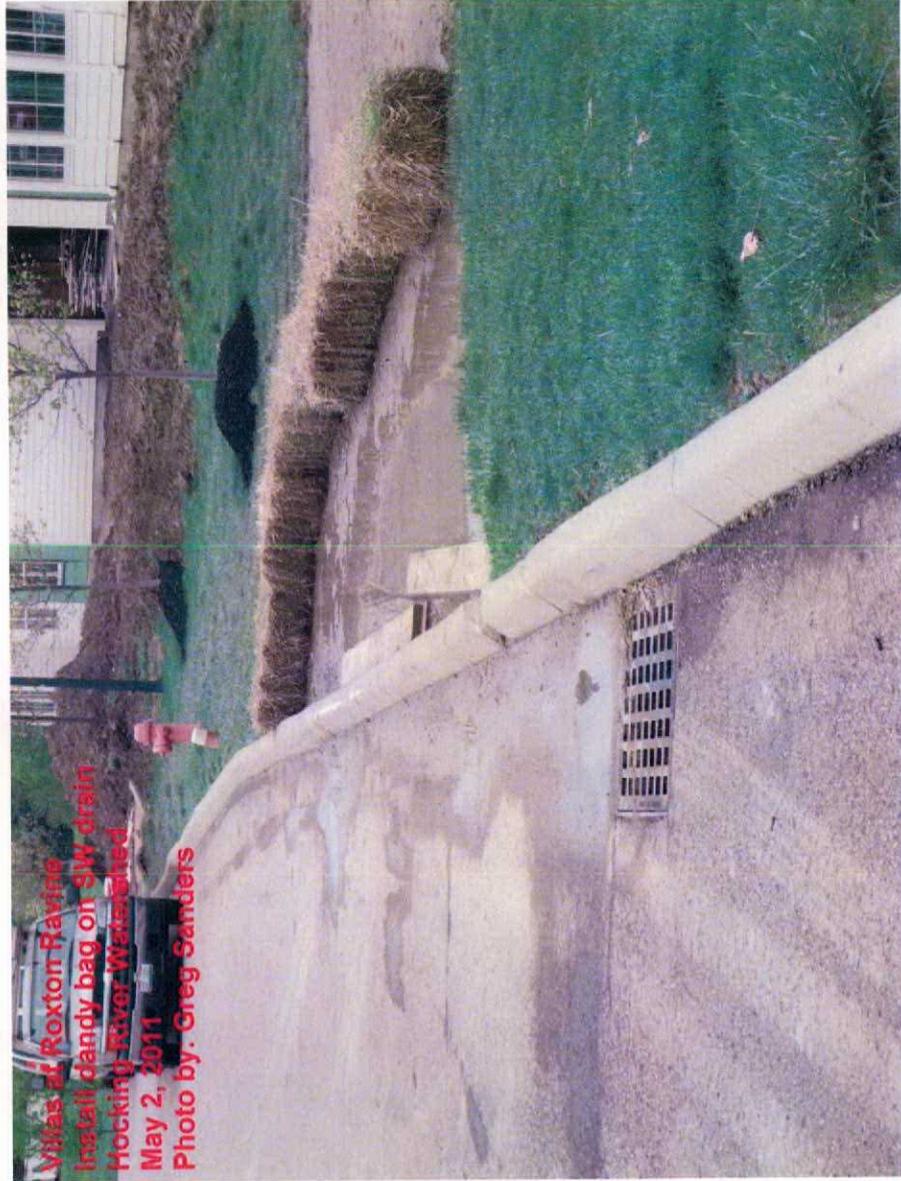
Work at Roxton Ravine
Install dandy bag on SW drain
Hocking River Watershed
May 2, 2011
Photo by: Greg Sanders
