**Re: Construction Storm Water Inspection at Memorial Drive Commercial Site  
Fairfield County  
Permit Number 4GC03140\*AG**

This letter is written in follow-up to a construction storm water inspection conducted by Stephen Riley and Megan Reising of Ohio EPA at the Memorial Drive Commercial Site at 2300 Memorial Drive on July 29, 2010. The purpose of the inspection was to evaluate compliance with the General Storm Water Permit Associated with Construction Activities. The following was noted:

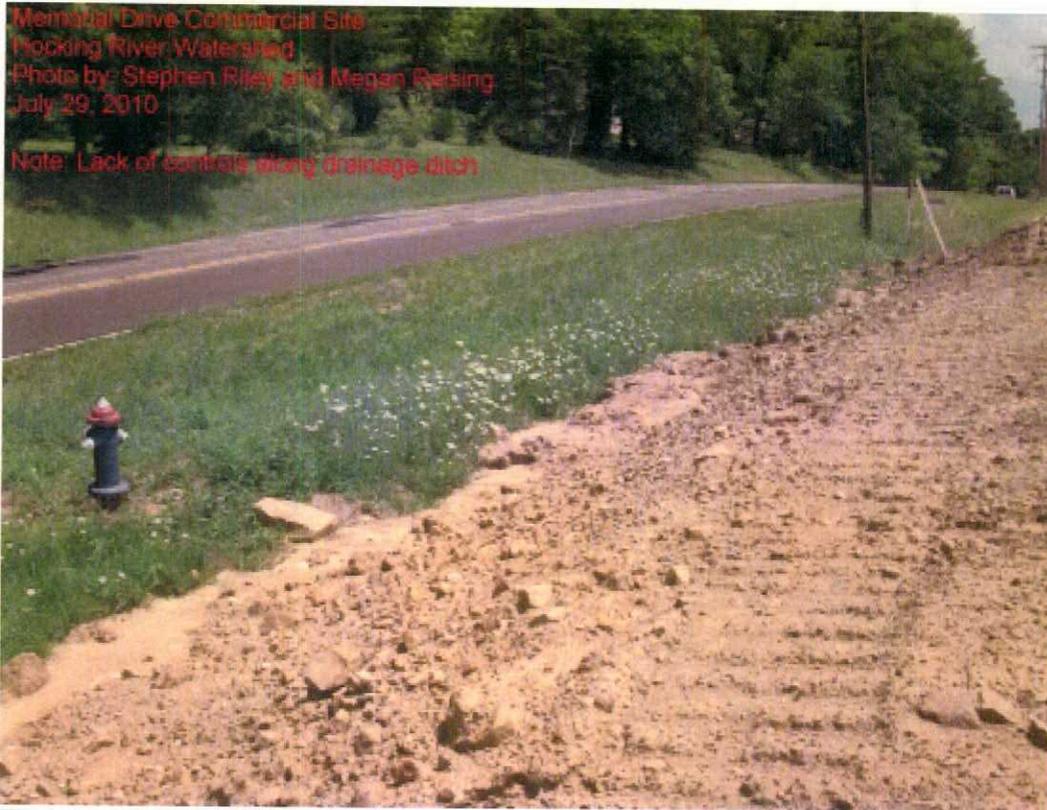
- The stockpile running parallel to North Columbus street requires silt fence installation and proper maintenance to minimize offsite sedimentation (see figure 1).

Figure 1: Lack of protection along North Columbus Street

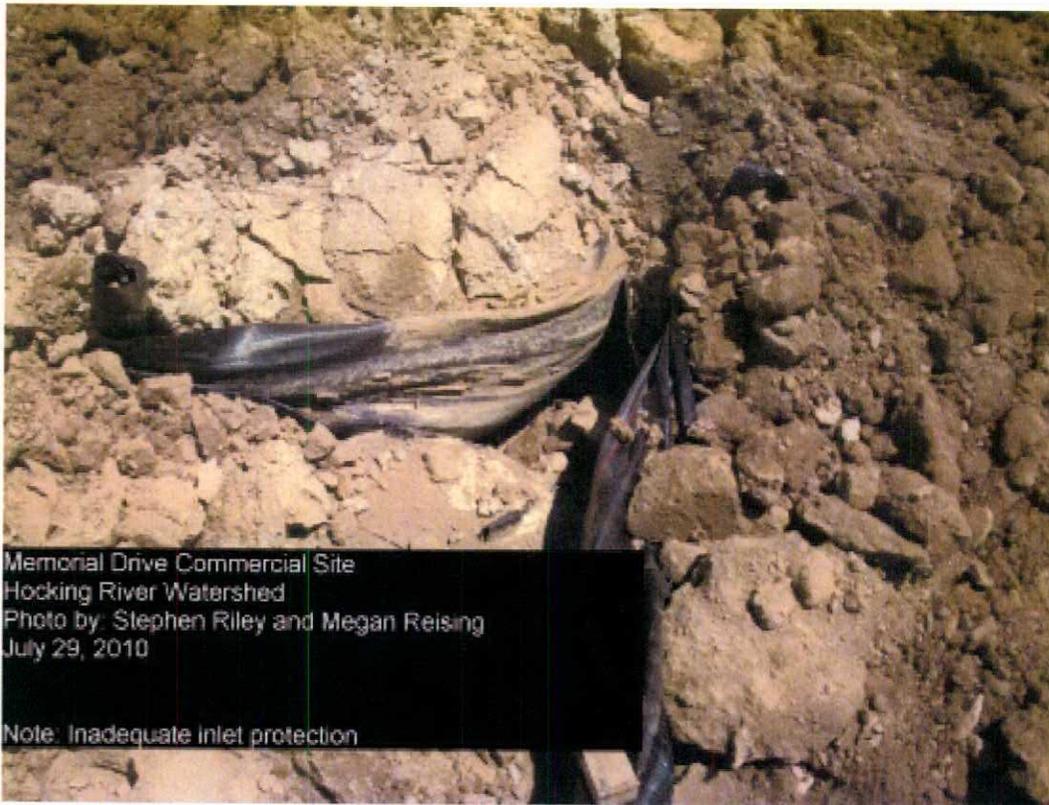
Note: Inadequate inlet protection

Figure 2: Inlet grate overrun by sediment

- Please install an inlet protection for the storm water inlet in front of the Golden Corral in order to minimize offsite sedimentation.
- During the inspection our staff observed an inlet protection overrun by sediment (Figure 2). Please remove the excess sediment and repair the silt fence and include lateral supports or frame.

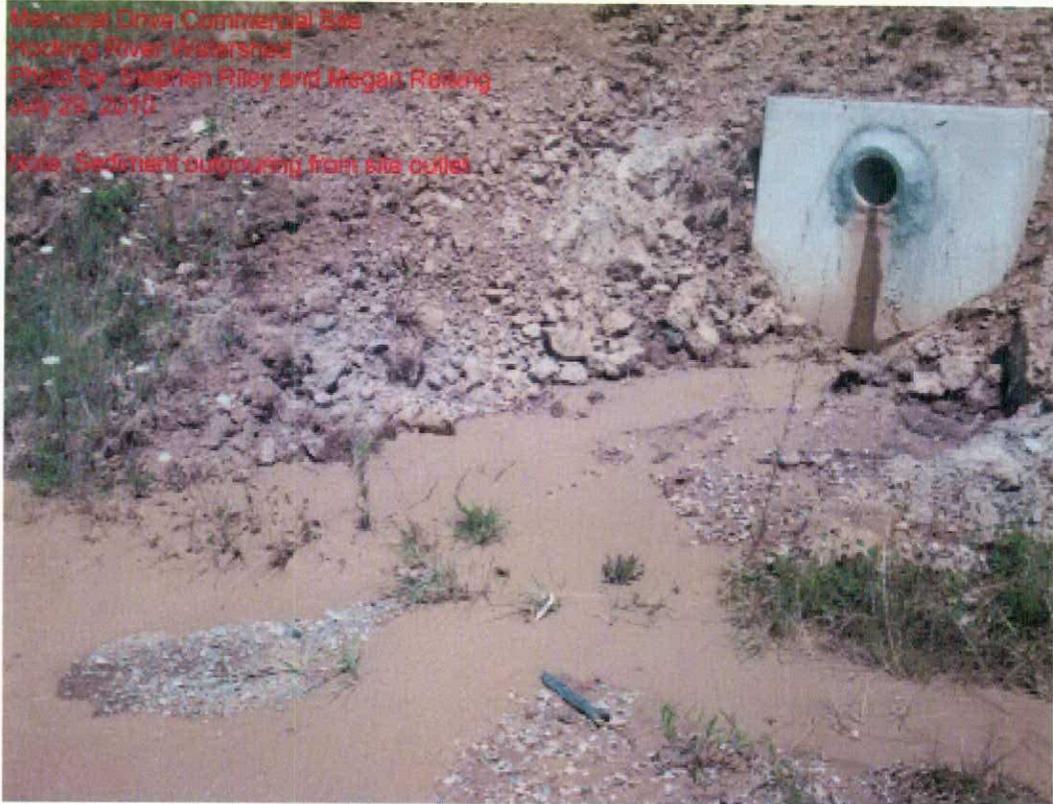
**Figure 3: Outlet adjacent to Memorial Drive outpouring sediment**

- Inlet protections must be carefully monitored and maintained.
- Our staff observed evidence of silt outpouring from the outlet adjacent to Memorial Drive (Figure 3) draining into a nearby existing storm drain due to an apparent lack of protective measures (Figure 4). Please ensure that the sediment retention pond outlet (Figure 5) is equipped with a temporary riser or a floating skimmer to avoid further sediment outpours.

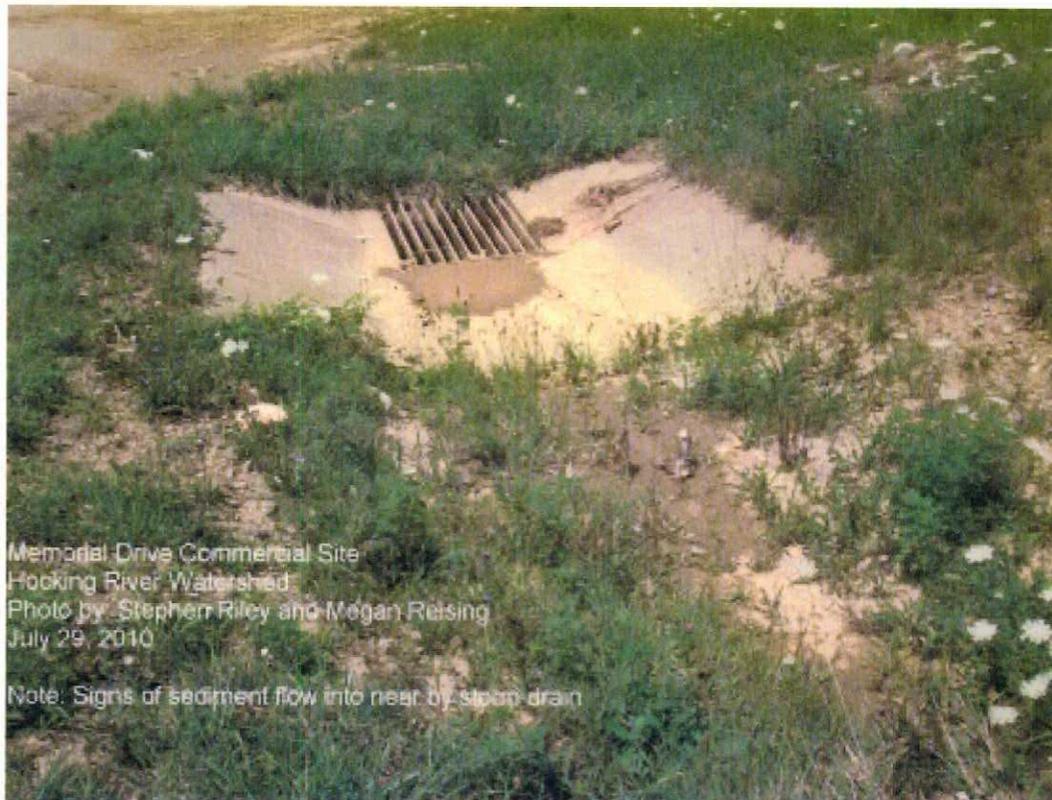
**Figure 4: Influx of sediment in existing storm drain adjacent to Memorial Drive**

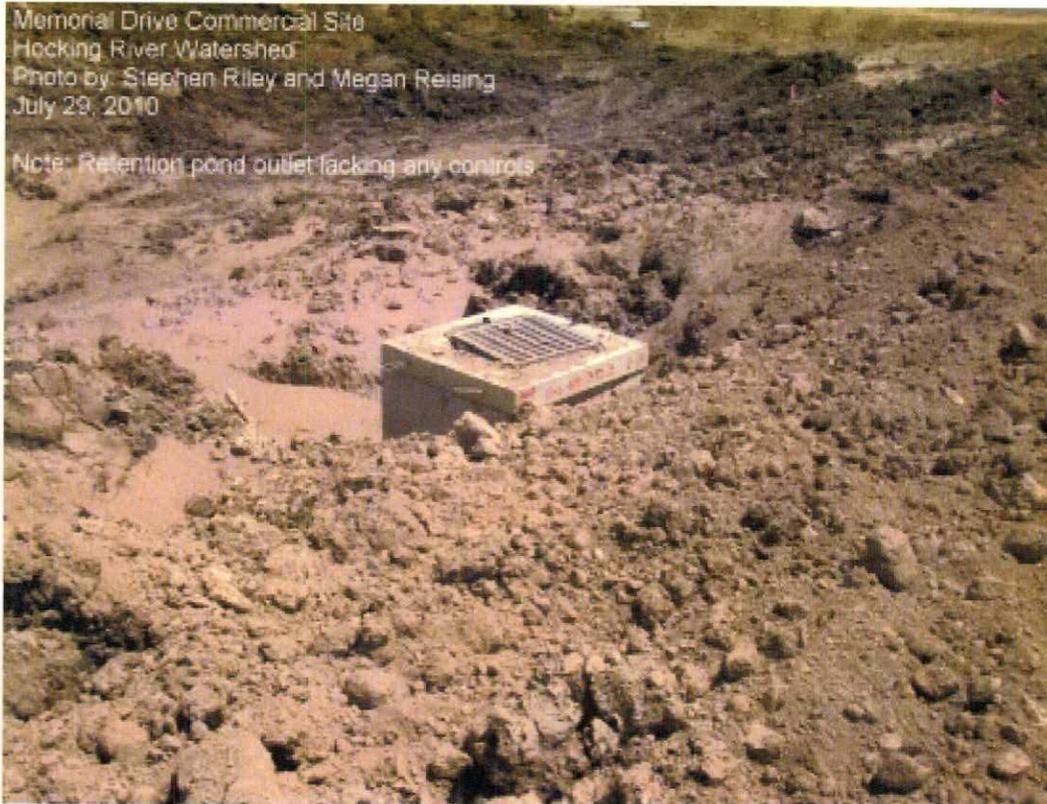
**Figure 5: Lack of protection on retention pond outlet**

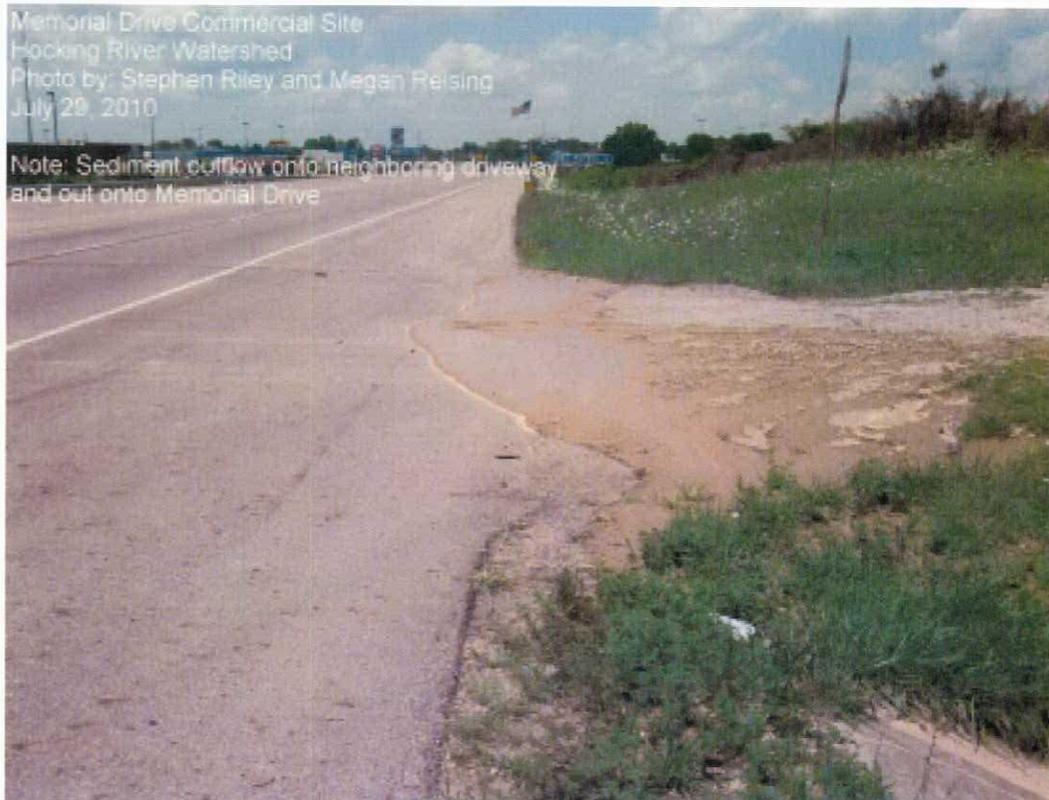
**Figure 6: Sediment outflow on neighboring driveway adjacent to Memorial Drive**

- Our staff observed sediment flowing offsite and down the driveway of the adjacent property (Figure 6). Please install sediment and erosion controls to avoid future uncontrolled discharges.
