State of Ohio Environmental Protection Agency

**Re: Construction Storm Water Inspection at Village at Hannah Farms
Franklin County
Permit Number: 4GC01921*AG**

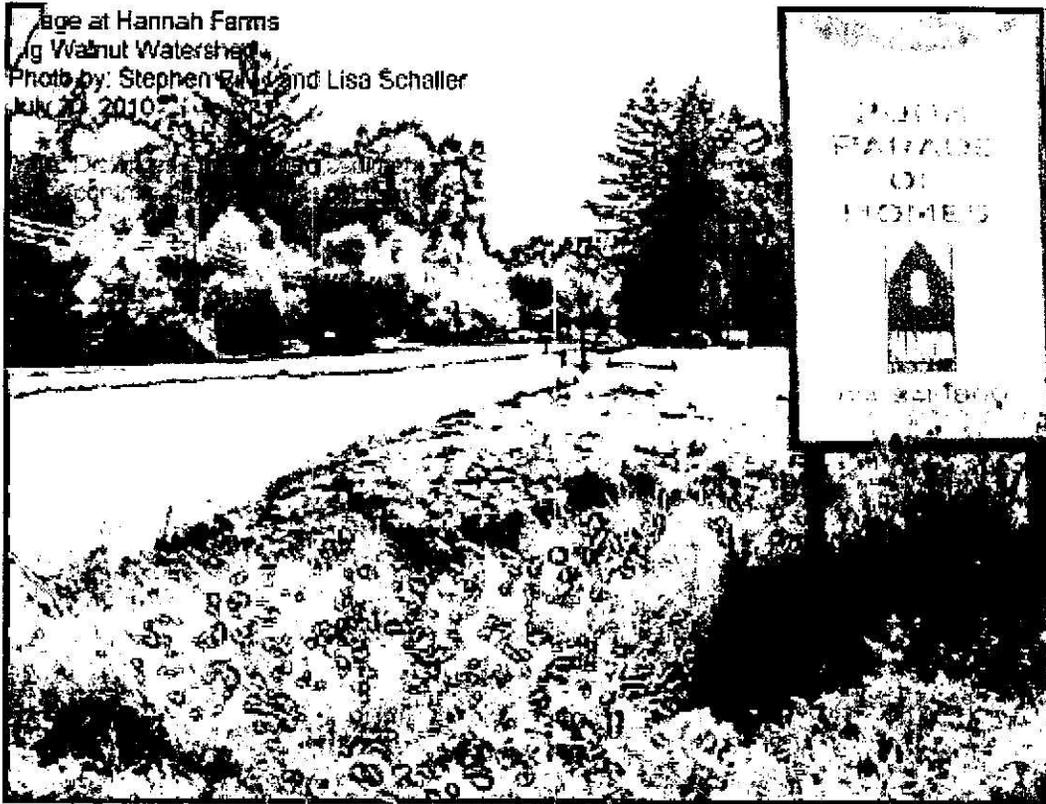
Figure 1: Lack of sediment controls along drainage ditch

- During the site investigation, our staff found a lack of sediment and erosion controls along Clark State Road (Figure 1).
- Sediment controls for this project must be implemented in accordance with the General Storm Water Permit. Silt fencing must be implemented along the contour and control areas where sheet flow is present. The silt fence must be trenched in otherwise proper reinstallation will be required.
