State of Ohio Environmental Protection Agency

July 29, 2010

**Re: Construction Storm Water Inspection at New Albany Medical Center II / Franklin County
Permit Number: 4GC03144*AG**

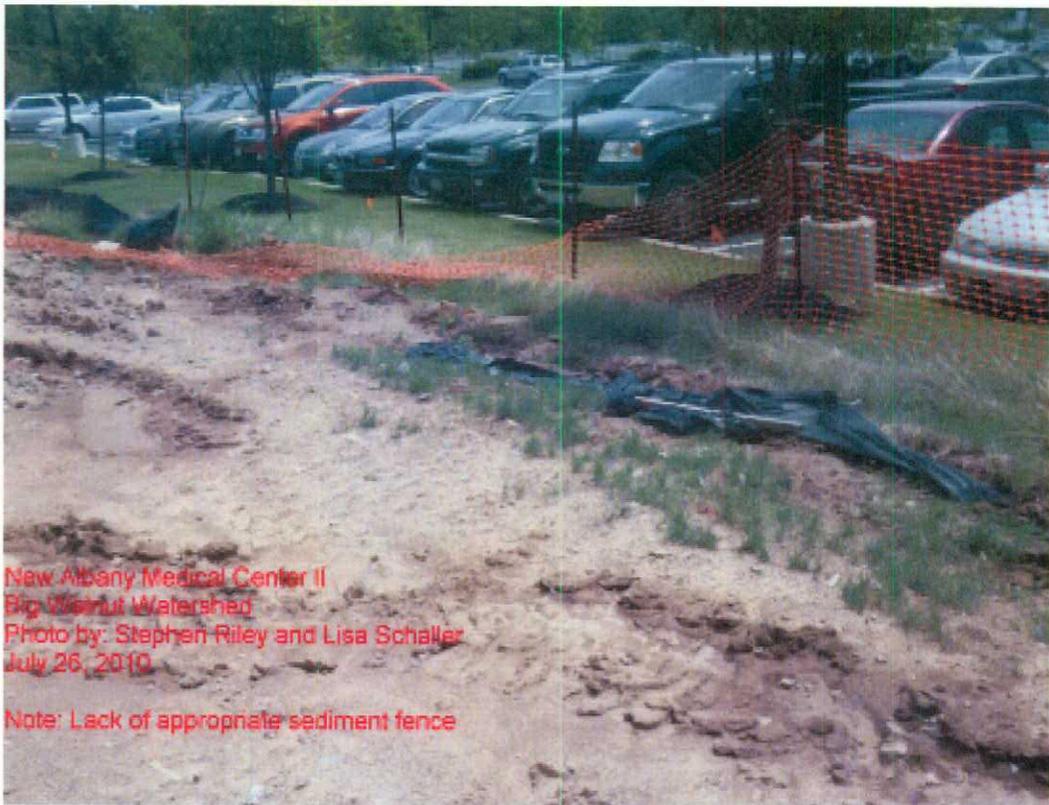
- During the site investigation, our staff found the majority of the silt fencing was damaged (Figure 1).
- Maintenance of Controls: The sediment controls implemented on this site will require maintenance or reinstallation to ensure a proper functioning condition. This general permit states that all sediment controls will be inspected and maintained every seven days or within 24 hours of a precipitation event equal to or greater than 0.5 inches. A log of inspection must be maintained on site for the agency to review.

Figure 1: Damaged silt fence along perimeter of site
