Re: Construction Storm Water Inspection at Alum Creek Drive at Rohr Road Minor Lane Addition, Wide / Franklin County Permit Number 4GC03220*AG

Alum Creek Dr at Rohr Rd Minor Lane Addition,
Wide
Big Walnut Creek Watershed

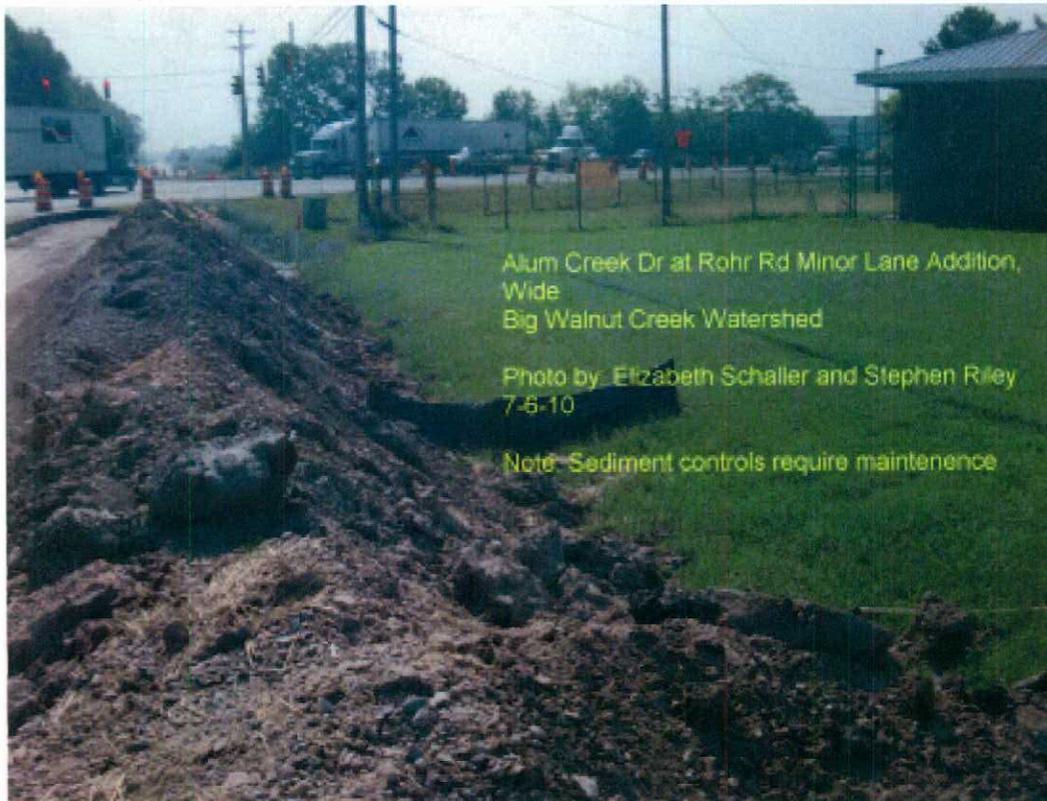
Note: Sediment controls require maintenance

Figure 1: Silt fences requiring maintenance

- The silt fence on the south side of Rohr Road requires repair to ensure efficient sediment and erosion control (See figure 1).
- The storm water catch basin at the corner of Rohr Road and Alum Creek Drive requires a silt fence box structure with ample lateral supports as noted in figure 2.

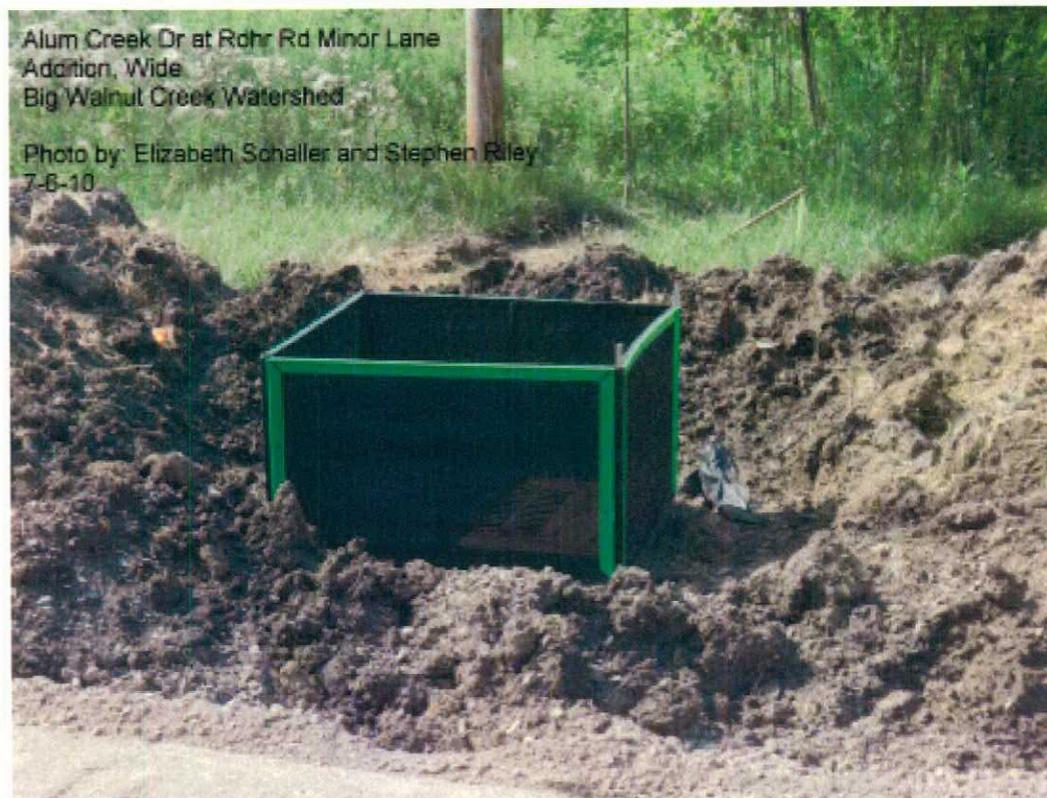
Figure 2: Silt fence box structure
