Attached is a report for a Reconnaissance Inspection that Kelly Thiel and I from this office performed July 8, 2009, at the wastewater treatment system serving the Geneva Hills facility. Please read the report carefully since there are several items needing your attention.

**NPDES  
Compliance Inspection Report**

<b>Name and Location of Facility Inspected</b> Presbytery of Scioto Valley (Geneva Hills) 1380 Blue Valley Road, SE Lancaster, Ohio 43130	<b>Entry Time</b> 10:15 A.M.	<b>Permit Effective Date</b> 11/1/08
	<b>Exit Time</b> 11:00 A.M.	<b>Permit Expiration Date</b> 10/31/13

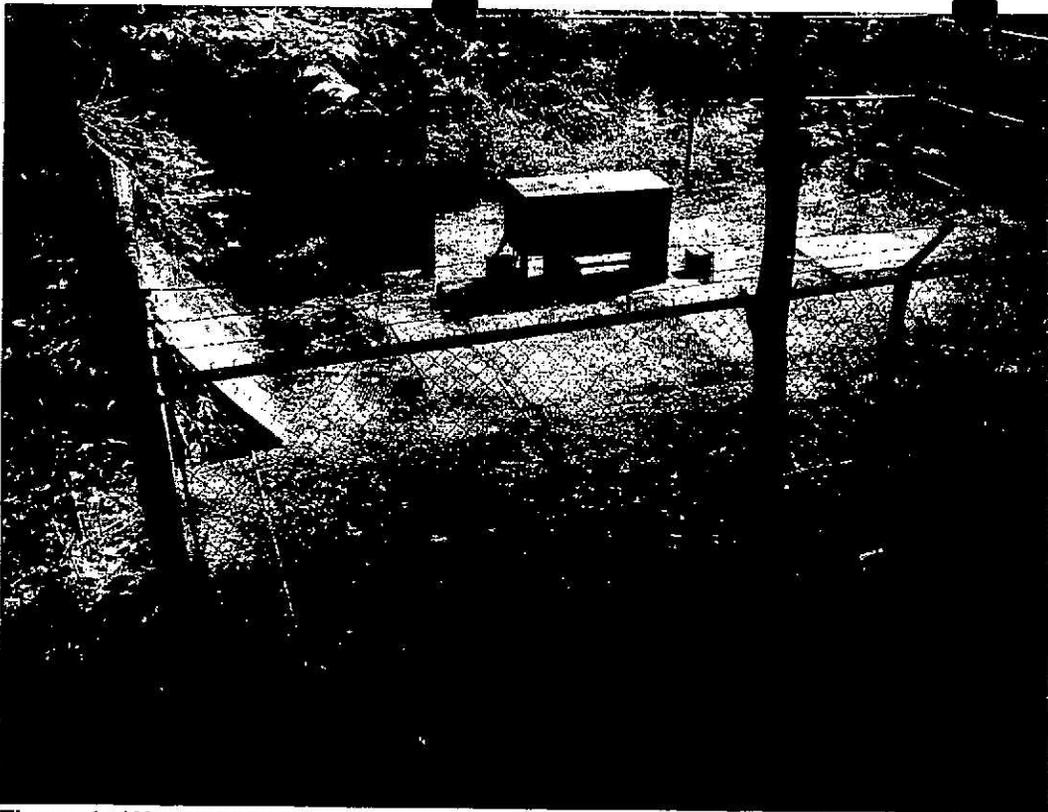
**Figure 1.** Wastewater is routed into this wastewater treatment plant prior to discharge into the wetland. The permittee should closely monitor the WWTP to minimize solids loss into the wetland.

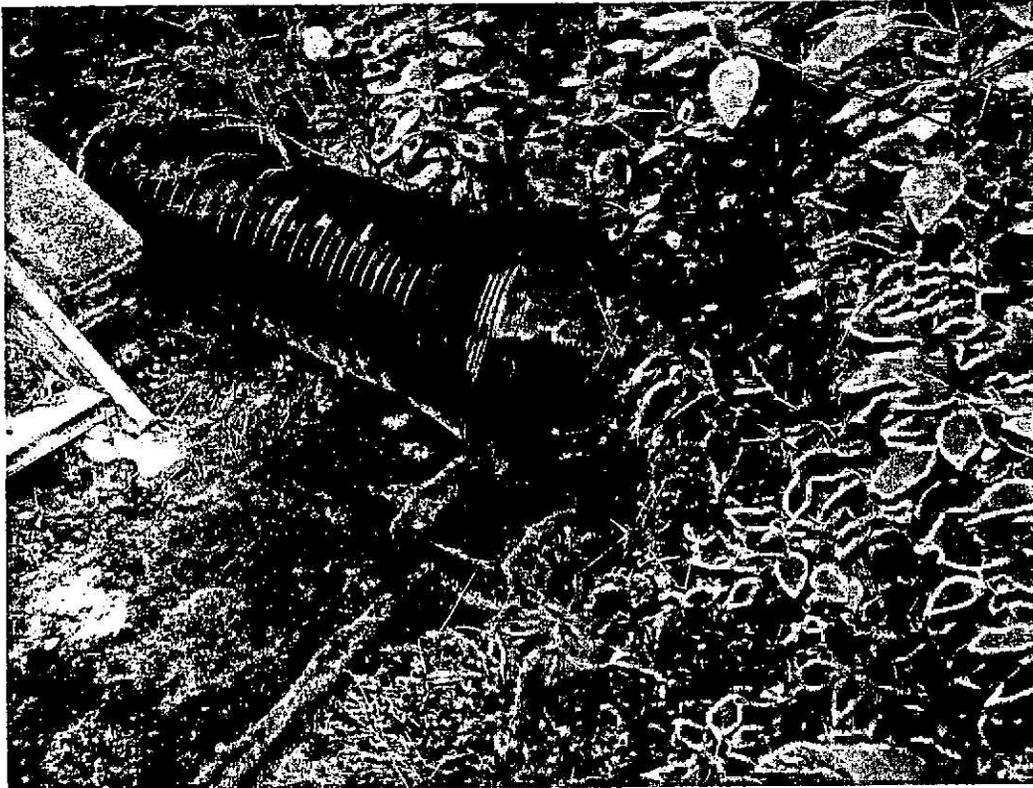
**Figure 4.** This photograph shows the wetland outlet pipe and a stepped arrangement of concrete block steps to help increase the dissolved oxygen concentration in discharged wastewater prior to the effluent sampling location.

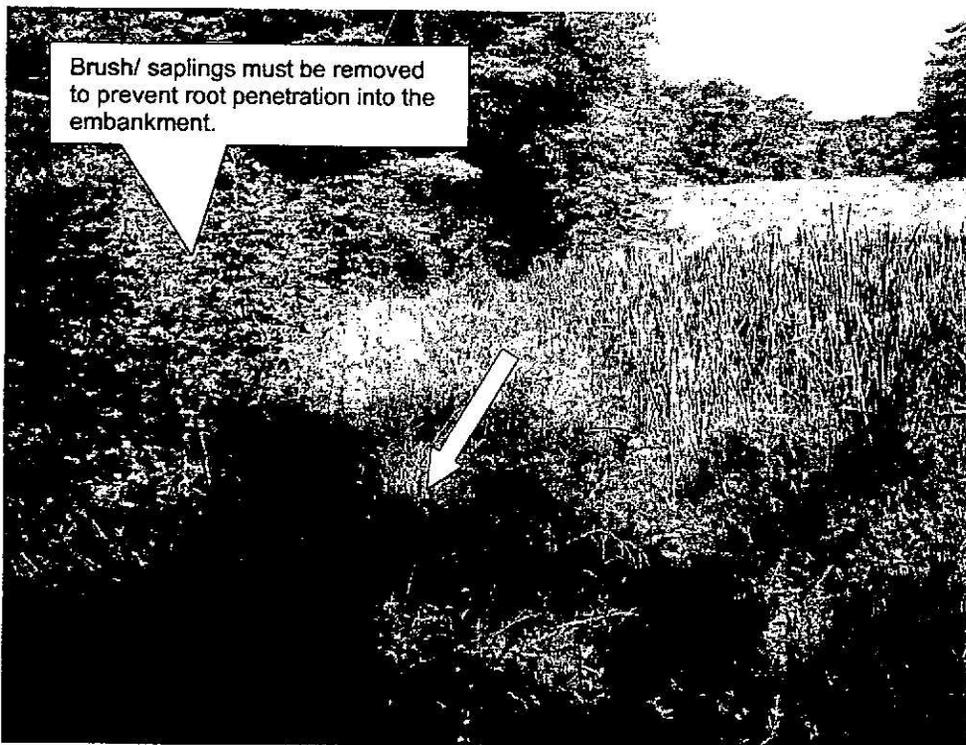
**Figure 6.** The white arrow in this photograph shows the top of the wetland embankment. Vegetation needs to be controlled to maintain a path along the embankment top and to prevent brush/sapling roots from penetrating into and damaging the embankment. Burrowing animals such as woodchucks must also be controlled to prevent embankment damage.

- M Facility Site Review – saplings/brush must be removed from the wetland embankment.
- N Collection System
- N Flow Measurement
- N Laboratory
- M/S Effluent/Receiving Waters – effluent limitation violations are listed in Attachment "A" of this report.
