CLARK HALL

January 21, 2011

**Re: Construction Storm Water Inspection at Clark Hall / Franklin County  
Permit Number 4GC03239\*AG**

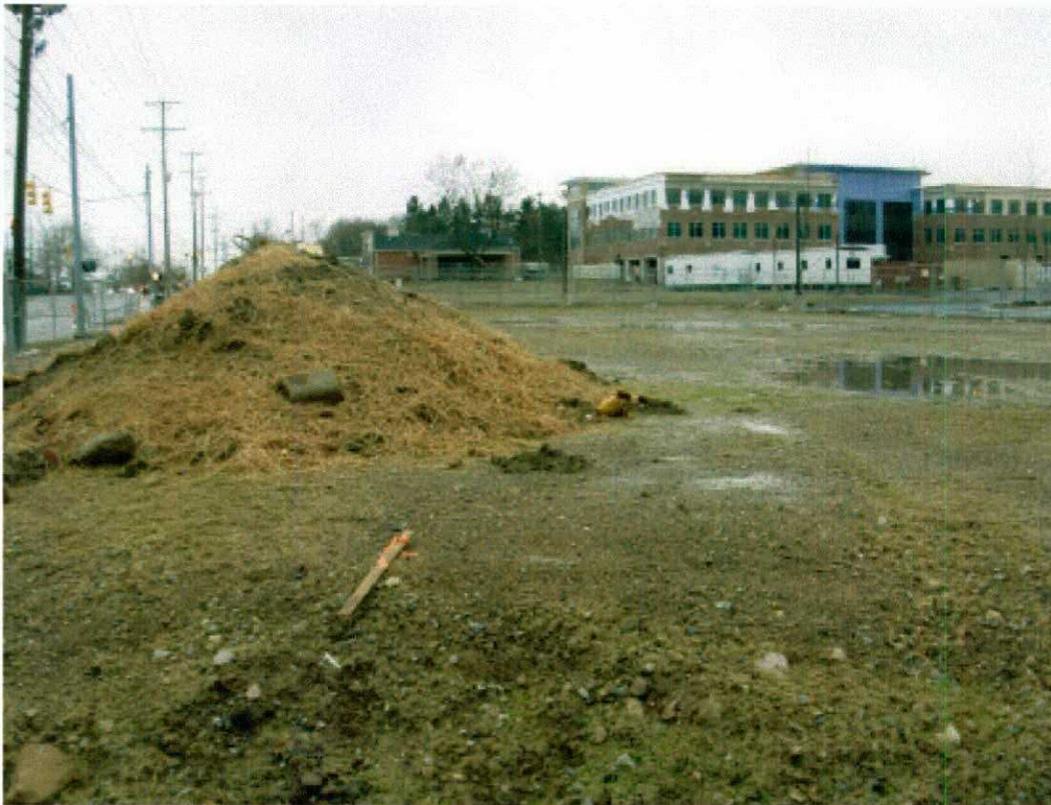
- I noted recent efforts of apparent soil stabilization through the application of straw mulch and seeding as depicted in several photographs submitted by the Friends of Big Walnut Creek. As I stated, the site was snow covered, but it did not appear there were any additional stabilization efforts since the time the pictures were taken during the week of January 1, 2011. If this is the case, the straw mulch application must be re-applied. I highly recommend the use of netting, tackifier, or crimping to ensure the straw mulch application is secured, or demonstrate an approvable alternative. In addition, there appeared to several barren areas where the vegetation was NOT established sufficient to control erosion. Given the time of year, a crimped mulch cover or approvable alternative is expected for all remaining barren areas by January 28, 2011.

**Figure 1: Barren areas which will require additional stabilization (Crimped mulch or approvable alternative) Photo by Friends of Big Walnut Creek 01-01-2011**

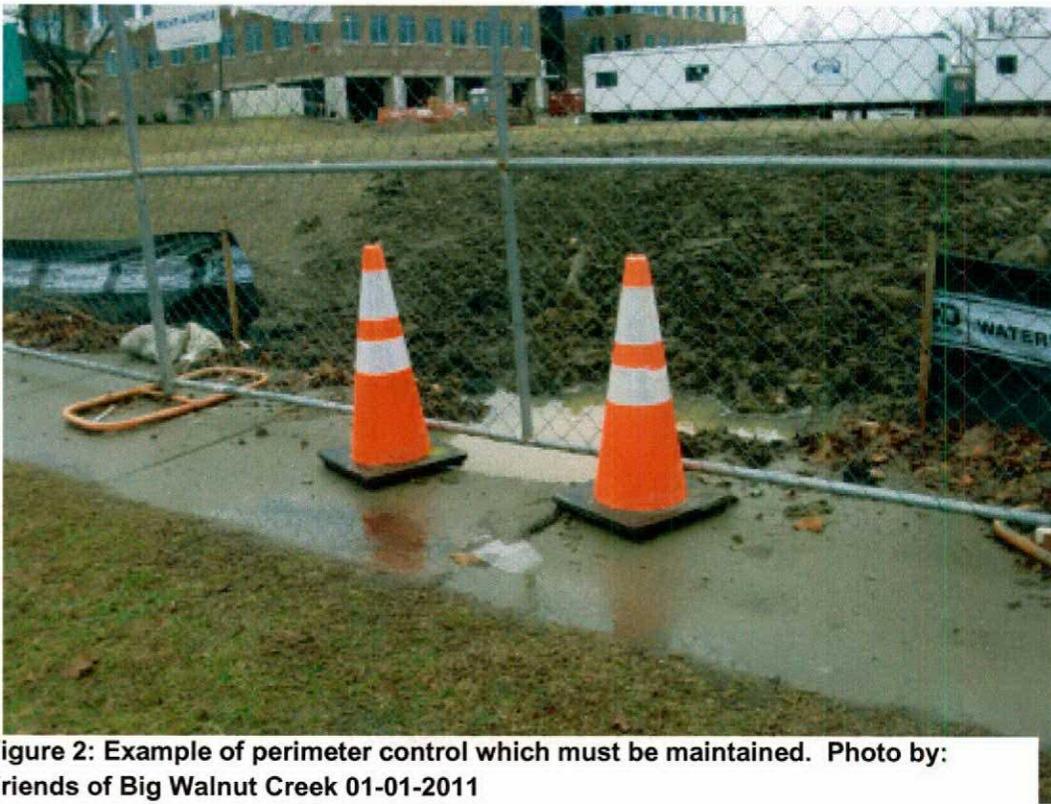
- The silt fence on the perimeter of the pond may be removed, as it is not receiving drainage.
- The perimeter controls, specifically on the eastern portion of the project require maintenance at this time. I spoke with a site representative who indicated the perimeter controls were compromised as a direct result from recent utility installation. I understand this may not be the direct result of the contractors work, however, you are responsible to ensure continued maintenance of all storm water controls. Maintenance of all controls including inlet protections, silt fence, and straw wattles is expected by January 21, 2011. Notification of my January 7, 2011 was brought to your attention vial email on January 13, 2011.

**Figure 2: Example of perimeter control which must be maintained. Photo by: Friends of Big Walnut Creek 01-01-2011**
