BEDFORD II LANDFILL COVER

**Re: Construction Storm Water Inspection at Bedford II Landfill Cover
Franklin County
Permit Number: 4GC03047*AG**

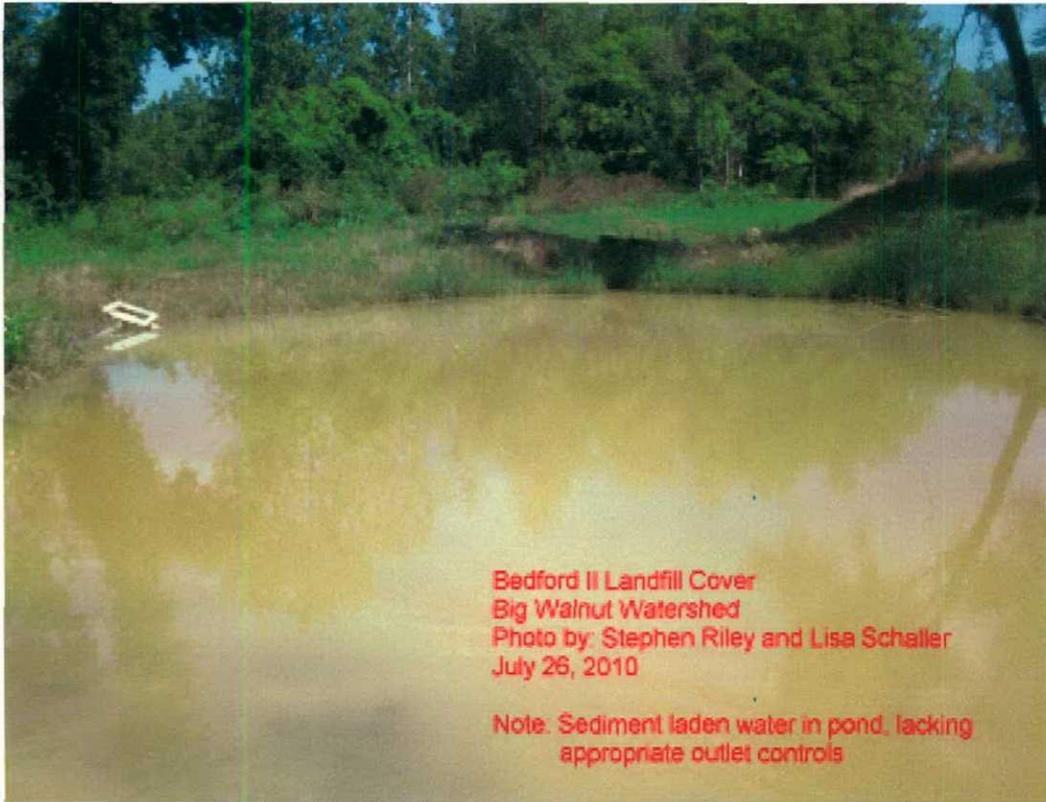
Bedford II Landfill Cover
Big Walnut Watershed
Photo by: Stephen Riley and Lisa Schaller
July 26, 2010

Note: Sediment laden water in pond, lacking
appropriate outlet controls

Figure 1: Sediment laden waters leaving property, skimmer also requires maintenance.

- The temporary skimmer has been compromised. Corrective measures must be conducted to ensure the intended function of the skimmer discharge. The sediment pond will require cleaning as it appears that fifty percent of the capacity of the pond has been eliminated due to accumulated sediments from recent rain events.
