WESTERVILLE NORTH HIGH SCHOOL STADIUM

**Re: Construction Storm Water Inspection at Westerville North High School Stadium
Delaware County
Permit Number: 4GC03542 *AG**

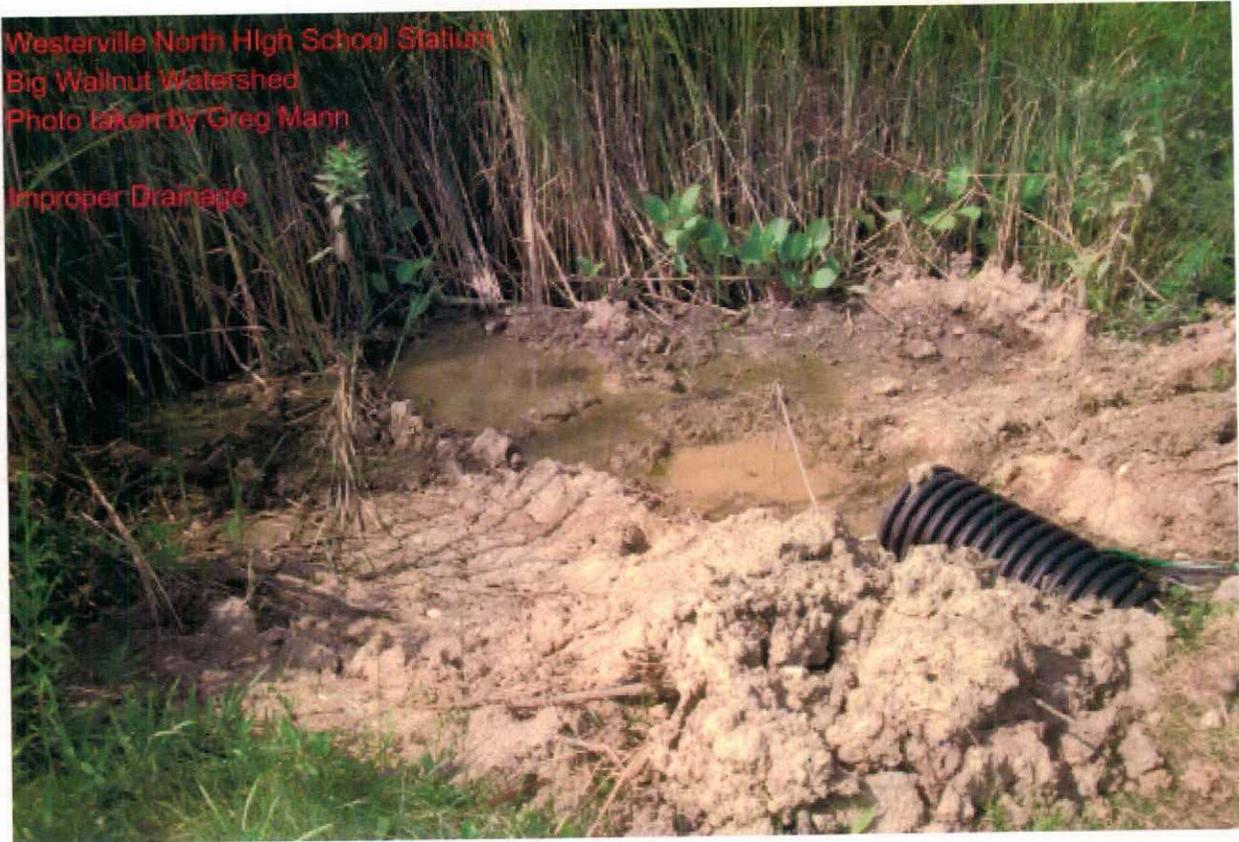
Figure 1

Westerville North High School Stadium
Big Walnut Watershed
Photo taken by Greg Mann

Improper Drainage

- Sediment controls for this project must be implemented in accordance with the General Storm Water Permit. Silt fencing must be implemented along the contour and control areas where sheet flow is present. The silt fence must be trenched in otherwise proper reinstallation will be required. Sediment traps must be utilized for areas of concentrated flow specifically as noted in **Figure 1**.
- All traps must be sized in accordance with the permit requirements.
- During our inspection our staff noted apparent uncontrolled barren areas draining to structures that are not intended for sediment control. Please include appropriate storm water control methods (sediment traps) to minimize off-site sedimentation turbidity from the site (see Figure 1).
