**Environmental
Protection Agency**

**RE: HAMILTON COUNTY
RUMPKE SANITARY LANDFILL
NOV**

**Subject: Notice of Violation
Failure to Strictly Control Odors**

ON-SITE INSPECTION:

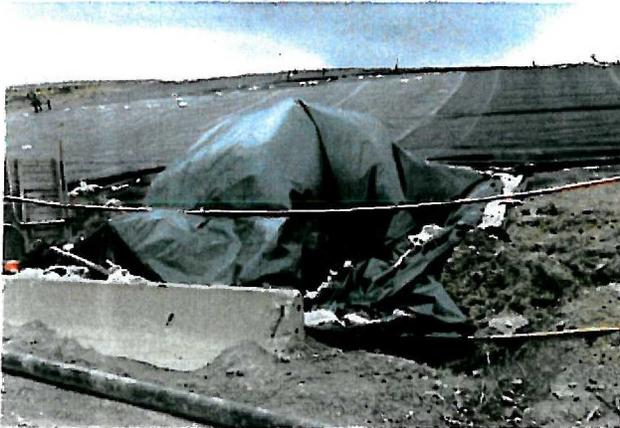
The Phase V side slope risers were covered with a tarp and the mobile odor control truck was stationed at this location and operating. No odors were observed from the location of the risers.

Picture 3 - Phase V side slope risers

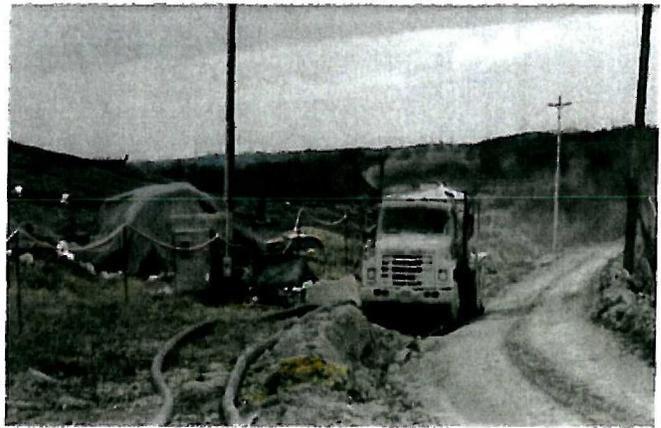
Picture 4 - Odor control truck

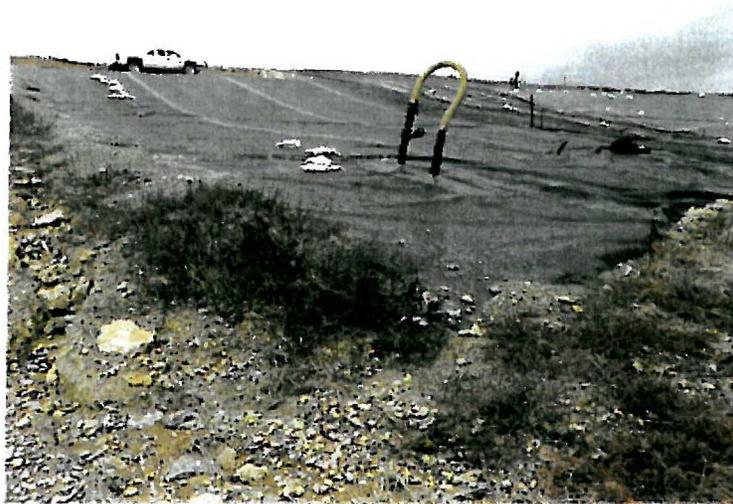
We observed this area and noted strong odors emanating from the soil at this location. Because of strong gusting winds, we were not able to identify a precise source of the odors. However, this area was identified as a source of odors. (Picture 5)

Picture 5 - OCB /soil interface

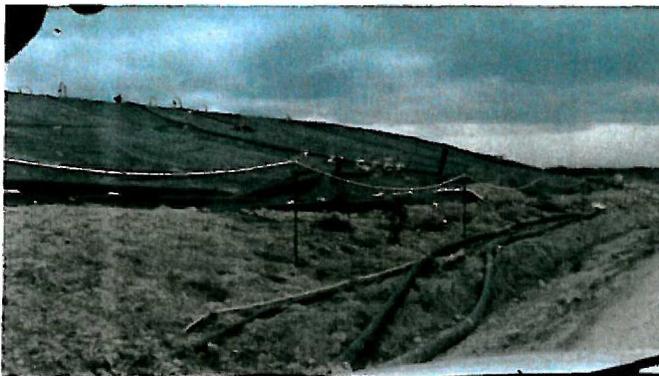
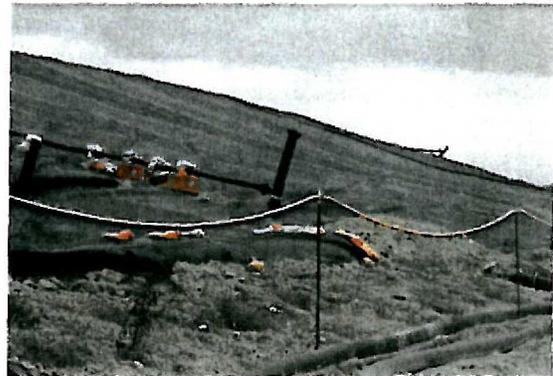
We observed that odor control misters had been newly installed along this area. Minimal odors were observed in this area. (Pictures 6&7)

Picture 6 - Odor misting hose along Phase V east side

Picture 7 - odor misting hose along Phase V east side

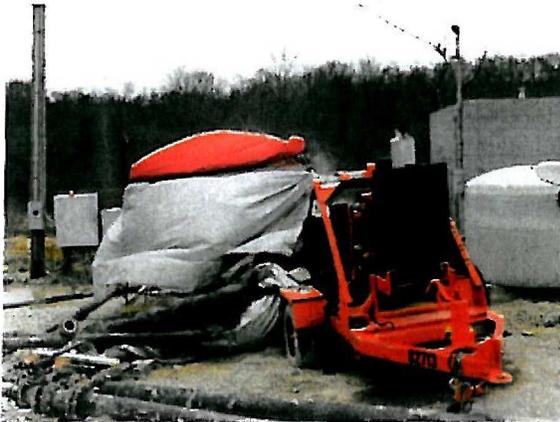
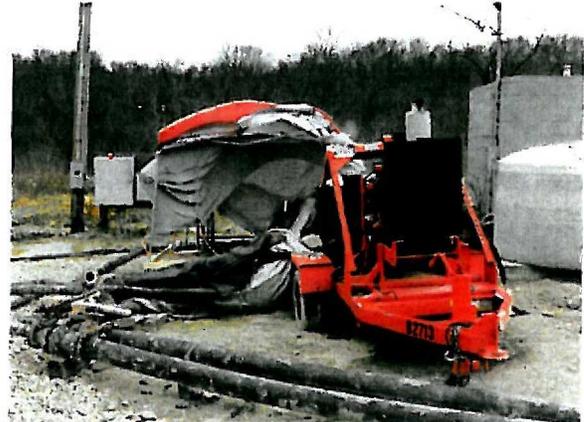
Aaron showed us the modification to the Northwest lift station that had been made since our last two visits on February 6 and 15. Rumpke installed a tent over the lift station with approximately 8 odor control spray nozzles. Observation of the operation of this new odor controlled mechanism was hampered by the strong gusting winds (15-32 mph). Aaron stated that Rumpke intends to install a dry scrubber, using wood chips/mulch, at this location to minimize odors. No odors were observed at this location.

Picture 8 - Northwest lift station enclosed by tent and tarps

Picture 9 - Northwest lift station enclosed by tent and tarps

Ohio EPA asked Aaron to provide additional information in an email the following week, on the current and future plans that Rumpke intends to implement to minimize odors at both the Phase II and NW lift station locations.

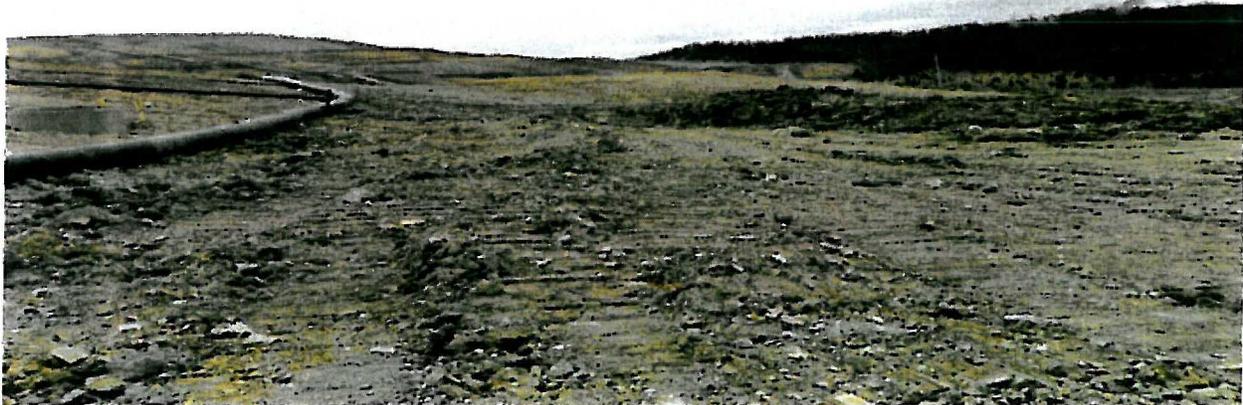
We observed the cover soil in the location was clean and without waste. No odors were observed.

Picture 10 - West buttress construction area

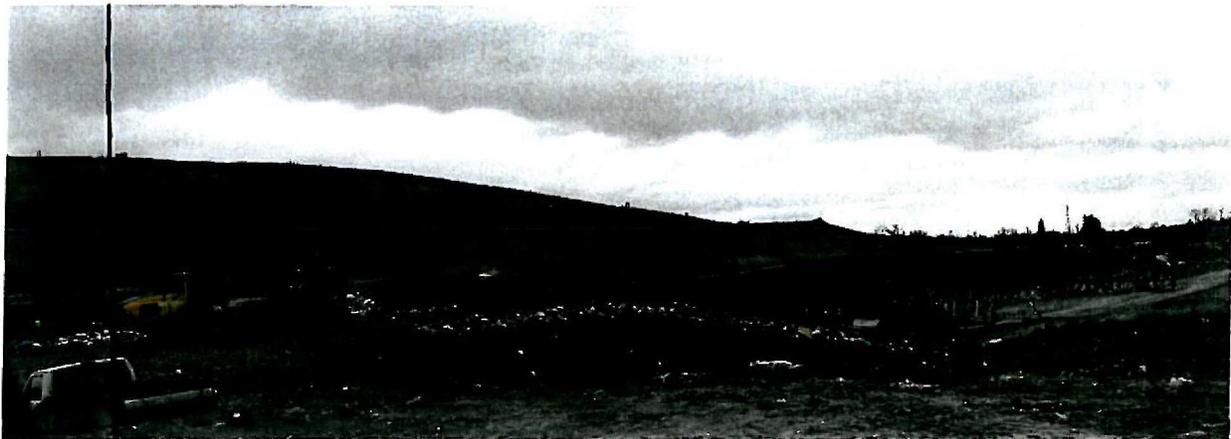
We observed the working face which was being kept smaller than usual due to the high winds. The facility was using wind screens to minimize blowing litter. Any litter observed beyond the screens remained on the landfill and was being picked up by Rumpke staff. We observed minimal odors in this area. (Picture 11)

Picture 11 - Working face with wind screens
