**Re: Construction Storm Water Inspection at Baumeister Tract Sections 1 & 2**

HK/nsm Baumeister Tract Sections 1 & 2 July 6, 2009

Baumelster Tract Sections 1 & 2  
Big Darby Creek Watershed  
Photo By: Ryan Griffin  
7/9/2009

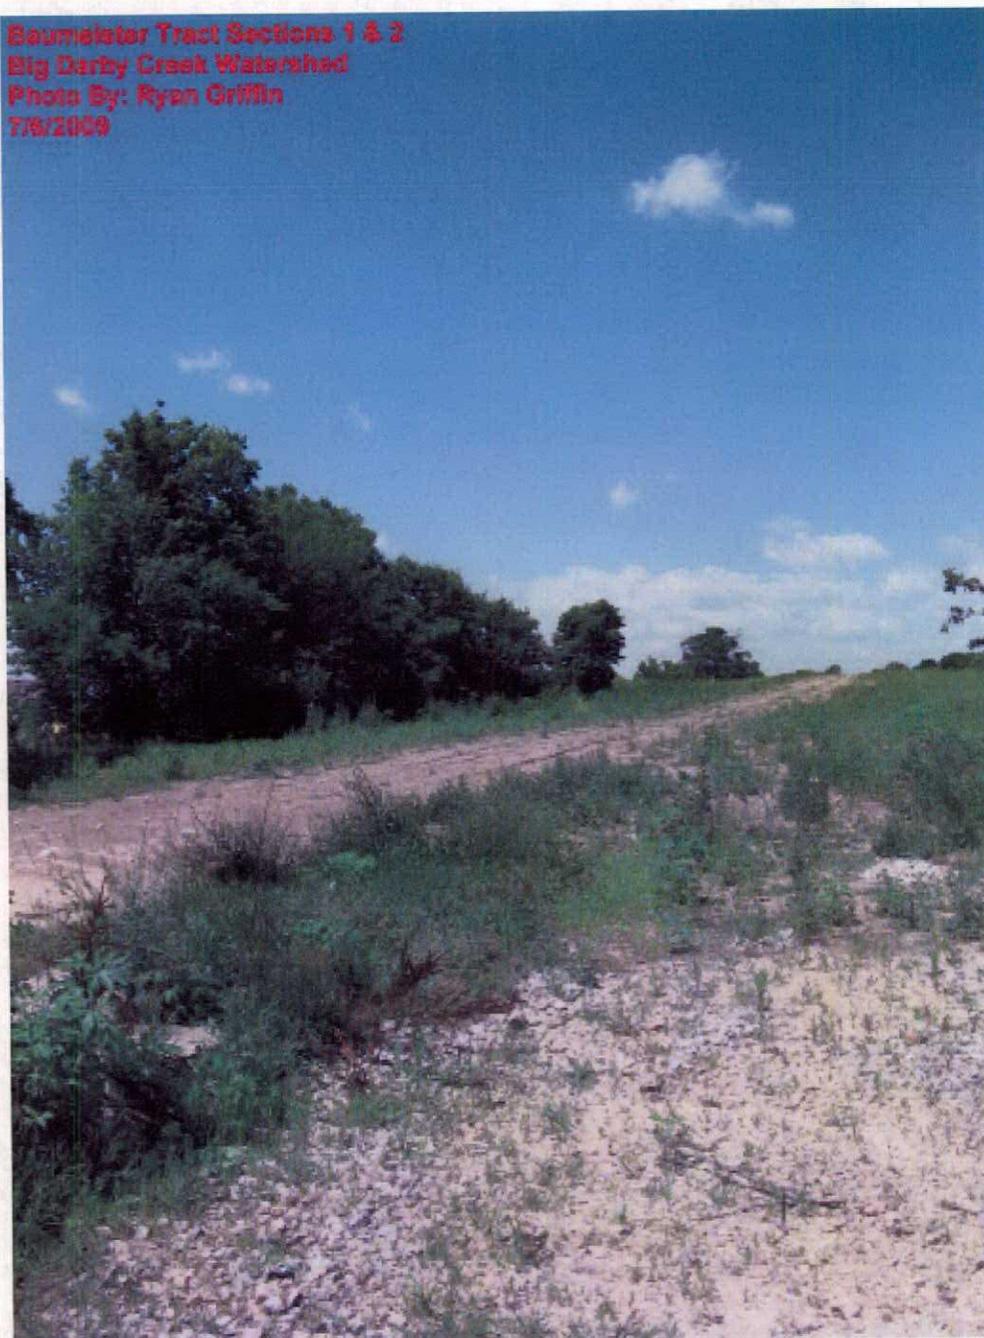
Figure 1 Stockpile Located West of Cosgray Road & North of Hilliard YMCA

- It has been noted previously from an inspection conducted on May 19, 2009 and concurrent with this inspection, the topsoil stockpile located behind the abandoned residence has not been adequately seeded (See Figures 1 & 2). Corrective measures are expected within 7 days from receipt of this letter.
