**Environmental
Protection Agency**

RE: TRUMBULL COUNTY
CITY OF WARREN
GLUNT INDUSTRIES, INC.
NPDES PERMIT NO. OHR000004
OHIO EPA PERMIT NO. 3GR01084*DG
INDUSTRIAL STORM WATER

On July 19, 2011, Ohio EPA conducted an inspection of Glunt Industries, Inc., located at 319 N. River RD NW, City of Warren, Trumbull County (facility). During the inspection, I was accompanied by Donna Kniss of Ohio EPA. The facility was represented by Gary Shells, Plant Manager, and Eric Williams, Project Manager. Ohio EPA records indicate that the site is covered by General National Pollutant Discharge Elimination System Permit for Storm Water Associated with Industrial Activity (General Storm Water Permit), permit No. 3GR01084*DG. The inspection documented the following:

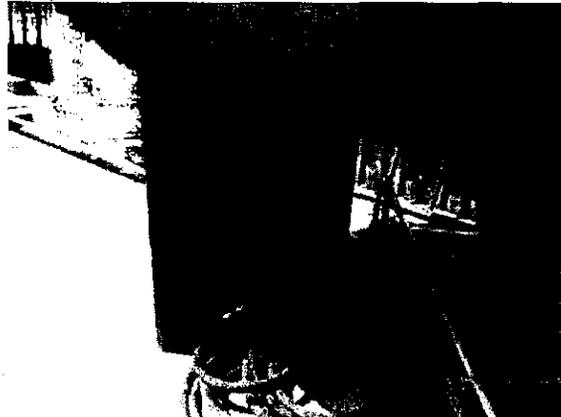
- The 1,500 gallon above ground oil storage tank (OST) is stored in a location that discharges to the facility's storm sewer (Figure 4). To address the OST, one of the following items must be performed:

Figure 4 - A spill kit should be relocated to the OST in order to quickly address any spill or leak that may occur.

1. Verify that the OST is double walled; or
 2. Provide a containment berm, wall, or other method necessary to contain one hundred ten percent (110%) of the OST's volume.

In addition, a spill kit should be relocated to the OST in order to quickly address any spill or leak that may occur;

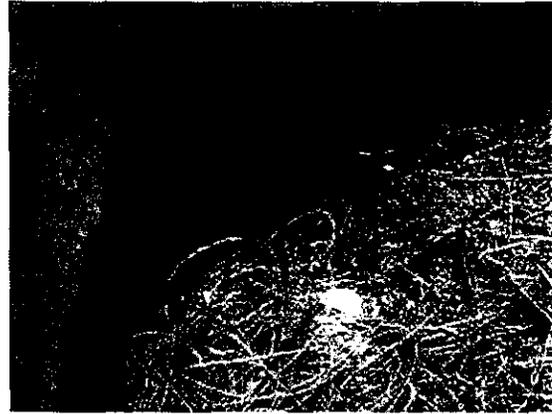
Figure 8 - Coolant was also observed pooled within hoppers.

- The sand blasting area requires improved BMPs to prevent the potential pollutants from being discharged into the storm sewer system serving the facility (Figure 5). The SWP3 should be revised to increase the sweeping frequency of the sand blasting area; and
- On the east side of the facility hoppers are utilized to collect coolant soaked metal chips (Figure 6). These hoppers are located in areas exposed to precipitation events. Staining was present on the ground in the hopper locations (Figure 7). Coolant was also observed pooled within hoppers (Figure 8). BMPs must be implemented to address the hopper locations, which may include the construction of covers, berms for containment, or other method necessary to minimize or eliminate the potential for pollutant discharge.
