Re: Huron County
Big Lots #34
NPDES Permit #2PR00053
Sewerage

On June 5, 2007, Tanushree Corlas and I conducted an inspection of the wastewater treatment plant serving the Big Lots Store #34 which is currently operating under National Pollutant Discharge Elimination System Permit (NPDES) No. 2PR00053*ED. At the time of our inspection the plant was operating, however several operation and maintenance issues were noted and need to be addressed. No samples were taken to verify compliance with permit limits. Our observations and recommendations are as follows:

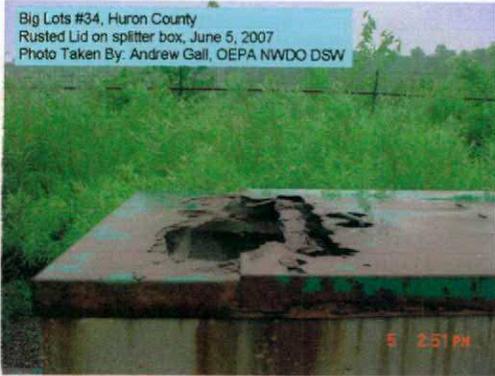
1. The metal lid to the influent splitter box has completely rusted through and needs to be replaced.
2. The contents of the south aeration tank were light grey to almost clear and very dilute. The rate of aeration appeared to be adequate. The north aeration tank was offline and its contents were green as a result of algae growth.

Big Lots #34, Huron County
Rusted Lid on splitter box, June 5, 2007
Photo Taken By: Andrew Gall, OEPA NWDO DSW

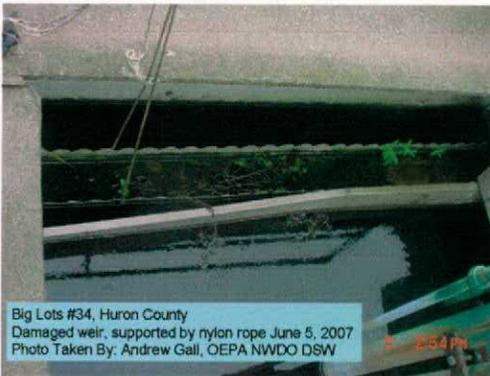
3. The south clarifier was online and the effluent appeared clear. The effluent weir that was noted as damaged during our agency's September, 2001 inspection is still damaged and now being held in place by a piece of nylon rope. Once again we are requesting that the weir be fixed or replaced as soon as possible.

Big Lots #34, Huron County
Damaged weir, supported by nylon rope June 5, 2007
Photo Taken By: Andrew Gall, OEPA NWDO DSW

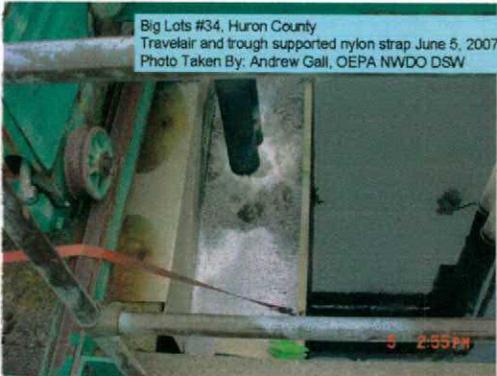
4. The travelaire system appears to be immobile and the return sludge trough was held in place by several well worn straps. **Part III, Item 3, Paragraph A. of your NPDES permit states that "at all times, the permittee shall maintain in good working order....all treatment or control facilities...installed or used by the permittee necessary to achieve compliance with the terms and conditions of this permit.**

Big Lots #34, Huron County
Travelair and trough supported nylon strap June 5, 2007
Photo Taken By: Andrew Gall, OEPA NWDO DSW

Therefore, the travelaire system must be repaired and the temporary straps supporting the return sludge trough must be replaced with a permanent support system so that the trough does not fall into the clarifier when the straps break.

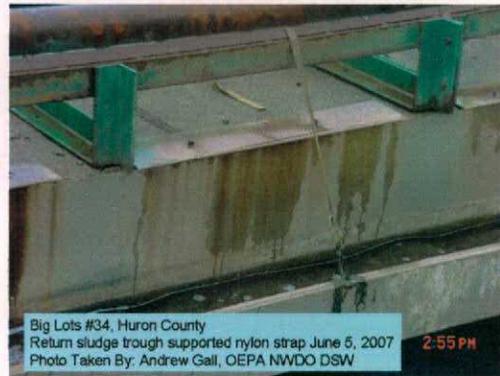
Big Lots #34, Huron County
Return sludge trough supported nylon strap June 5, 2007
Photo Taken By: Andrew Gall, OEPA NWDO DSW

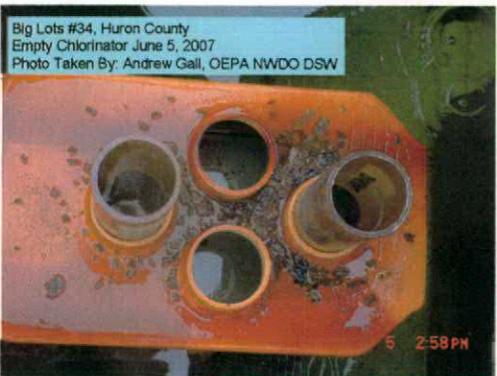
5. We were pleased to see the disinfection tablet feeder has been installed. However, there were no chlorine tablets in the chlorine tablet feeder. Tablets are required to be in the chlorinator and dechlorinator from May through October. In addition, the concrete portion of the tank was beginning to crack and fall apart, exposing portions of the rebar. Big Lots may want to address this so that the tank does not become a safety hazard as the concrete continues to deteriorate.

Big Lots #34, Huron County
Empty Chlorinator June 5, 2007
Photo Taken By: Andrew Gall, OEPA NWDO DSW

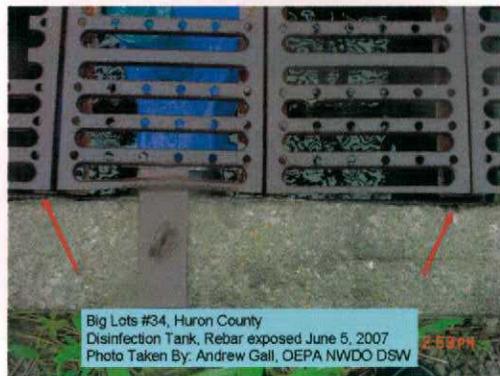
Big Lots #34, Huron County
Disinfection Tank, Rebar exposed June 5, 2007
Photo Taken By: Andrew Gall, OEPA NWDO DSW
