Re: Allen County
Shelly Co.
Construction
Storm Water

July 8, 2009

On June 4, 2009, I inspected the Shelly Company Facility at 3111 South Dixie Highway, Fort Shawnee, Allen County (pictures taken). The purpose of my visit was to evaluate compliance of the site with the National Pollutant Discharge Elimination System (NPDES) permit for storm water discharges associated with construction activity (Construction General Permit), Facility ID No. 2GC02263. The inspection was conducted under the provisions of Ohio's water pollution control statutes, Ohio Revised Code (ORC) Chapter 6111. Ohio EPA has no record of other permittees for this site.

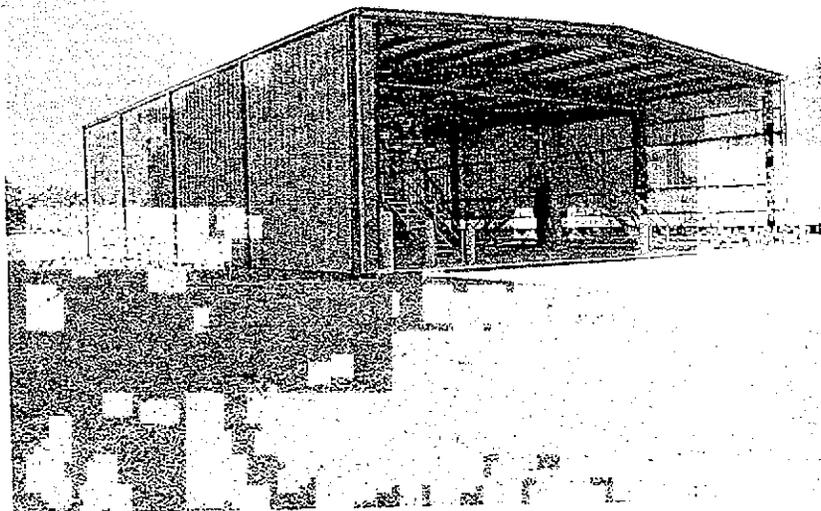
2. Also, some spot reseeding may be required west of the fuel canopy structure to fill in the patchy growth.

June 4, 2009, 12:30 PM. Shelly Co. Allen County. New fuel canopy. Grass not at 70% density west of the structure. Taken by Danielle Meienburg. ShellyCo_060409_08.jpg
