RE: COLUMBIANA COUNTY  
CITY OF SALEM  
SALEM CHRYSLER JEEP DODGE  
CONSTRUCTION STORM WATER

On June 14, 2011, I performed an inspection at the above-referenced site to determine compliance with the Ohio EPA General Storm Water National Pollutant Discharge Elimination System (NPDES) Permit for Construction Activities #3GC05369\*AG. While on site, I spoke with Chad Les of Les Contracting. Our records indicate that Ron Jon Investments LLC was granted coverage under the NPDES permit on March 31, 2011.

**Salem Chrysler Jeep Dodge**  
City of Salem    Columbiana County

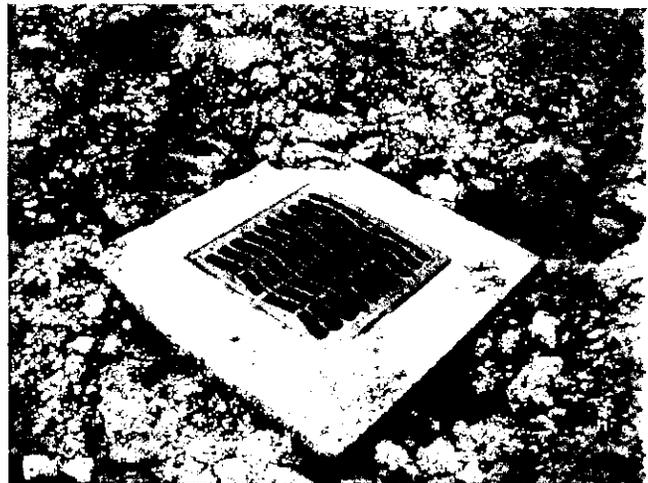
Figure 4 – Inlet protection is needed around the outlet structure of the sediment pond.

2. Until the area has been stabilized, inlet protection is needed around the outlet structure of the sediment basin (Figure 4). As stated in the NPDES permit, control practices must be utilized to minimize the amount of sediment that enters storm drains.
