**Environmental
Protection Agency**

July 19, 2011

RE: CUYAHOGA COUNTY
CITY OF MIDDLEBURG HEIGHTS
WILLOUGHBY SUPPLY
NPDES PERMIT NO. OHC000003
OHIO EPA PERMIT NO. 3GC04723*AG
CONSTRUCTION STORM WATER

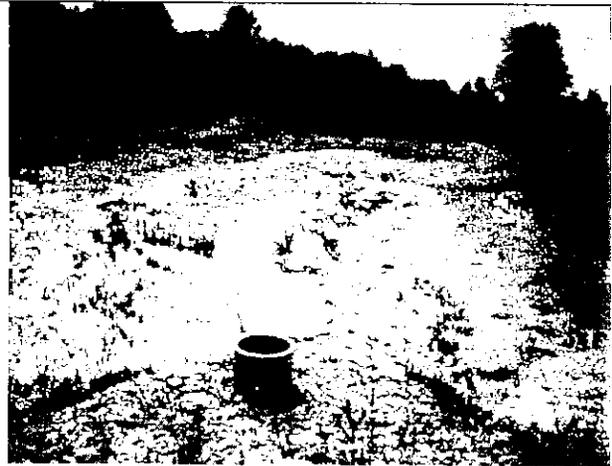
Figure 2. The area around the sediment basin needs to be stabilized.

- There were several areas throughout the site with permanent stabilization issues, specifically in the swale along the driveway, the area behind the building, and around the sediment basin. It appeared as if seeding and straw mulch has been applied once before, but did not take well due to weather conditions, etc. Please be sure to stabilize these areas with adequate amounts of seeding and straw mulch to establish a growth density of 70% or greater (See Figures 1-3).

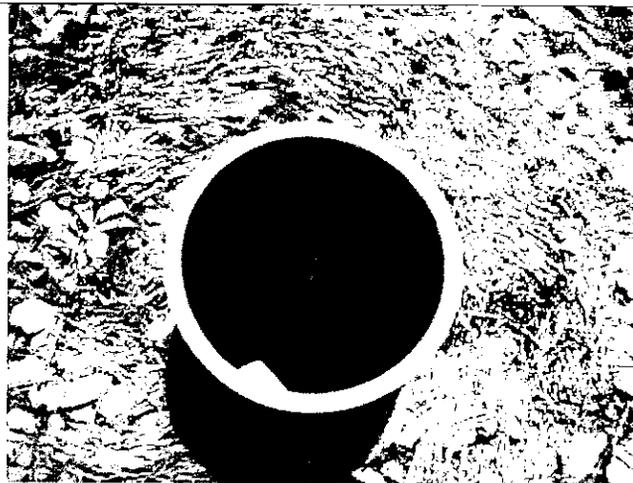
Figure 5. The perforated pipe needs to be capped or screened on the top.

- The perforated pipe structure in the sediment basin is not capped, allowing the opportunity for any trash or debris to clog the structure and not function properly. Please cap the structure to prevent the pipe from clogging (See Figure 5).

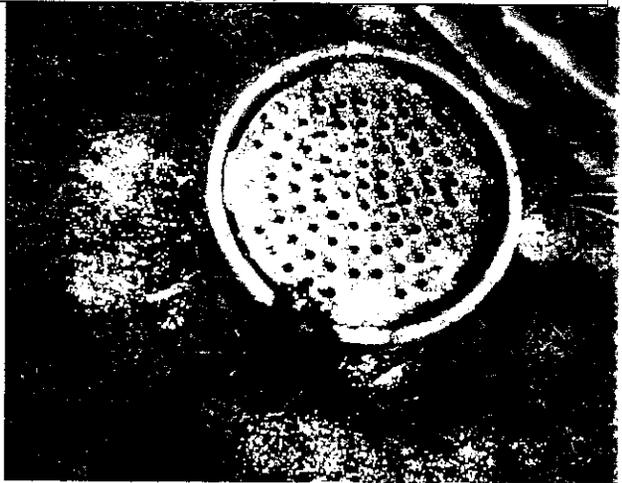
Figure 6. Geotextile fabric needs to be removed from the catch basins.

- There appeared to be several catch basins with geotextile material still stretched across them. Please remove the geotextile material from under the grates immediately (See Figures 6).
