**Environmental
Protection Agency**

June 30, 2011

RE: HOLMES COUNTY
WALNUT CREEK
WALNUT CREEK FOODS
CONSTRUCTION STORM WATER

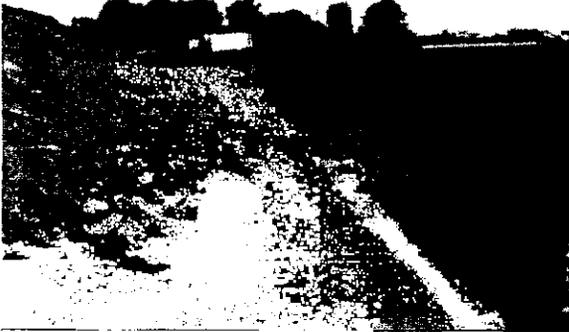
Figure 3 – No silt fence is present along the boundaries of the earth disturbance.

1. No silt fence is present along the boundaries of the earth disturbance, even though silt fence is shown on the Storm Water Pollution Prevention Plan (SWP3). In order to prevent sediment from leaving the site, you must install silt fence around all disturbed areas, as well as around the dirt stockpiles that are present on the site (Figures 1-3). If these stockpiles will not be used within the next 21 days, you must also temporarily stabilize them within seven days of last use.

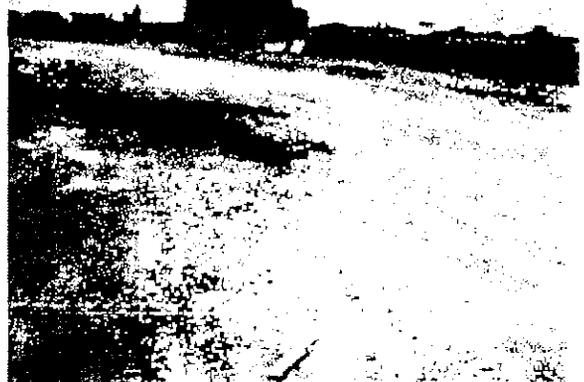
Figure 4 – The rock construction entrance needs maintenance.

2. The rock construction entrance needs maintenance (Figure 4). Please add more stone to this area to reduce the off-site tracking of sediment that is currently occurring.

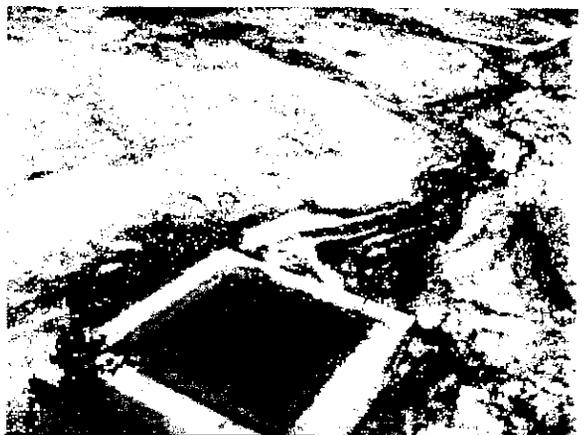
Figure 6 – Concrete washout is flowing into the storm drains.

4. Concrete trucks are being washed out over bare soil, and the water from these activities is flowing directly to the storm drains (Figures 6-8). According to the NPDES permit, you must designate contained areas for concrete washout, and these locations must be outlined in your SWP3. You are not permitted to discharge concrete waste water to the storm drains.

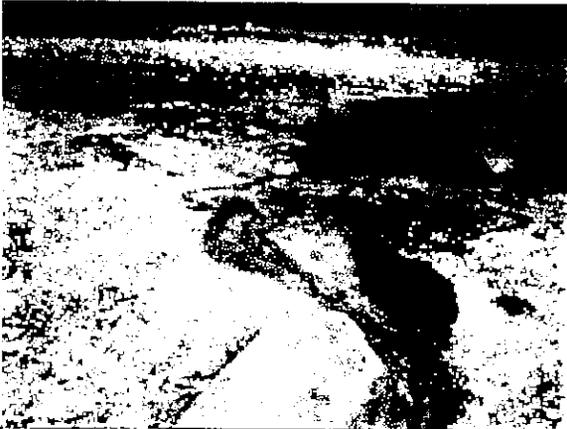
Figure 7 – Concrete washout is present on the exposed dirt.
