**Environmental
Protection Agency**

RE: Lorain County
Wetlands & Tributaries to Black River
LORCO Phase I, Project # 083343
Notice of Violation

NOTICE OF VIOLATION

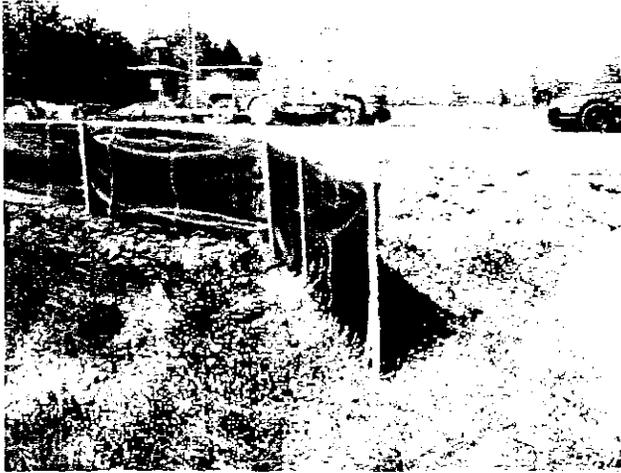
Fig 1 (LEFT). The end of the silt fence is turned downslope rather than upslope. This allows sediment-laden runoff to flow around the end rather than cause it to pond behind the fence.

- **Failure to install silt fence in a functional condition.** This is a violation of Part III.G.2.d of the NPDES permit and ORC 6111.04 and 6111.07. Silt fence, like any other sediment control, must be capable of ponding runoff if it is to be considered functional. Please trench in and backfill silt fence, and turn the ends of the silt fence upslope to assure that runoff ponds behind it.

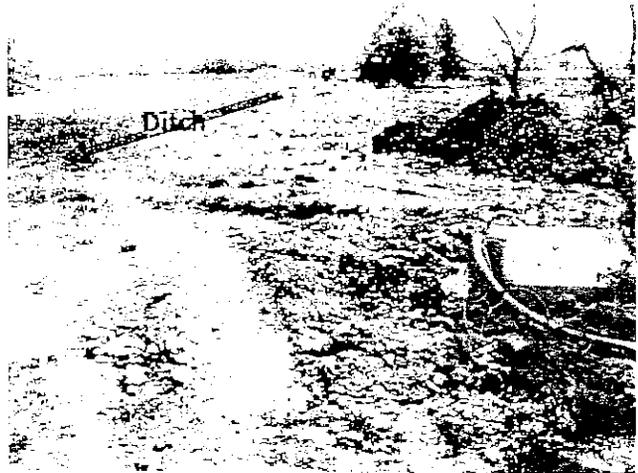
Fig 2 (RIGHT). There is no silt fence between the edge of disturbance for the Cowley Rd Pump Station and the drainage ditch.

- **Failure to install silt fence along the drainage ditch near the Cowley Road Pump Station.** This is a violation of Part III.G.2.d.ii of the NPDES permit. Silt fence or other perimeter control must be installed to control sheet flow discharges from disturbed soils to the ditch.

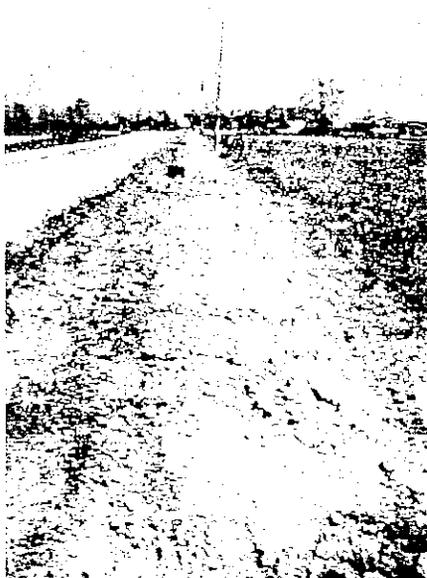
Fig 3 (LEFT). No temporary stabilization of disturbed areas has been initiated along Cowley Rd.

- **Failure to initiate temporary stabilization of disturbed areas in the timeframes required by the NPDES permit.** This is a violation of Part III.G.2.b.i of the NPDES permit and ORC 6111.04 and 6111.07. Once a section of sewer pipe or force main is installed and backfilled, it must be seeded and mulched, or just mulched, within 7 days if the soil will not be reworked within 21 days or longer. There are many sections of sewer pipe that were installed during winter conditions or longer than 21 days ago but the soil was never stabilized. Please seed and mulch all disturbed areas as required by the NPDES permit.

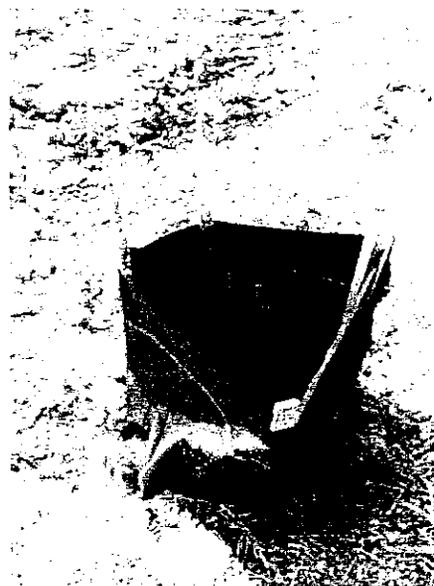
Fig 4 (RIGHT). Storm drain inlet protection has not been constructed per approved specifications.

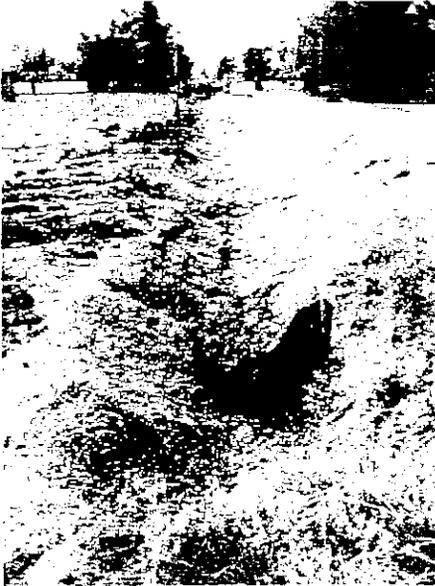
Fig 5. Placing silt fence across a ditch will not provide adequate sediment control for concentrated flows of runoff. Sediment traps must be placed at key locations to control such flows.

- **Failure to implement sediment ponds to control concentrated storm water runoff.** This is a violation of Part III.G.2.d.ii of the NPDES permit and ORC 6111.04 and 6111.07. The contractor has installed silt fence across the road ditch as an attempt to prevent sediment from discharging to the aforementioned drainage ditch. Please be aware that this is not an allowable use of silt fence. Concentrated flows of storm water runoff, such as those that pass through the Cowley Road ditch, must be controlled through the use of sediment ponds. For drainage areas up to 5 acres in size, sediment traps may be implemented within the Cowley Road ditch prior to where it discharges to an existing culvert pipe or a water of the state. Please consult with the project engineer to size, design and locate appropriate sediment traps for this project.

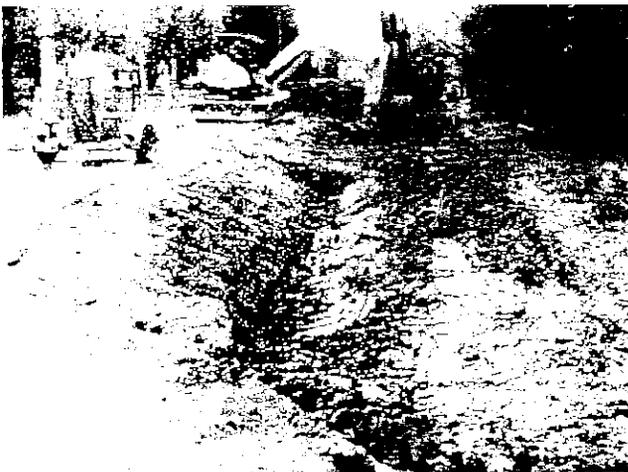
Fig 6 (LEFT). Special measures such as erosion control matting, rock rip-rap, sod or rock check dams may be required to stabilize road ditches.

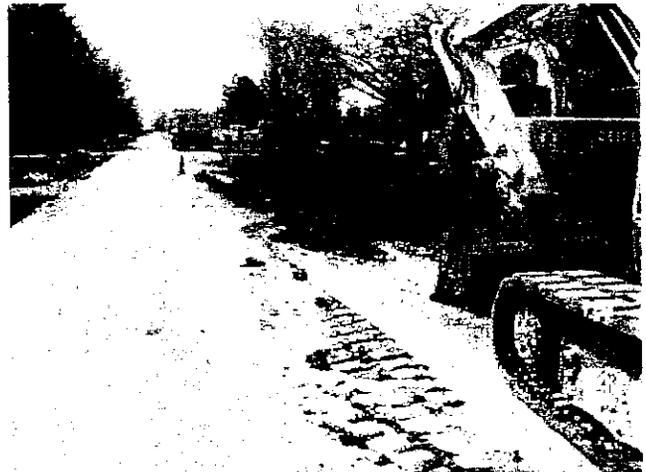
Fig 7 (RIGHT). To minimize off-site tracking, street sweeping must occur more frequently. Wherever feasible, soil excavated to install pipe should not be stockpiled on roadways, but rather be placed upslope of the sewer trench.

- **Failure to minimize off-site tracking of sediment onto Hawke Road.** This is a violation of Part III.G.2.g.ii of the NPDES permit and ORC 6111.04 and 6111.07. Please be sure to sweep streets as frequently as needed to minimize the amount of soils on roadways. This is particularly important since soil excavated to lay the sewer pipe is often stockpiled on roadway surfaces, leaving an appreciable amount of soil on pavement after the pipe is backfilled. Further, please be aware that a mechanical brush is not as effective as a vacuum sweeper. Ohio EPA recommends the use of a vacuum sweeper for larger projects such as this one.

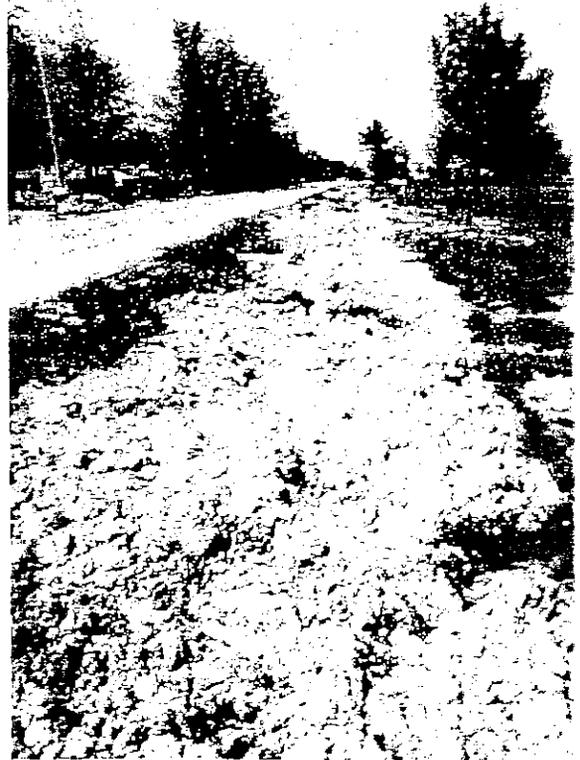
Fig 9 (RIGHT). Temporary stabilization has not been initiated along Henwill Rd.

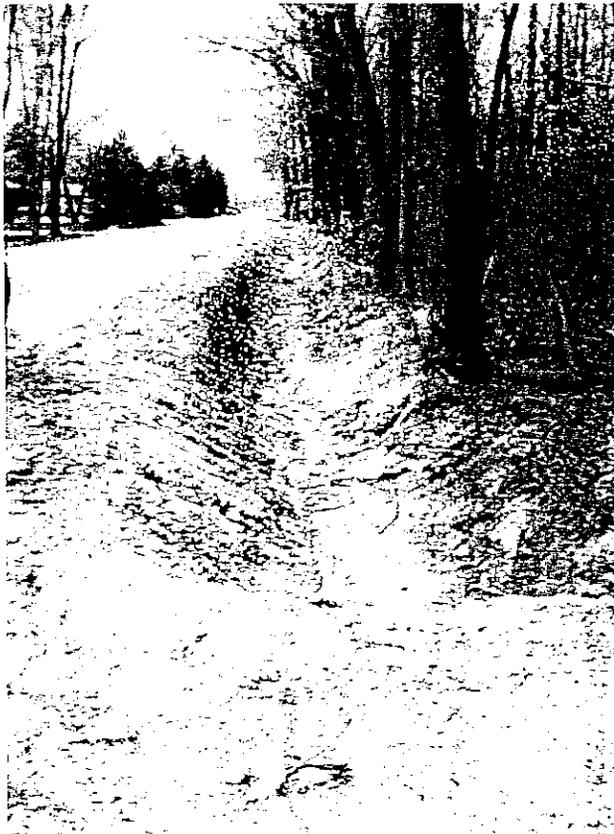
Fig 10 (LEFT). The road ditch along Reed Rd is at final grade for longer than 7 days, yet permanent stabilization has not been initiated.

- **Failure to initiate permanent stabilization of disturbed areas at final grade within 7 days of reaching final grade.** This is a violation of Part III.G.2.b.i of the NPDES permit and ORC 6111.04 and 6111.07. Ditch work along Brokaw Road has been complete for approximately 6 weeks now, yet the road ditch has not been stabilized. Please seed and mulch the road ditch. Be aware that erosion control matting, rock rip-rap or rock check dams may be required to stabilize the road ditch. Please see the enclosed specifications on the proper stabilization of storm water conveyances and consult with the project engineer to determine where special measures must be applied.

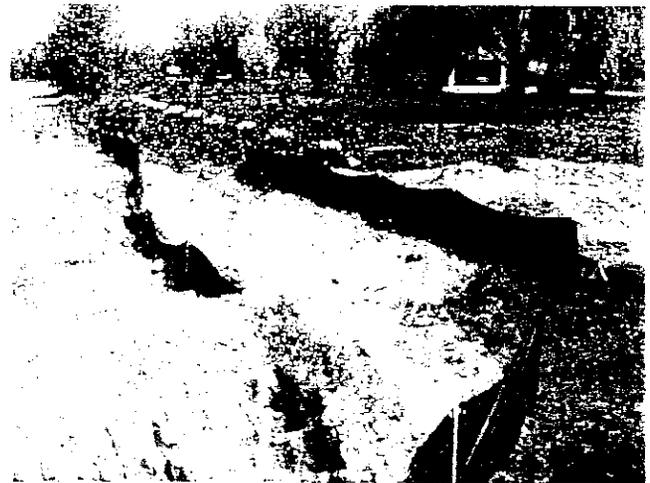
Fig 11 (ABOVE). Silt fence along this drainage ditch is not trenched in and backfilled as required, is not pulled tight and has not been extended to the length needed to intercept sheet flow runoff before it enters the ditch.

- **Failure to install silt fence in a functional condition.** This is a violation of Part III.G.2.d of the NPDES permit and ORC 6111.04 and 6111.07. Silt fence, like any other sediment control, must be capable of ponding runoff if it is to be considered functional. Please trench in and backfill silt fence, and turn the ends of the silt fence upslope to assure that runoff ponds behind it.

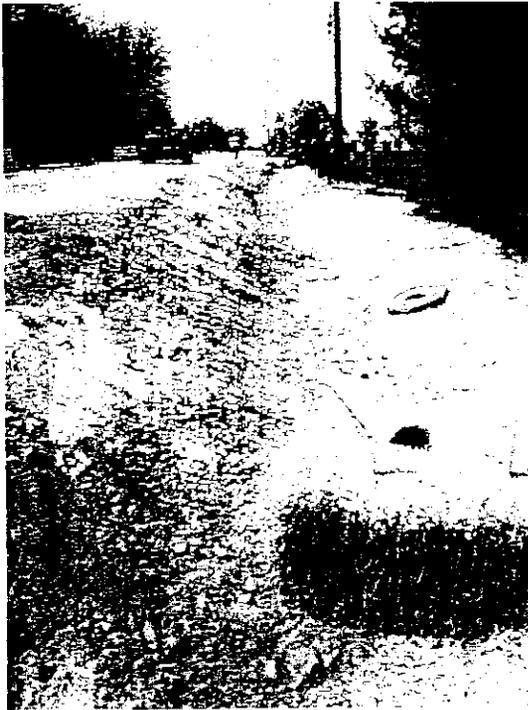
Fig 12 (LEFT). Placing straw bales across a ditch will not provide adequate sediment control for concentrated flows of runoff. Sediment traps must be placed at key locations to control such flows.

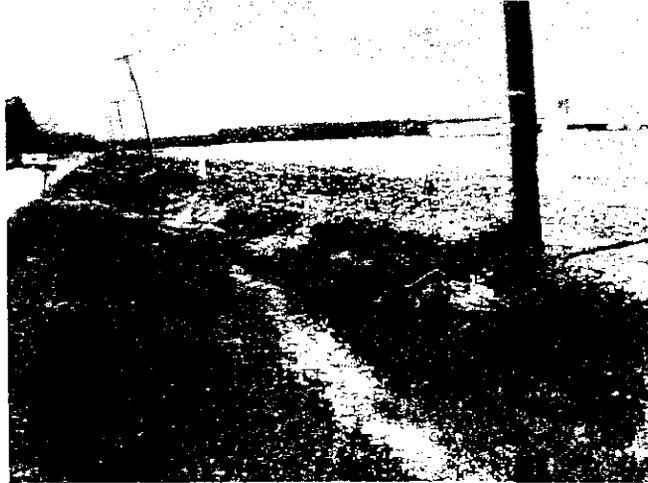
Fig 13 (ABOVE). Silt fence that had been installed along the Cooley Road ditch has been removed before stabilizing the area disturbed by construction.

- **Failure to maintain silt fence in a functional condition until the area it controls reaches final stabilization.** This is a violation of Part III.G.2.h of the NPDES permit and ORC 6111.04 and 6111.07. A section of silt fence along Cooley Road has been removed, yet the area disturbed by construction activities has not been stabilized. Please reinstall the silt fence and maintain it until vegetation is established to a growth density of 70% or greater.

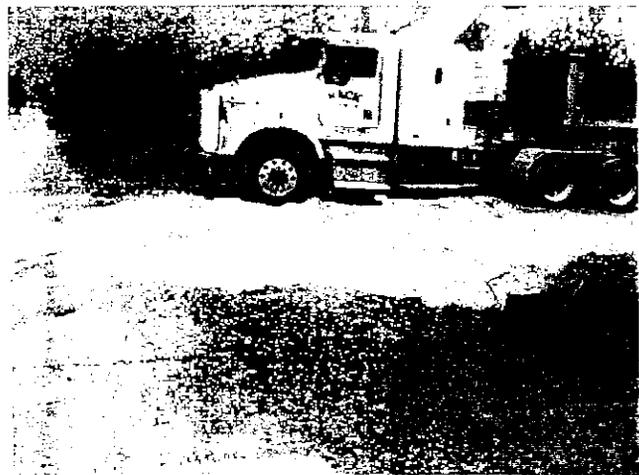
Fig 14 & 15. The rock construction entrances near SR 83 and Cooley Road (LEFT) and at the SR 83 North Pump Station (RIGHT) have not been constructed per accepted standards.

- **Failure to construct the rock construction entrance at SR 83 and Cooley Road per the specifications in the Storm Water Pollution Prevention Plan (SWP3).** This is a violation of Part III.G.2 of the NPDES permit and ORC 6111.04 and 6111.07. Please see enclosed specifications from *Rainwater and Land Development, Ohio's Standards for Storm Water Management, Land Development and Urban Stream Protection* (Ohio Dept. of Natural Resources, 2006) for proper construction of a rock construction entrance. These specifications are referenced in the SWP3. Note that ODOT #2 stone is to be underlain with geotextile. The contractor has not used the proper stone and has omitted the geotextile. Rock construction entrances are needed near the corner of Cooley Rd and SR 83 and at the SR 83 North Pump Station.

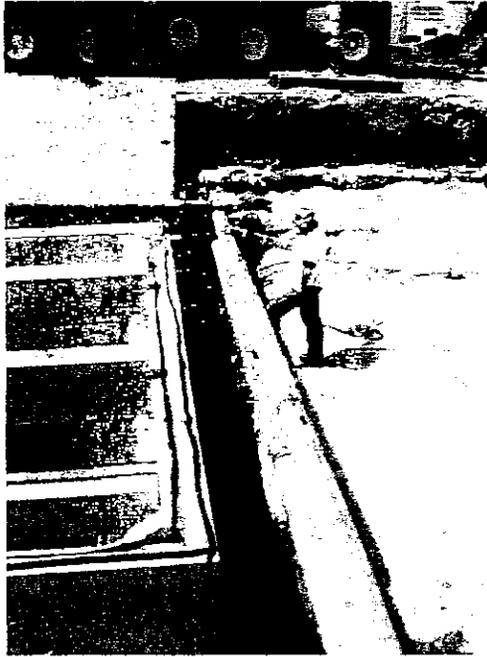
Fig 16 – 19. Improper excavation dewatering at the SR 83 North Pump Station has resulted in a discharge of sediment to an unnamed tributary of Banister Ditch.

- **Failure to implement proper trench and groundwater dewatering techniques.** This is a violation of Part III.G.2.g.iv of the NPDES permit and ORC 6111.04 and 6111.07. The NPDES permit requires sediment-laden trench or groundwater to be passed through a sediment-settling pond or other equally effective sediment control device such as a dewatering bag specifically designed for this task. The contractor did not implement any control practices when dewatering the excavation at the SR 83 North Pump Station. As a result, sediment-laden water from the excavation was pumped directly into an unnamed tributary of Bannister Ditch.

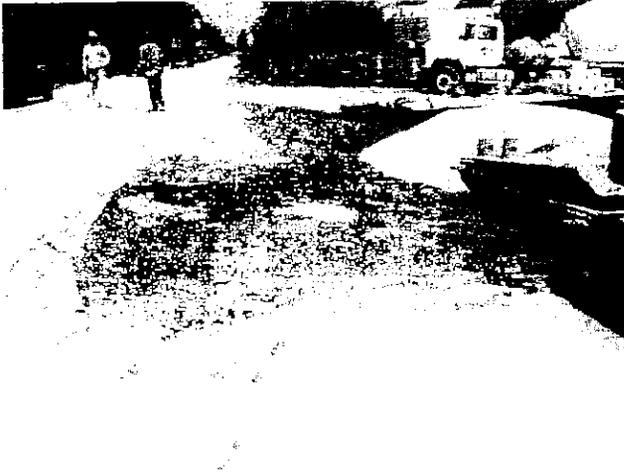
Fig 20 (LEFT). Cement trucks were washing out along the side of SR 83 in an area just upslope of a storm drain. No washout pit had been provided.

- **Failure to implement controls to prevent the discharge of liquid waste.** This is a violation of Part III.G.2.g of the NPDES permit and ORC 6111.04 and 6111.07. Cement trucks were being washed out at the pump station just upstream from a storm sewer inlet. No containment pit or washout area had been established for cement trucks to use. Fortunately, this activity was caught early on so that an actual discharge to the storm sewer was prevented. A cement washout pit was hastily constructed near the corner of SR 83 and Cooley Rd.

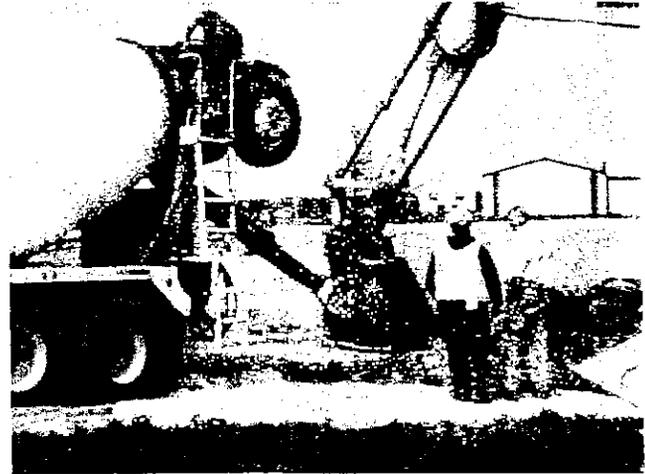
Fig 21 (RIGHT). A washout pit was hastily constructed at SR 83 and Cooley Rd. However, please note that the cement truck driver is washing out the drum and chute before the pit has been established even after he was just told that he was not permitted to wash out in an uncontained area.

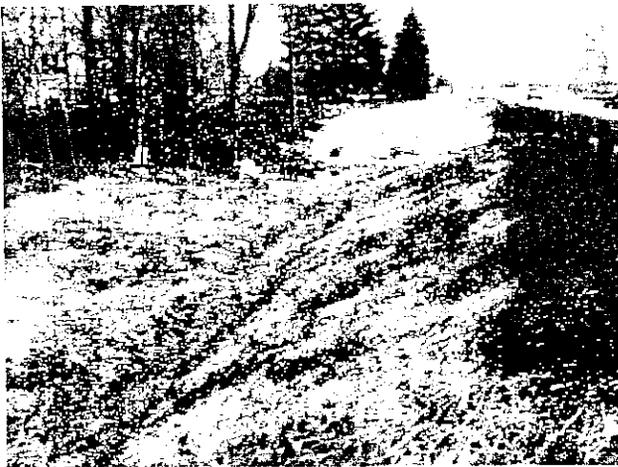
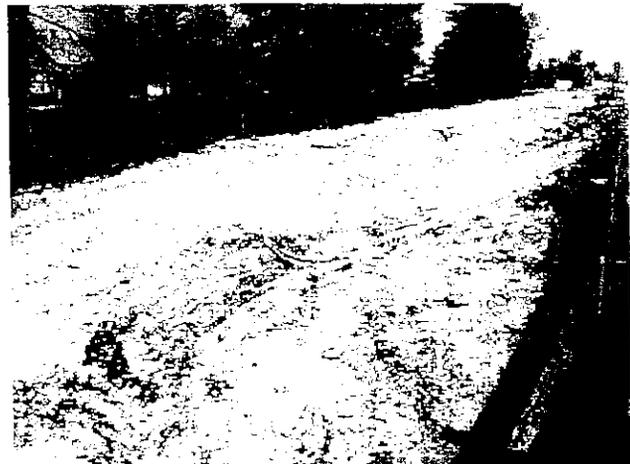
Fig 22 & 23. Temporary stabilization at the SR 82 crossing over Willow Creek was performed well to the west, but poorly to the east of the bridge. In addition, there is no sediment control in place to prevent sediment-laden discharges to Willow Creek until the grass can establish.

- **Failure to initiate temporary stabilization of disturbed areas in the timeframes required by the NPDES permit.** This is a violation of Part III.G.2.b.i of the NPDES permit and ORC 6111.04 and 6111.07. Once a section of sewer pipe or force main is installed and backfilled, it must be seeded and mulched, or just mulched, within 7 days if the soil will not be reworked within 21 days or longer. Although this contractor has implemented temporary stabilization on some parts of his project area, it was not implemented for disturbances south of Durkee Rd and west of Willow Creek. Please seed and mulch all disturbed areas as required by the NPDES permit.

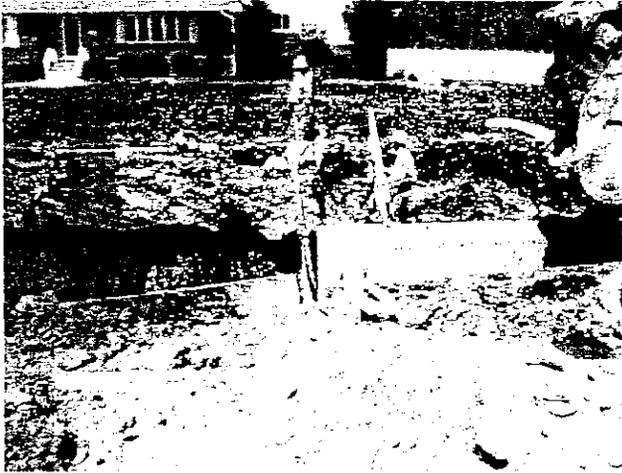
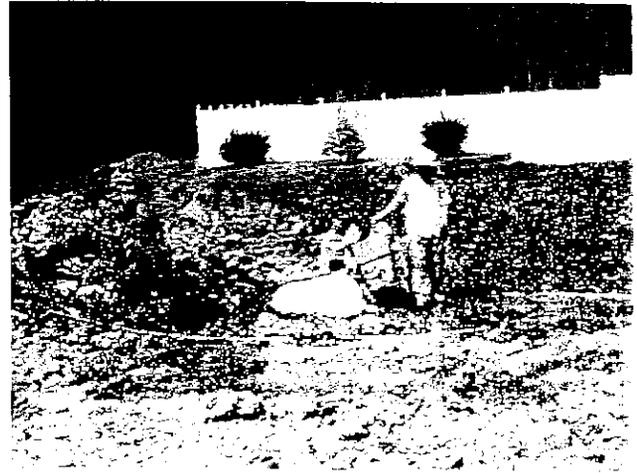
Fig 24 & 25. Controls for trench dewatering were not in place at the time of inspection, resulting in sediment-laden discharges to the SR 82 road ditch. Here a worker is trying to place the end of the hose in a Dandy Bag intended for storm drain inlet protection, not dewatering.

- **Failure to implement proper trench and groundwater dewatering techniques.** This is a violation of Part III.G.2.g.iv of the NPDES permit and ORC 6111.04 and 6111.07. The NPDES permit requires sediment-laden trench or groundwater to be passed through a sediment-settling pond or other equally effective sediment control device such as a dewatering bag specifically designed

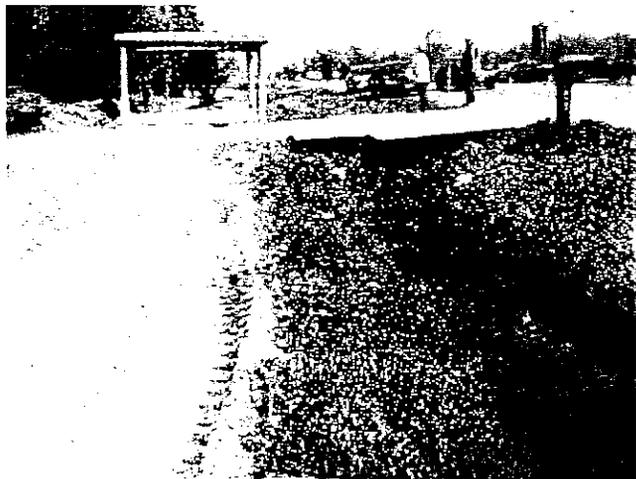
Fig 27 (RIGHT). The area along the SR 82 road ditch has been disturbed by construction activity, yet there is no silt fence in place to minimize sediment-laden discharges.

- **Failure to install silt fence along the drainage ditch west of the current workzone along SR 82.** This is a violation of Part III.G.2.d.ii of the NPDES permit. Silt fence or other perimeter control must be installed to control sheet flow discharges from disturbed soils to the ditch.

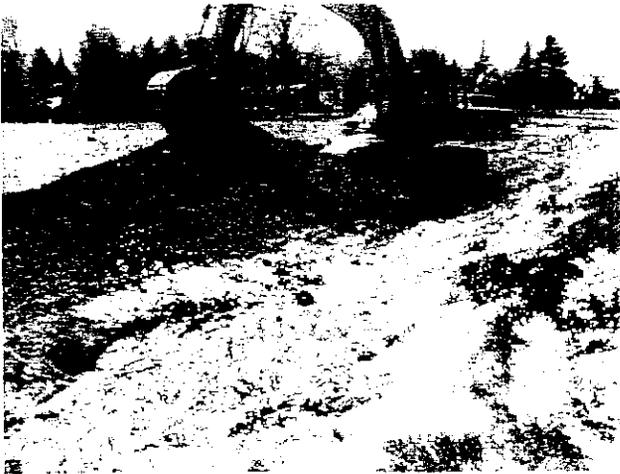
Fig 28 (LEFT). Although the contractor indicated that this stockpile would be removed by the end of the day, note that it was placed in the road ditch along SR 82. This is not a suitable location for stockpiles. If it rains, this soil would wash down the ditch and into Robson Ditch.

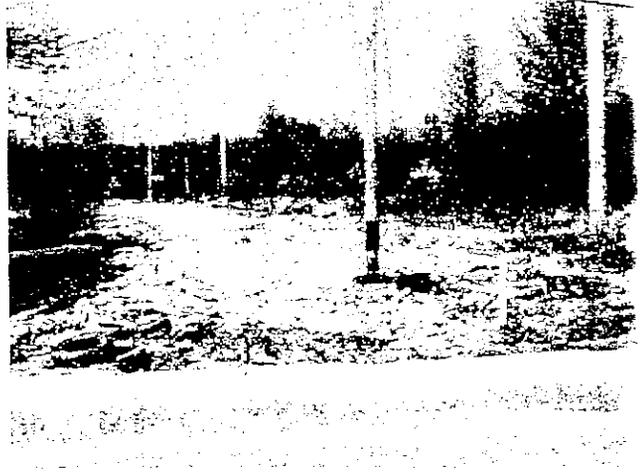
Fig 29 (RIGHT). The area disturbed where the sewer line breaks north toward Avon Lake has been disturbed but has not been stabilized and is not being worked.

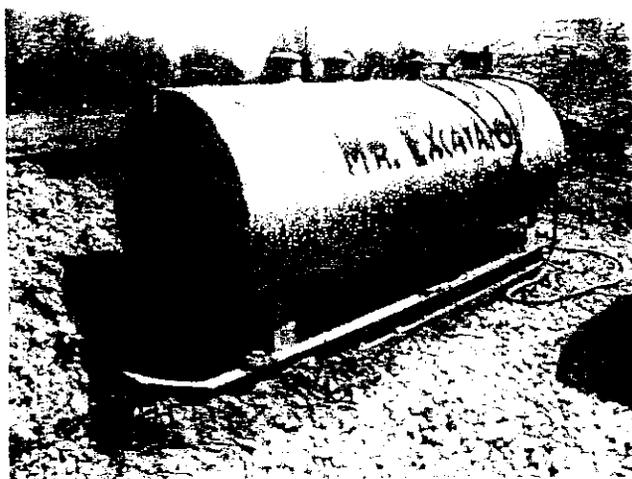
Fig 30 (LEFT). The diesel fuel tank is not in containment and there is no spill kit on site.

- **Failure to implement non-sediment pollutant controls for tanks and drums that contain liquids.** This is a violation of Part III.G.2.g.i of the NPDES permit and ORC 6111.04 and 6111.07. Although the fuel tank is double-walled, there is no spill kit and it is not within a containment dike. These measures are necessary to prevent spilled fuel from discharging from the site. In addition, no containment has been provided for the drum of Magic Kote. Drums of chemicals used during construction should be stored on a spill containment tray or in a trailer. A drip pan should be placed under the spigot.

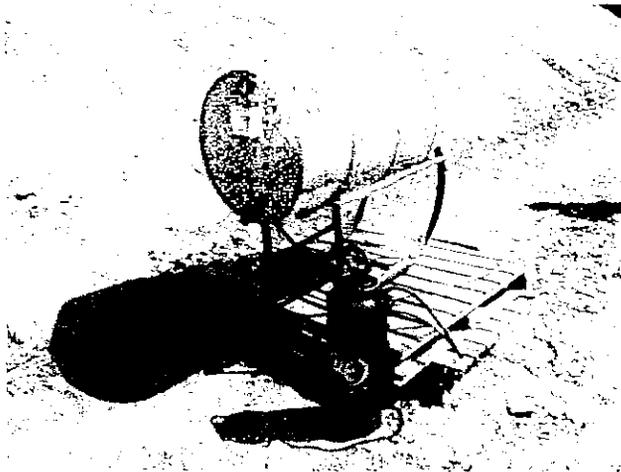
Fig 34 (LEFT). The drum of Magic Kote is not placed within containment. There is no drip pan beneath the spigot.

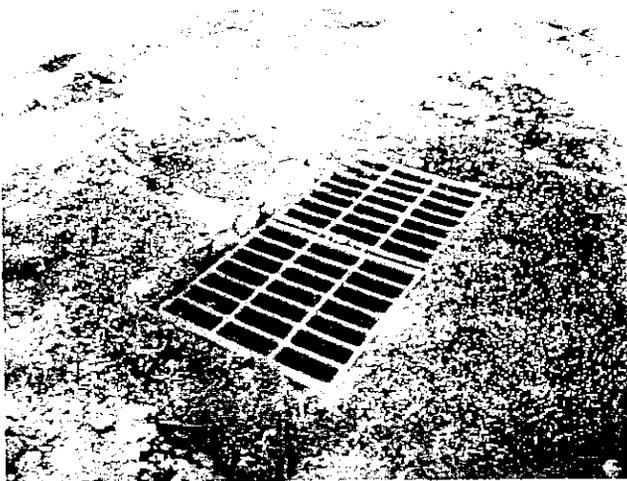
Fig 38 (LEFT). No inlet protection has been installed around this storm drain along Indian Hollow Road.

- **Failure to install storm drain inlet protection around catch basins that receive runoff from disturbed areas of the site.** This is a violation of Part III.G.2.d.iv of the NPDES permit and ORC 6111.04 and 6111.07. A catch basin immediately downslope of the current workzone on Indian Hollow Rd had not inlet protection installed. Please install inlet protection, being sure to build it per the specifications contained in the Storm Water Pollution Prevention Plan (SWP3) or the enclosed specifications from *Rainwater and Land Development, Ohio's Standards for Stormwater Management, Land Development and Urban Stream Protection* (ODNR, 2006). Be sure to install storm drain inlet protection on future sections of the project prior to disturbing soils that would drain to that inlet.

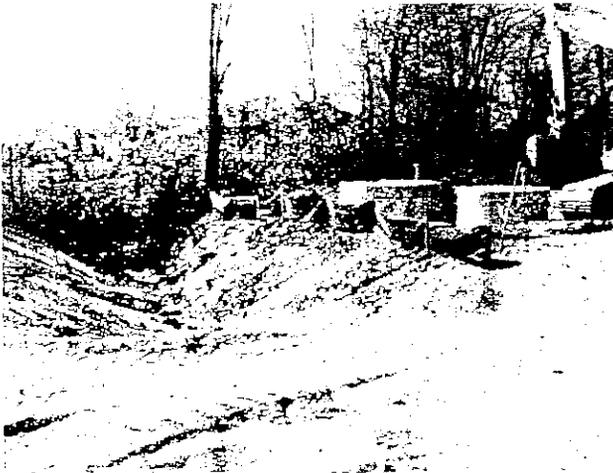
Fig 41 (LEFT). Silt fence has been installed along this unnamed tributary of Dent Ditch by the Slife Road Pump Station, but it has not been properly trenched in, pulled tight and backfilled.

- **Failure to install silt fence in a functional condition.** This is a violation of Part III.G.2.d of the NPDES permit and ORC 6111.04 and 6111.07. Silt fence, like any other sediment control, must be capable of ponding runoff if it is to be considered functional. Please trench in and backfill silt fence, pull it tight, and turn the ends back upslope to assure that runoff ponds behind it. The silt fence was not properly installed along the north side of the unnamed tributary to Dent Ditch at the Slife Road Pump Station. No silt fence was installed along the south side of this stream.

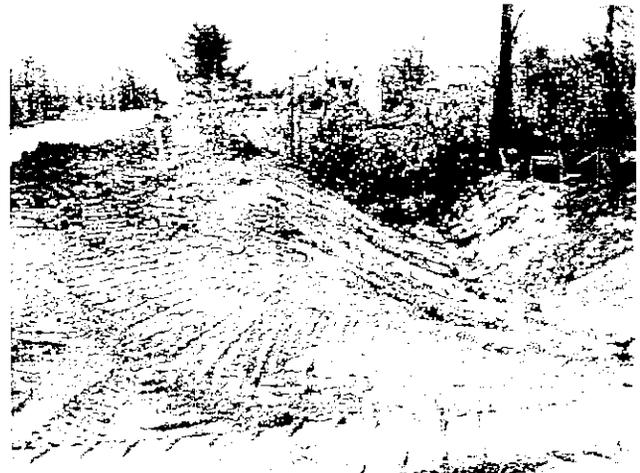
Fig 42 (RIGHT). Silt fence has not been installed along the south side of the stream pictured in Fig 42. In addition, a rock construction entrance has not been provided to access the pump station site.

- **Failure to construct the rock construction entrance at the Slife Road Pump Station per the specifications in the Storm Water Pollution Prevention Plan (SWP3).** This is a violation of Part III.G.2 of the NPDES permit and ORC 6111.04 and 6111.07. Please see enclosed specifications from *Rainwater and Land Development, Ohio's Standards for Storm Water Management, Land Development and Urban Stream Protection* (ODNR, 2006) for proper construction of a rock construction entrance. These specifications are referenced in the SWP3. Note that ODOT #2 stone is to be underlain with geotextile. The contractor has not used the proper stone and has omitted the geotextile.
