Re: Defiance County
Sherwood Crossing Subdivision
Phase II
Construction
Storm Water

July 17, 2009

On July 6, 2009, Mackenzie Coughlan and I inspected the Sherwood Crossing Subdivision Phase II Project at the intersection of State Route 18 and U.S. Route 127, Delaware Township, Ohio (pictures taken). The purpose of our visit was to evaluate compliance of the site with the National Pollutant Discharge Elimination System (NPDES) permit for storm water discharges associated with construction activity (Construction General Permit), Facility ID No. 2GC01583. The inspection was conducted under the provisions of Ohio's water pollution control statutes, Ohio Revised Code (ORC) Chapter 6111. Ohio EPA has no record of other permittees for this site.

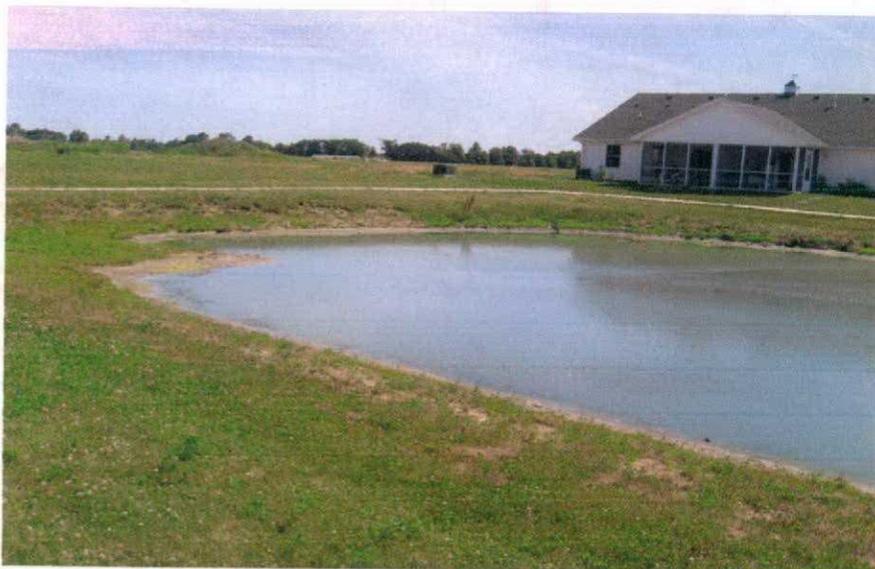
July 6, 2009, 10 AM. Sherwood Crossing Subdivision Phase II. Defiance County. Bare areas on banks of retention pond. Taken by Danielle Meienburg. ShewoodCrossingSubdivisionPhaseII_070609_01.jpg

2. There appeared to be a retention pond on the northwest corner of the site. This structure is required to meet the design requirements for a sediment settling pond until construction activities have ended and a perennial vegetative cover of 70% density has been achieved over the tributary area. Without reviewing the SWP3, I am unable to determine if the pond meets the requirements of the permit. *Permit Requires:* Settling ponds must be sized at 67 cubic yards per acre of total contributing drainage area, have a 2:1 length to width ratio between inlets and the outlet, and have a maximum depth of 5 feet

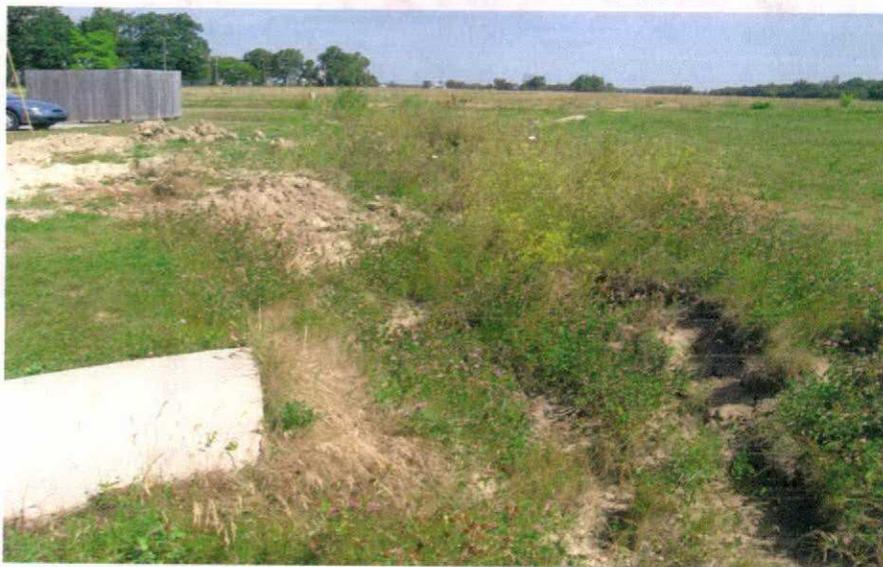
July 6, 2009, 10 AM. Sherwood Crossing Subdivision Phase II. Defiance County. Large trench cut through the sidewalk leading to the retention pond. Taken by Danielle Meienburg. ShewoodCrossingSubdivisionPhaseII_070609_02.jpg

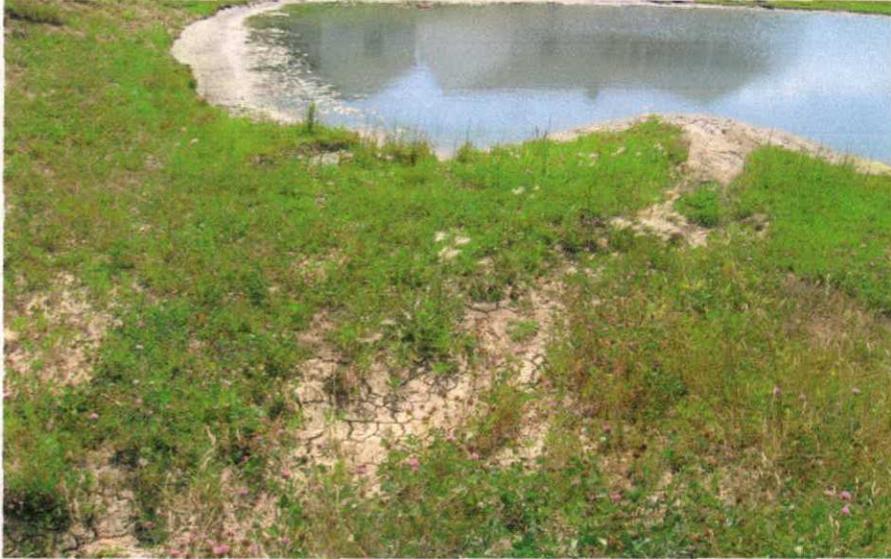
July 6, 2009, 10 AM. Sherwood Crossing Subdivision Phase II. Defiance County. Area where large trench accesses the pond. Taken by Danielle Meienburg.
ShewoodCrossingSubdivisionPhaseII_070609_03.jpg

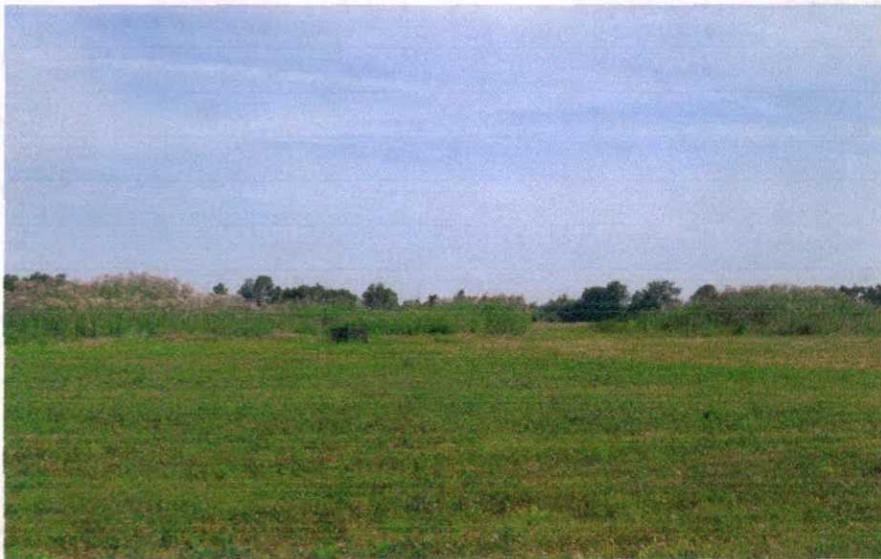
July 6, 2009, 10 AM. Sherwood Crossing Subdivision Phase II. Defiance County. Weed covered soil stockpiles on the north side of the property. Taken by Danielle Meienburg.
ShewoodCrossingSubdivisionPhaseII_070609_04.jpg

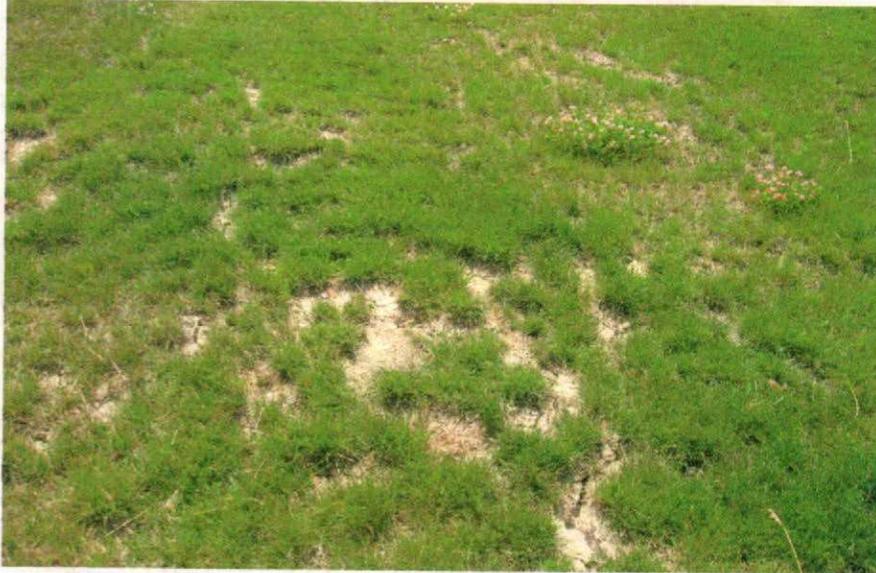
July 6, 2009, 10 AM. Sherwood Crossing Subdivision Phase II. Defiance County. Bare areas on vacant lots. Taken by Danielle Meienburg. ShewoodCrossingSubdivisionPhaseII_070609_05.jpg

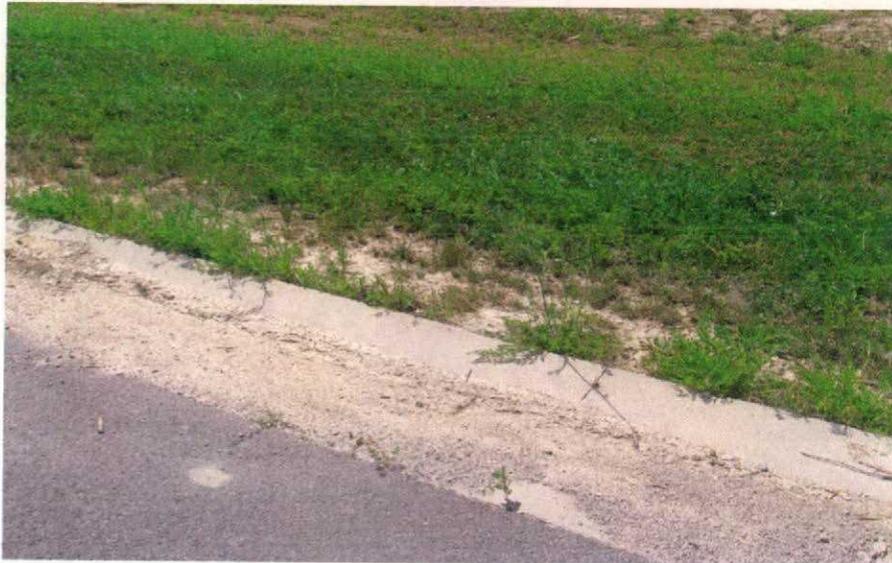
July 6, 2009, 10 AM. Sherwood Crossing Subdivision Phase II. Defiance County. Sediment in curbs. Taken by Danielle Meienburg. ShewoodCrossingSubdivisionPhaseII_070609_06.jpg

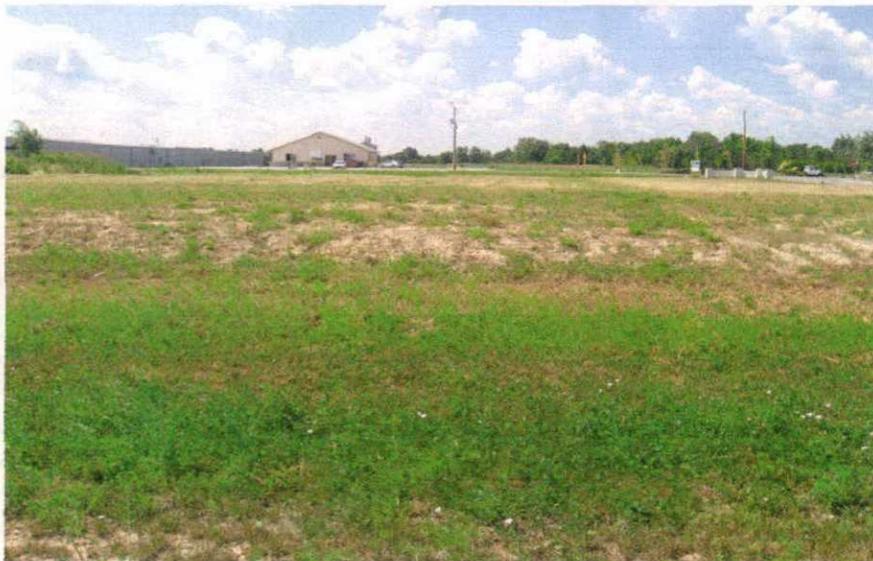
July 6, 2009, 10 AM. Sherwood Crossing Subdivision Phase II. Defiance County. Bare areas on vacant lots. Taken by Danielle Meienburg. ShewoodCrossingSubdivisionPhaseII_070609_07.jpg

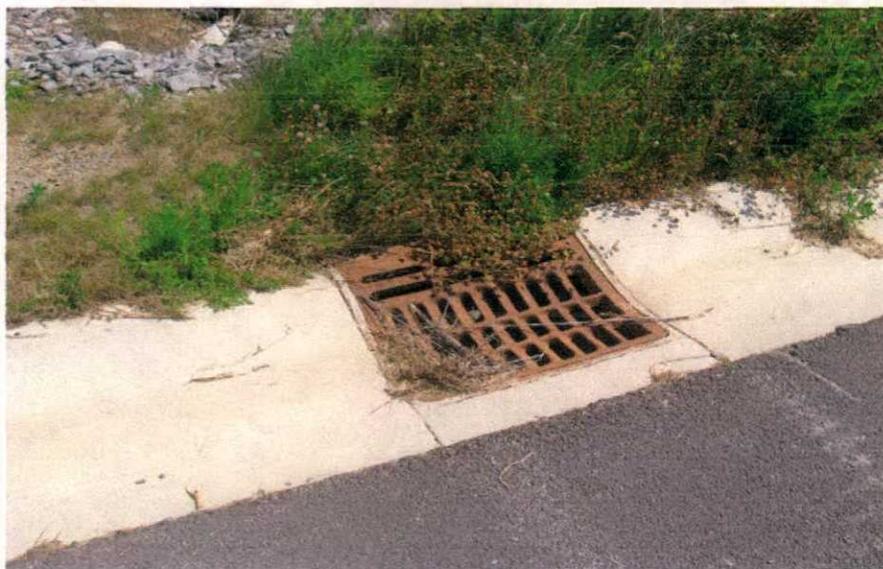
July 6, 2009, 10 AM. Sherwood Crossing Subdivision Phase II. Defiance County. No inlet protection on curb inlets. Taken by Danielle Meienburg. ShewoodCrossingSubdivisionPhaseII_070609_08.jpg

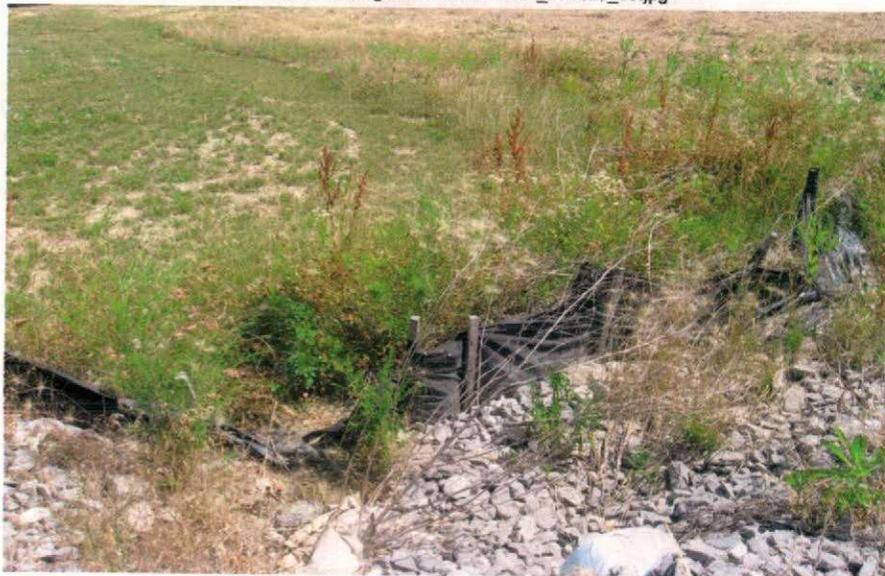
July 6, 2009, 10 AM. Sherwood Crossing Subdivision Phase II. Defiance County. Silt fence in disrepair on the bank of small unknown creek. Taken by Danielle Meienburg. ShewoodCrossingSubdivisionPhaseII_070609_09.jpg

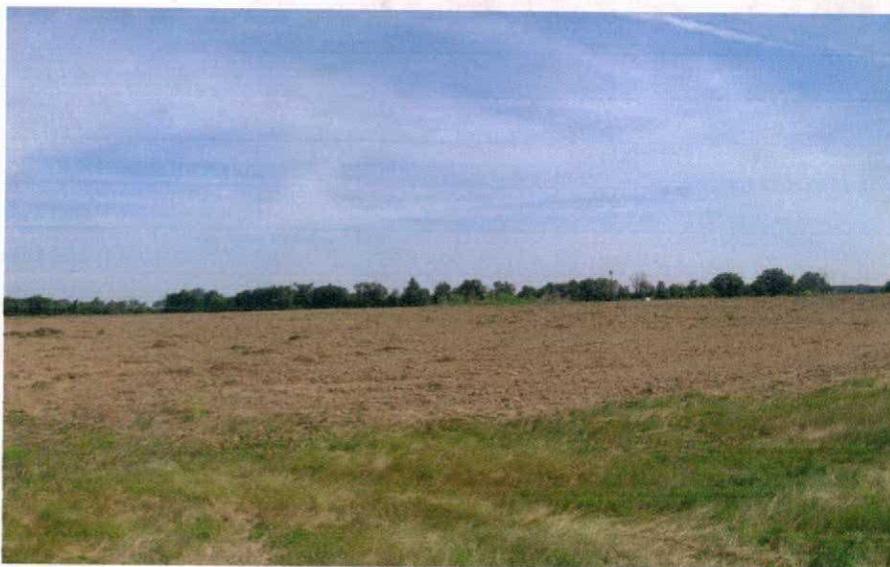
July 6, 2009, 10 AM. Sherwood Crossing Subdivision Phase II. Defiance County. Bare idle ground on vacant lots. Taken by Danielle Meienburg. ShewoodCrossingSubdivisionPhaseII_070609_10.jpg

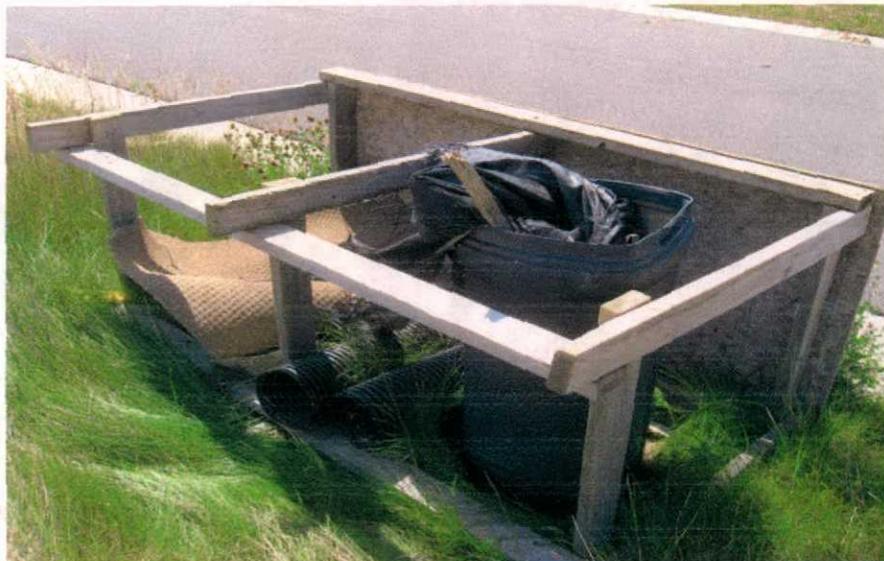
1. At the time of inspection, the site was inactive. The road, curbs, and storm sewer had all been completed. Weed growth was evident on some vacant lots and it appeared that some lots have been graded recently. There was a debris pile located on one of the vacant lots on the eastern side of the property. Due to the absence of personnel or a construction trailer, the Storm Water Pollution Prevention Plans (SWP3) and inspection logs were not available for review.

July 6, 2009, 10 AM. Sherwood Crossing Subdivision Phase II. Defiance County. Trash and debris sitting on a vacant lot. Taken by Danielle Meienburg.
ShewoodCrossingSubdivisionPhaseII_070609_11.jpg
