Environmental  
Protection Agency

July 19, 2011

RE: STARK COUNTY  
CITY OF ALLIANCE  
DLW VENTURES LLC  
CONSTRUCTION STORM WATER

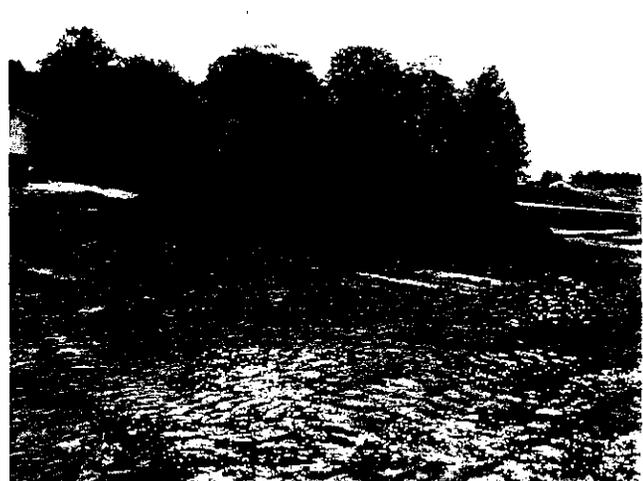
Figure 4 – Much of the site lacks stabilization, including the soil stockpile.

5. Much of the site lacks stabilization (Figures 3 and 4). Please seed and mulch the banks of the sediment basin to prevent erosion gullies from forming. In addition, if you will not be conducting further construction activities in any areas within the next 21 days, you must temporarily stabilize these areas within seven days of the last earth disturbance.
