**Environmental  
Protection Agency**

RE: STARK COUNTY  
JACKSON TOWNSHIP  
WATERSIDE CONDOMINIUMS  
CONSTRUCTION STORM WATER

**NOTICE OF VIOLATION**

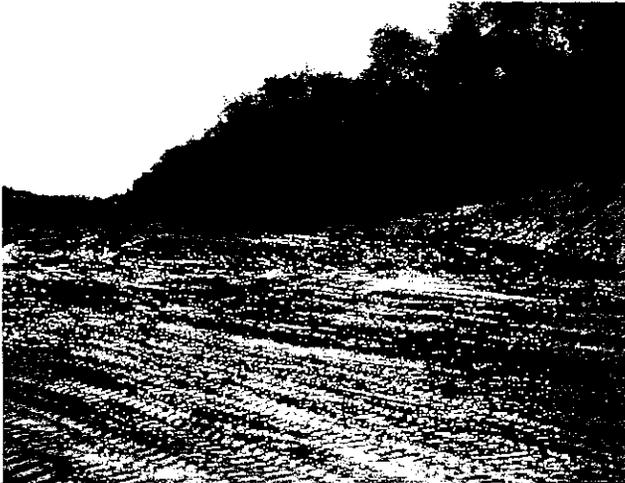
4. The entire site lacks stabilization (Figure 3). Please bring all areas to final grade and then permanently stabilize the site according to the landscaping plan.

Figure 3 – Much of the site lacks stabilization.

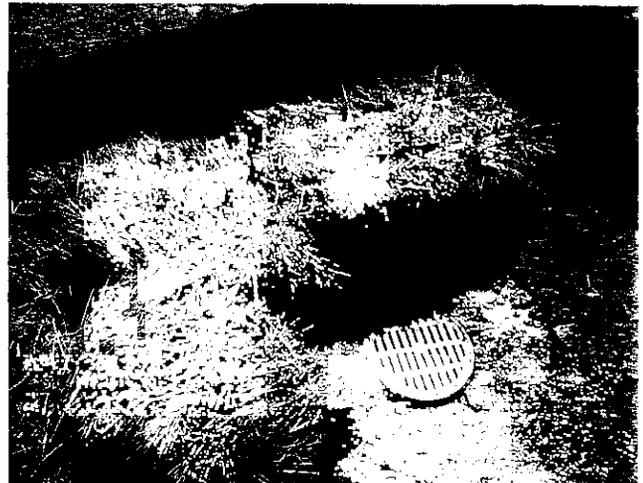
5. Straw bales are being used as inlet protection (Figure 4), which is not acceptable according to the NPDES permit. Please install an appropriate form of inlet protection per the specifications given in the *Rainwater and Land Development Manual* (Ohio Department of Natural Resources, 2006), available online at <http://www.dnr.state.oh.us/tabid/9186/default.aspx>.

Figure 4 – The inlet protection on the storm drain should be modified.

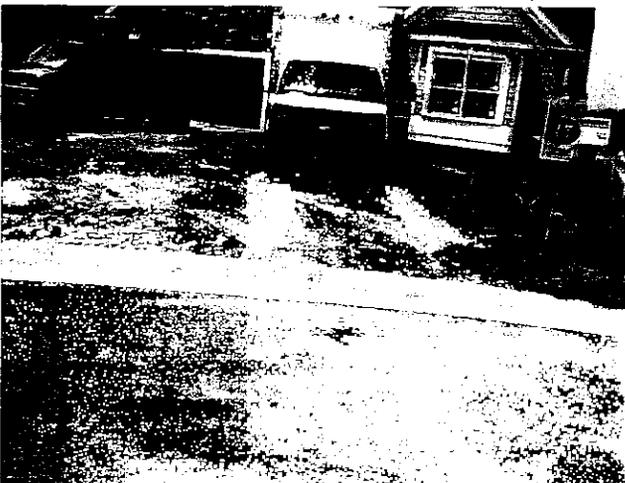
6. No rock construction entrance is present (Figure 5), and as a result sediment is being tracked onto the neighboring roadway. Please place additional gravel at the entrance to the site to reduce the amount of off-site tracking that occurs.

Figure 5 – Sediment is being tracked onto the paved roadway.
