July 15, 2011

RE: STARK COUNTY
CITY OF ALLIANCE
ALLIANCE PLAZA
CONSTRUCTION STORM WATER

NOTICE OF VIOLATION

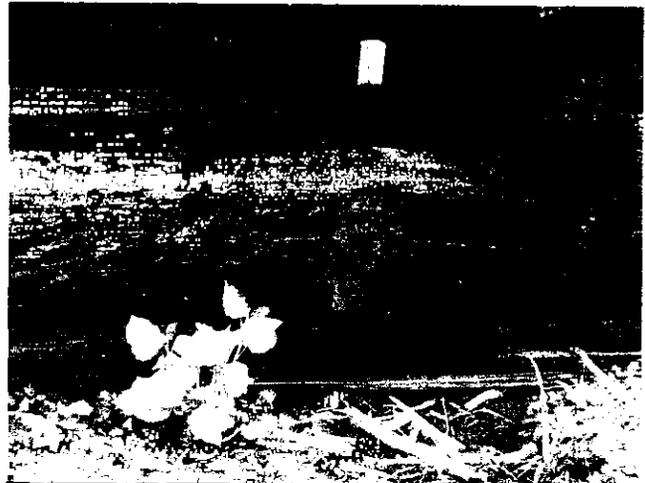
1. The silt fence that is currently in place needs maintenance. Holes are visible in the geotextile fabric, and the fence has not been trenched into the ground, as required in the NPDES permit (Figure 2). Please reinstall the silt fence on the west side of the property and be sure to trench the geotextile fabric at least six inches into the ground. You must also extend the silt fence along the north and west edges of the site so that all disturbed areas are surrounded (Figure 3).

Figure 2 – Holes are visible in the silt fence, and the geotextile fabric is not properly trenched.

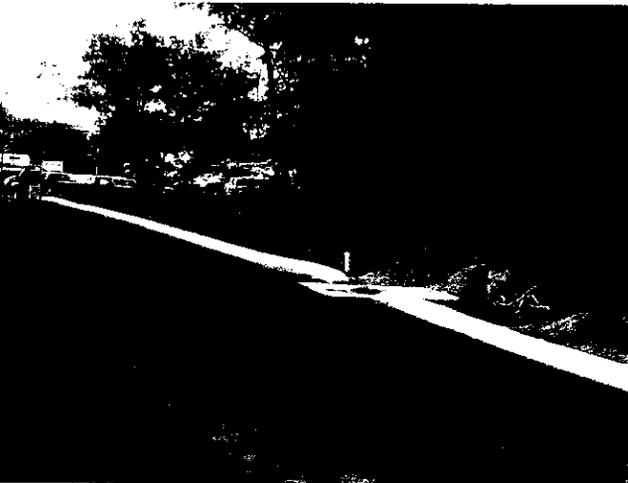
Figure 3 – The silt fence should be extended along the west side of the property.
