**Environmental
Protection Agency**

July 8, 2011

RE: SUMMIT COUNTY
CITY OF HUDSON
VETERINARY CENTER OF HUDSON
CONSTRUCTION STORM WATER

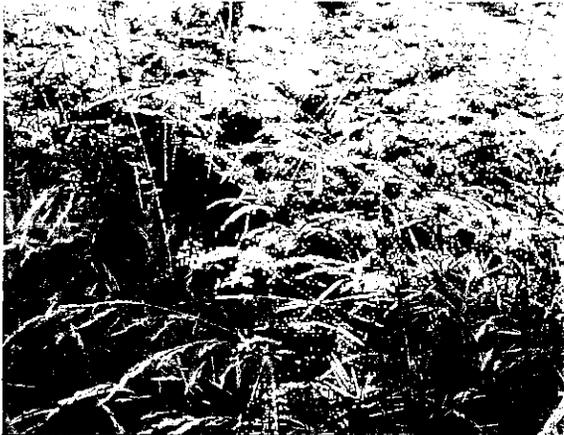
Figure 1 – The silt fence needs maintenance.

1. The silt fence needs maintenance (Figure 1). You must repair and maintain the silt fence around all disturbed areas until these locations reach final stabilization. Final stabilization means that all soil disturbing activities at the site are complete and a uniform perennial vegetative cover (i.e., evenly distributed, without large bare areas) has reached a growth density of 70% or greater on all unpaved areas and areas not covered by permanent structures. Equivalent stabilization measures, such as the use of landscape mulches, rip-rap, or gabions, may be employed, where appropriate, in lieu of vegetation.
