**Environmental
Protection Agency**

RE: TRUMBULL COUNTY
BRISTOL TOWNSHIP
VOLUNTEER FIRE STATION #17
NPDES PERMIT NO. OHC000003
OHIO EPA PERMIT NO. 3GC04764*AG
CONSTRUCTION STORM WATER

On July 14, 2011, Ohio EPA conducted an inspection of the Bristol Township Volunteer Fire Department project located at SR 88 & SR 45, Bristol Township, Trumbull County. Ohio EPA records indicate that the site is covered by the General National Pollutant Discharge Elimination System (NPDES) Permit for Storm Water Associated with Construction Activity (General Storm Water Permit), permit No. 3GC04764*AG.. The inspection documented the following:

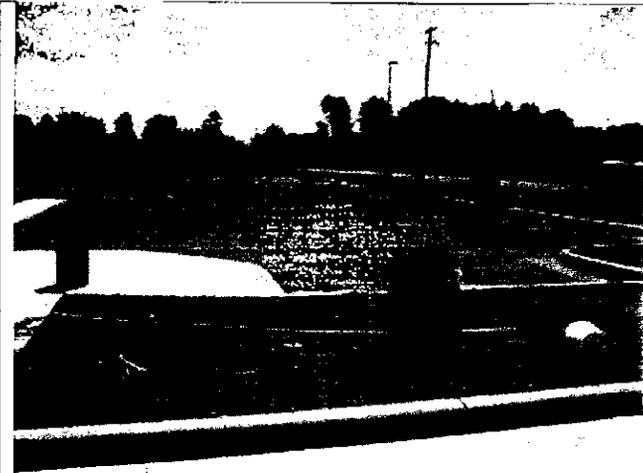
- The site is near completion with the exception of a small amount of concrete work to be done. Once the site is completed and has reached final stabilization, you must submit a Notice of Termination form (NOT) within forty five (45) days. Final stabilization means that all soil disturbing activities at the site are complete and a uniform perennial vegetative cover (i.e., evenly distributed, without large bare areas) has reached a growth density of 70% or greater on all unpaved areas and areas not covered by permanent structures. Equivalent stabilization measures such as the use of landscape mulches, rip-rap or gabions may be employed, where appropriate, in lieu of vegetation. In addition, all temporary erosion and sediment control practices must be removed and disposed and all sediment trapped by these practices must be permanently stabilized (See Figure 1).

Figure 1. Site is near completion except for some concrete work.

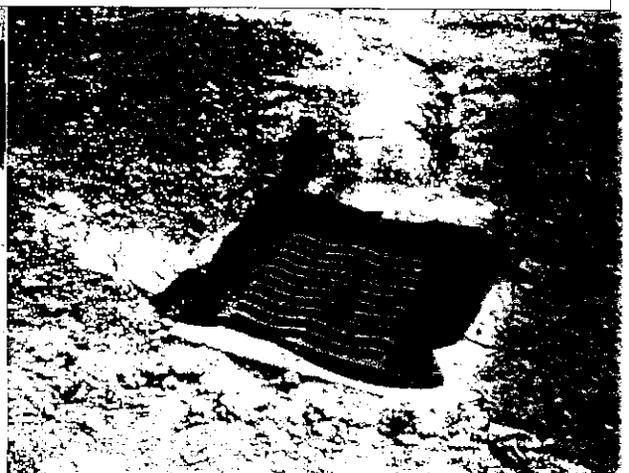
Figure 4. Inadequate inlet protection.

- If any disturbed areas are to remain idle for twenty one (21) days or greater, please be sure to temporarily stabilize them with seeding and straw mulch until the site can be permanently stabilized (See Figure 3).
- There is a catch basin on site with inadequate inlet protection. Simply stretching geotextile material under the grate is not an appropriate form of inlet protection. Please refer to the ***Ohio Rainwater and Land Development Manual (attached)*** and install appropriate inlet protection to prevent sediment laden water from discharging to surface waters of the state (See Figure 4).
