**Environmental
Protection Agency**

April 22, 2011

RE: Wayne County
City of Orrville
JM Smucker Co – Project Heritage
Construction Storm Water

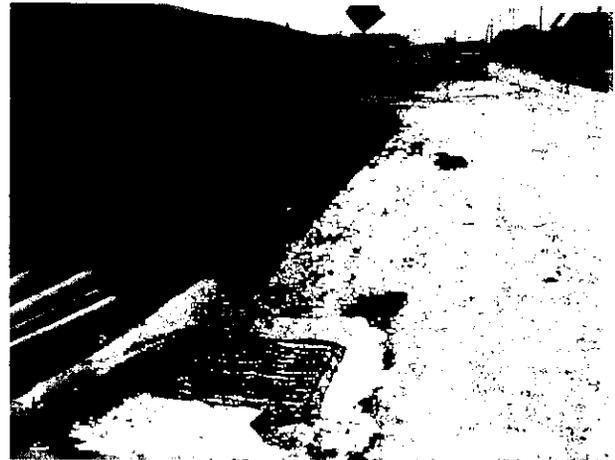
Fig 1 & 2. The rock construction entrance off Mill Street has not been installed. Sediments tracked off-site are making their way into unprotected storm inlets on Mill Street.

- The Rock Construction Entrance (RCE) depicted on the SWP3 off Mill Street has not been installed. Vehicles are accessing the site from this location and sediment was being tracked onto Mill Street on the date of inspection. Please install the RCE as depicted in the SWP3. Because the RCE will slope toward Mill Street, be sure to include the right-of-way diversion depicted in the RCE detail drawing shown on Drawing No. CN502.

- Storm drain inlet protection depicted on the SWP3 on Mill Street on Drawing CE101 has not been installed. Please install inlet protection as shown on the SWP3 to minimize the discharge of sediment to the storm sewer system.

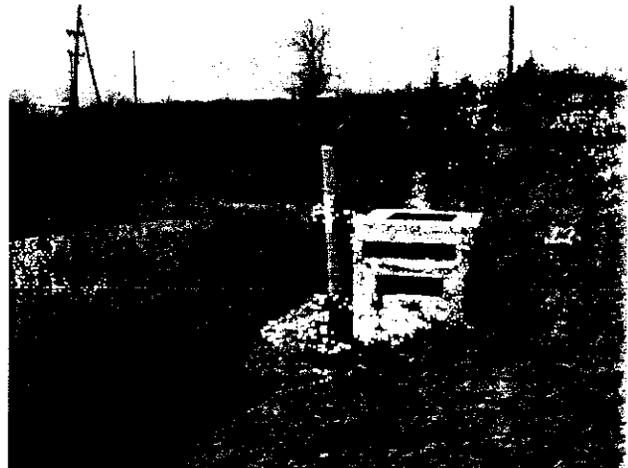
Fig 4 (RIGHT). Detention and Storm Water Quality Basin #1 has been fitted with a riser pipe in an attempt to establish a sediment basin, however the SWP3 has not been updated to reflect this change and engineering design has not been reviewed to ensure that the modifications made meet sediment basin design specifications.

The sediment and erosion control plan actually being implemented on site is different than the plan depicted in the SWP3. On the date of inspection, Sediment Trap #1 and #2 had been removed and runoff was being directed to Detention and Stormwater Quality Basin #1. Although a temporary riser pipe has been installed on the outlet structure in an attempt to establish a sediment basin, the SWP3 has not been updated to reflect this change in design and construction. As such, Ohio EPA has insufficient information to verify compliance with NPDES permit requirements.

Ohio EPA is not opposed to a temporary modification to Detention and Stormwater Quality Basin #1 so that it can act as a sediment basin during the construction process, however the modifications must ensure compliance with design standards and requirements for sediment basins (see enclosure). Please review the sediment and erosion control scheme being implemented to ensure compliance with regulatory requirements. Update the SWP3 as needed to reflect any changes in design and construction related to Detention and Stormwater Quality Basin #1 and the elimination of Sediment Traps #1 and #2. Please provide me with a copy of any SWP3 updates, including all supporting calculations and stage-storage data to demonstrate compliance. The SWP3 must be kept up to date at all times.

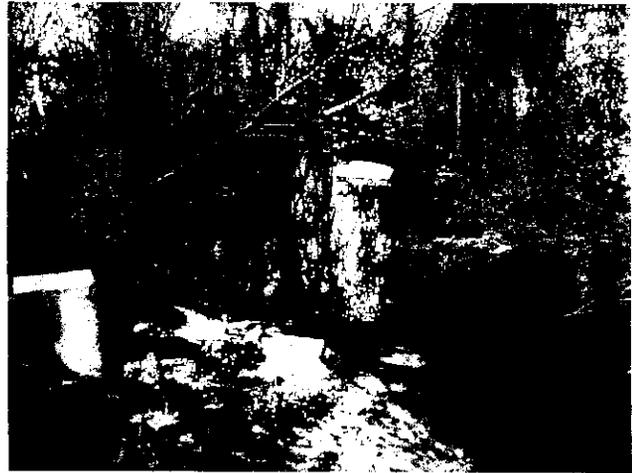
Fig 6 (RIGHT). Ohio EPA is concerned that there is insufficient rip-rap to protect the receiving stream from erosive discharges from Detention and Storm Water Quality Basin #1. Further, the angle at which discharge to the receiving stream occurs will likely lead to accelerated streambank erosion on the side opposite the pipe.

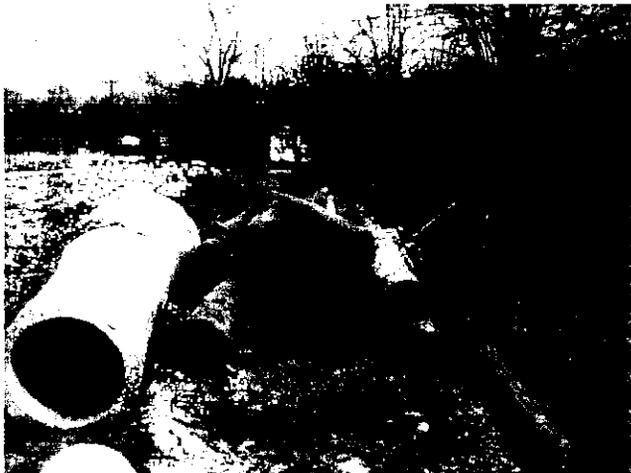
Fig 7 (LEFT). Silt fence has not been installed along the south side of the clearing that leads back to Detention and Storm Water Quality Basin #1. Please install as depicted on the SWP3.

- The silt fence along the south side of the clearing back to Detention and Storm Water Quality Basin #1 has not been installed. Silt fence is required to protect the wetlands from sedimentation. Please install as depicted in the SWP3.

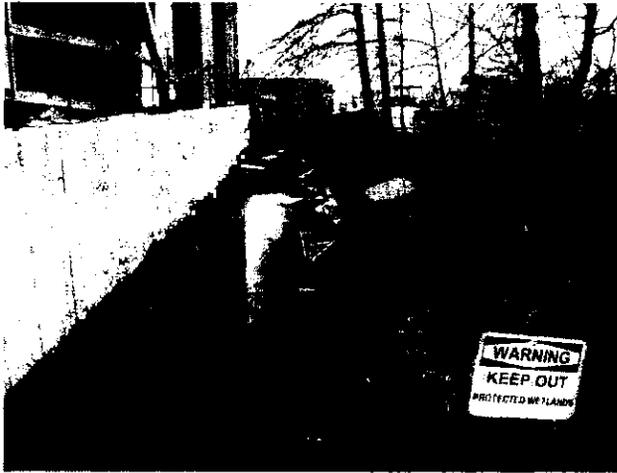
Fig 9 (LEFT). Construction debris must be kept out of the protected Wetlands. Please employ good housekeeping practices to remove debris from wetlands and dispose of it in a dumpster.

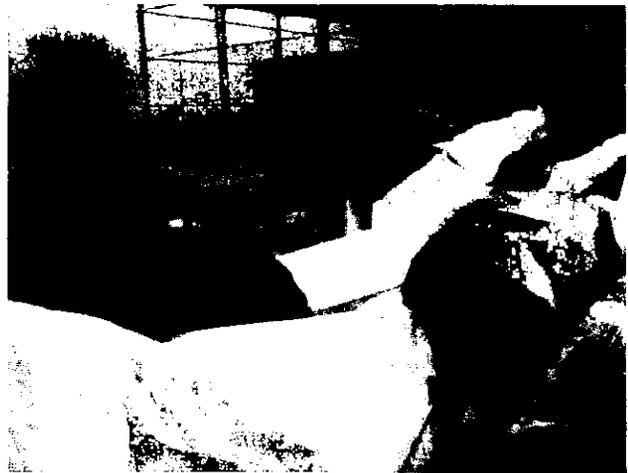
Fig 10 (RIGHT). The trash dumpster is not lidded and no tarp was observed nearby. Note that the dumpster was not covered on the date of inspection.

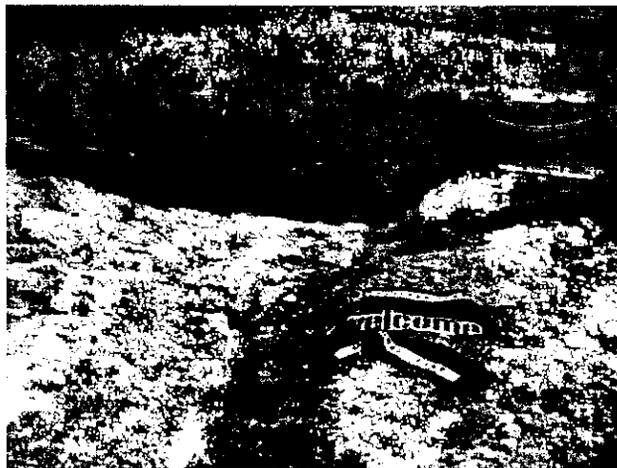
- To facilitate drainage from working areas of the site, a swale has been cut toward the silt fence just south of the culvert noted in the item above. Installation of a swale results in the creation of concentrated flow. Concentrated flow should not be directed to silt fences as they are not intended to control concentrated flow. A

Fig 11 & 12. A swale has been cut to drain the construction site toward the perimeter silt fence, resulting in a concentrated flow of storm water to the silt fence. An appreciable amount of sediment was observed in the wetlands downslope of the silt fence.

better solution would be to remove the swale and re-grade the area to allow positive drainage, but ensure that runoff flows toward the existing silt fence as sheet flow. Another solution is to cut a swale to Sediment Trap #3, and if necessary, enlarge the trap to account for any additional drainage area being directed to it.
