**Environmental  
Protection Agency**

RE: WAYNE COUNTY  
CITY OF RITTMAN  
NEW RITTMAN HIGH/MIDDLE SCHOOL  
CONSTRUCTION STORM WATER

On June 28, 2011, I performed an inspection at the above-referenced site to determine compliance with the Ohio EPA General Storm Water National Pollutant Discharge Elimination System (NPDES) Permit for Construction Activities #3GC04408\*AG. While on site, I spoke with Tim Farling of CT Taylor Construction and Dave Lay of MKC Associates. Our records indicate that Rittman Exempted Village School District was granted coverage under the NPDES permit on April 2, 2009. Our records further indicate that Richard L Bowen & Associates submitted a Co-Permittee Notice of Intent on October 13, 2010.

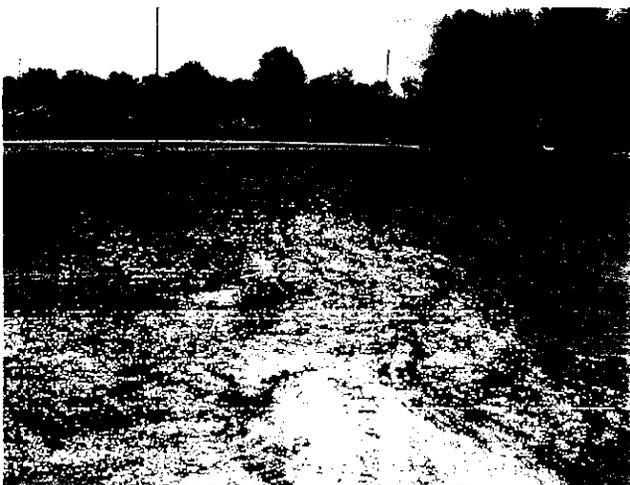
Figure 3 – The site lacks stabilization.

2. Much of the site lacks stabilization (Figure 3). Please bring all areas to final grade and permanently stabilize all bare soil with seed and mulch.
3. If concrete will be used in the future, please ensure that all water used to wash the concrete trucks is contained onsite in a designated area.

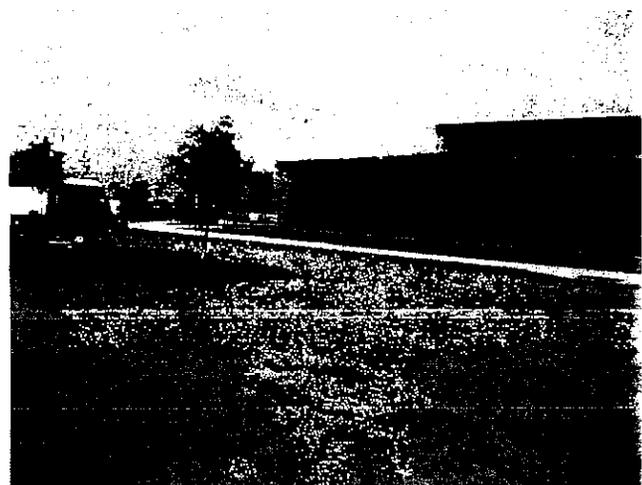
Figure 4 – Sediment is being tracked onto the paved parking lot.

4. Sediment is currently being tracked onto the paved parking lot (Figure 4). Please clean the parking lot regularly to prevent this sediment from being washed into the storm drains.
