**Environmental  
Protection Agency**

RE: WAYNE COUNTY  
APPLE CREEK BASIN  
CITY OF WOOSTER  
CAMPUS CENTER RECREATION CENTER

On July 13, 2010, Ohio EPA conducted a follow-up inspection of the Campus Center Recreation Center, Phase 1, located at 1267 Beall Avenue, City of Wooster, Killbuck Township, Wayne County (site). Ohio EPA records indicate that the site is covered by the General National Pollutant Discharge Elimination System (NPDES) Permit for Storm Water Associated with Construction Activity (General Storm Water Permit), permit No. 3GC04852\*AG. I was accompanied by Adam Bogner of BCMC Inc. The inspection documented the following:

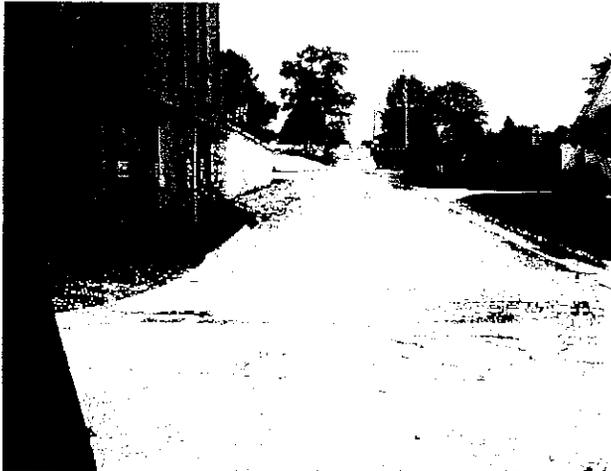
- Installation of the sediment basin has not been completed. Mr. Bogner stated that the timeline for the completion of the sediment basin is the month ending July 2010.
- Offsite tracking continues to be an issue. A significant amount of offsite tracking was observed along Gasche Street to the north of University Street (Figure 1). This is most likely due to construction activities associated with the installation of the sediment basin. Storm sewer inlets were observed at the intersection of Gasche Street and University Street (Figure 2). If offsite tracking in this area continues to be a problem, a revision will need to be made to the site's storm water pollution prevention plan (SWP3) to include these inlets.

Figure 1. A significant amount of offsite tracking was observed along Gasche St. north of University St.

A written report detailing how the above deficiencies will be addressed must be submitted to Ohio EPA within seven days of receiving this letter. The above deficiencies must be addressed within 14 days of receiving this letter. Should you have any questions regarding this matter, please contact me at your earliest convenience at (330) 963-1128.

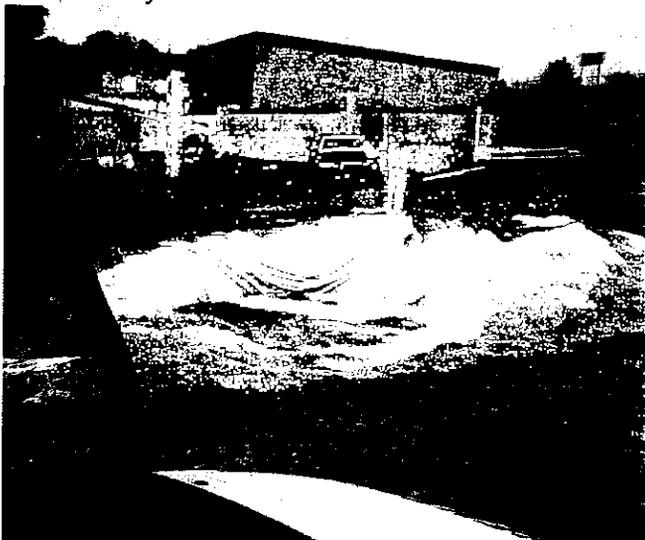
- The construction entrance has been reinstalled and observed to be in working condition. Maintain the construction entrance in accordance with the site's SWP3.
- The concrete washout pit has been properly reinstalled (Figure 5). Maintain the concrete washout pit in accordance with the site's SWP3.
- SWP3 inspections are being conducted weekly or after a rainfall event of 0.5 inches or larger. Records are being kept on-site.

Figure 5. The concrete washout pit has been properly reinstalled.
