Environmental
Protection Agency

June 28, 2011

RE: WAYNE COUNTY
CITY OF WOOSTER
TARTAN RIDGE SUBDIVISION
CONSTRUCTION STORM WATER

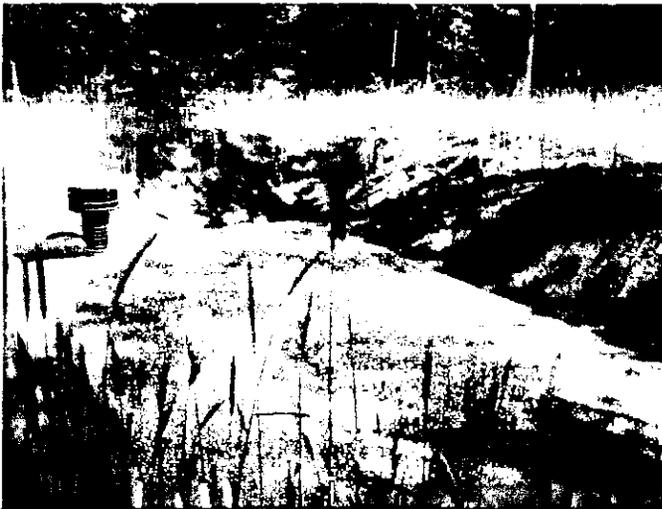
Figure 7 – The banks of the sediment basins lack vegetation.

3. The diversions and the banks of the sediment basins lack vegetation (Figure 7). In order to prevent further erosion in these areas, please stabilize the bed of each diversion, as well as the areas surrounding the sediment basins.

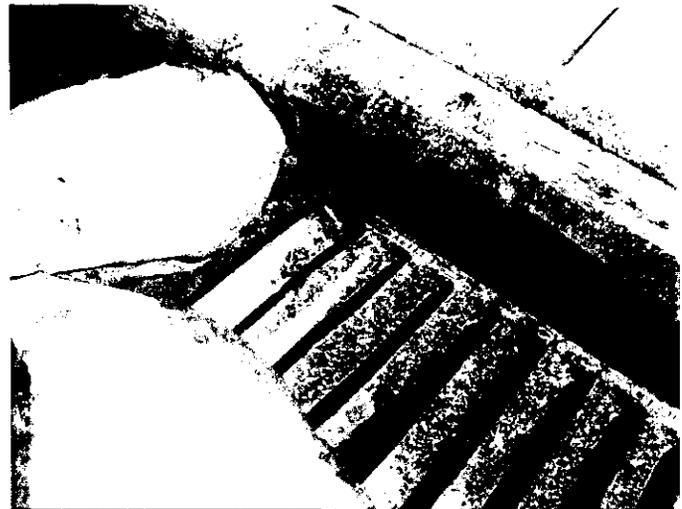
Figure 8 – Sediment is escaping under the sand bags.

5. The inlet protection that is present onsite is not an appropriate sediment control measure (Figures 8). The sand bags do not effectively prevent the flow of sediment into the storm drains (Figure 9). You must install inlet protection per the guidelines given in the *Rainwater and Land Development Manual* (Ohio Department of Natural Resources, 2006), available on-line at <http://www.dnr.state.oh.us/tabid/9186/default.aspx>.

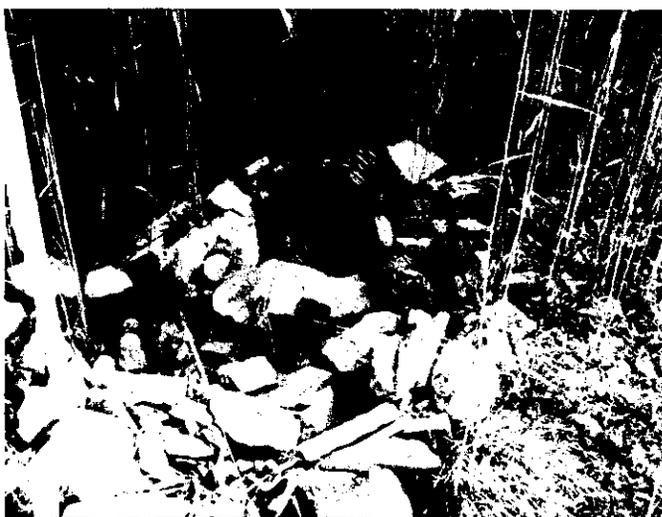
Figure 11 – Sediment-laden water is being

7. Sediment has built up in the basins, causing sediment-laden water to discharge from these treatment practices (Figure 11). Please clean out all sediment basins when they become full to ensure that they contain the appropriate sediment storage volume. Also, please install rip-rap around any inlet pipes that carry water to these basins. This will prevent further erosion along the banks of the basins.

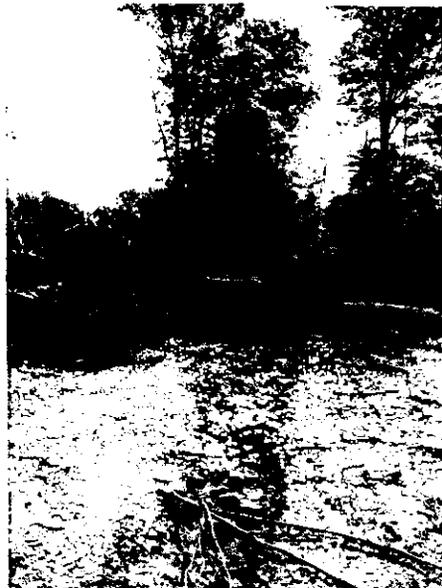
Figure 13 – An erosion gully has formed along the incline to the area with the dirt stockpile.

9. An erosion gully has formed along the hill that leads from the paved roadway to the dirt stockpile in the rear of the property (Figure 13). In order to prevent storm water from picking up speed and causing further erosion as it travels along this drive, please either seed and mulch this area to stabilize the bare dirt or install a rock construction drive along this incline.
