LUCAS VACANT LOT 2GC02288 2009/06/03 HABLITZEL, LYNETTE SYLVANIA

Re: Lucas County
Vacant Lot 8820 Central Avenue
Construction
Storm Water

June 3, 2009

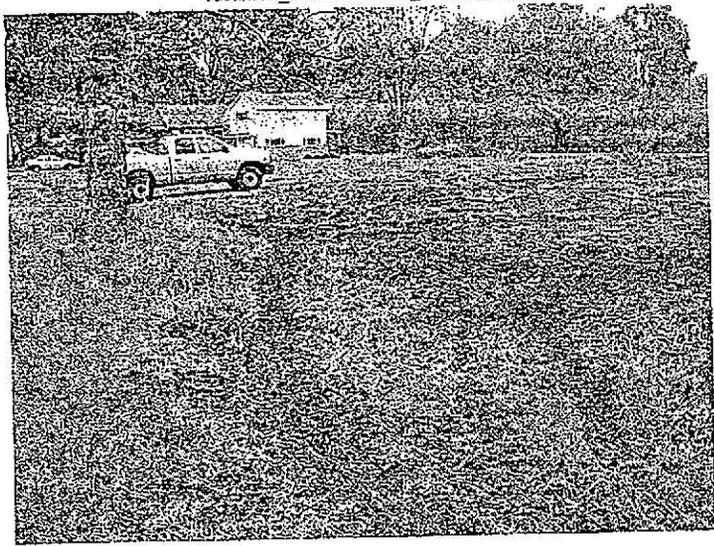
May 13, 2009, 3:30pm, Vacant Lot (8820Central Ave.) Lucas County, Standing on west side of property at catch basin looking northeast. No sediment controls. Taken by Lynette Hablitzel. VacantLot_8820CentralAve_051309_01.jpg

I recommend installing a system of diversion trenches/berms leading to a sediment trap to lessen the discharge of sediment laden runoff.

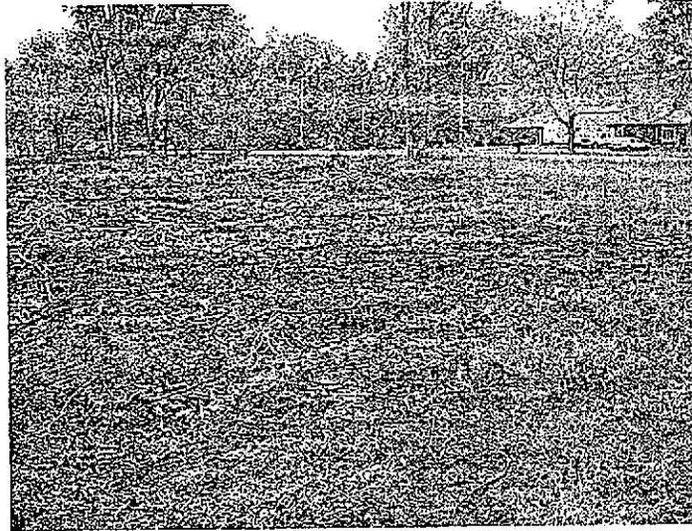
May 13, 2009, 3:30pm, Vacant Lot (8820Central Ave.) Lucas County. Standing on west side of property at catch basin looking southeast. No sediment controls. Taken by Lynette Hablitzel.
VacantLot_8820CentralAve_051309_03.jpg

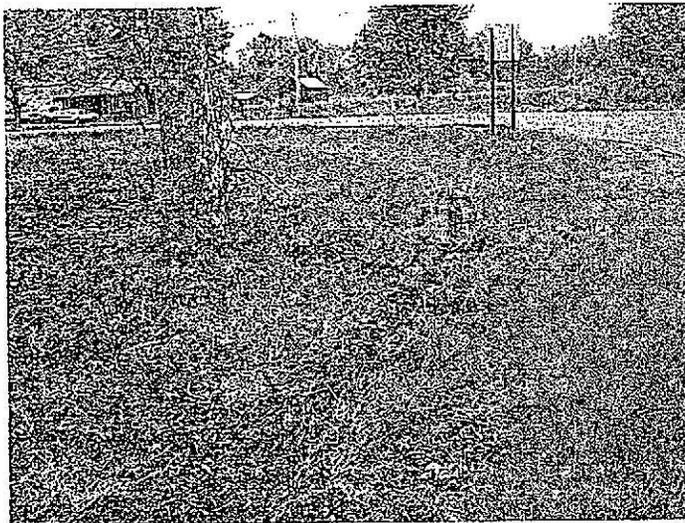
May 13, 2009, 3:30pm, Vacant Lot (8820Central Ave.) Lucas County. Standing on west side of property at catch basin, looking south. No sediment controls. Taken by Lynette Hablitzel.
VacantLot_8820CentralAve_051309_04.jpg
