RE: GRAND RIVER ACADEMY
OHIO EPA PERMIT 3PT00115
AUSTINBURG TWP., ASHTABULA COUNTY
COMPLIANCE EVALUATION INSPECTION

Observations

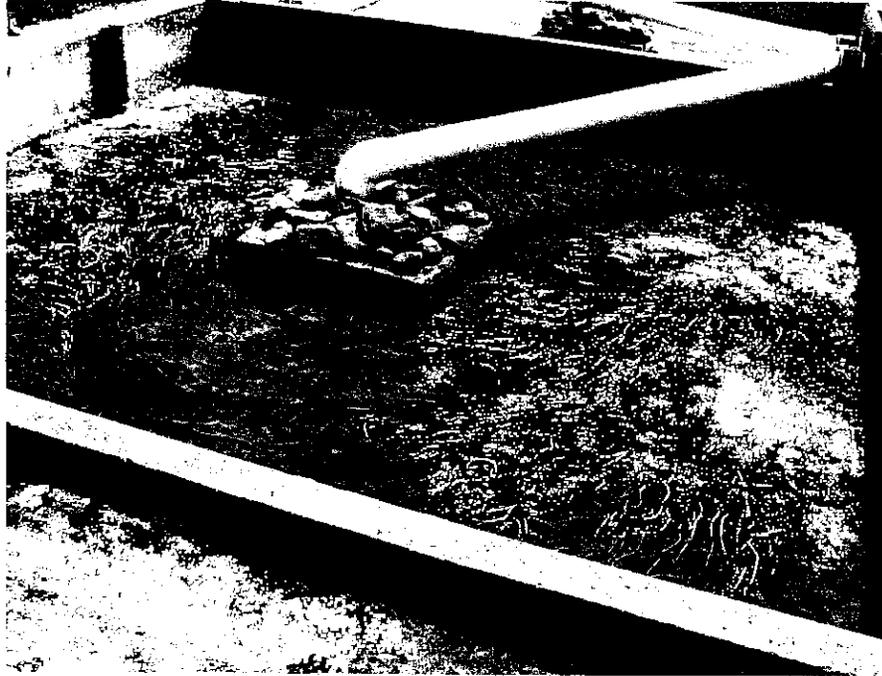
4. The slow sand filter dosing station pumps were cycled and found in operating condition. The plant was not discharging at the time of the inspection. The wastewater entering the sand filters was observed as clear. The south filter was found as free of vegetation and sludge, but the north filter had an accumulation of vegetation (see pictures). Vegetation must be removed and sand replaced as necessary. Both filters appear recently raked.

North Sand Filter @ New West 5,000 gpd Plant
