**Environmental
Protection Agency**

November 5, 2010

RE: STARK COUNTY
BETHLEHEM TOWNSHIP
RED DOG SALOON
7151 SHERMAN CHURCH
NPDES 3PR00317

On October 27, 2010, this office conducted a compliance evaluation inspection of the wastewater treatment system serving the above referenced facility. Present during the inspection were Todd Ascani, Stark County Health Department, Dean Stoll, Ohio EPA and this writer.

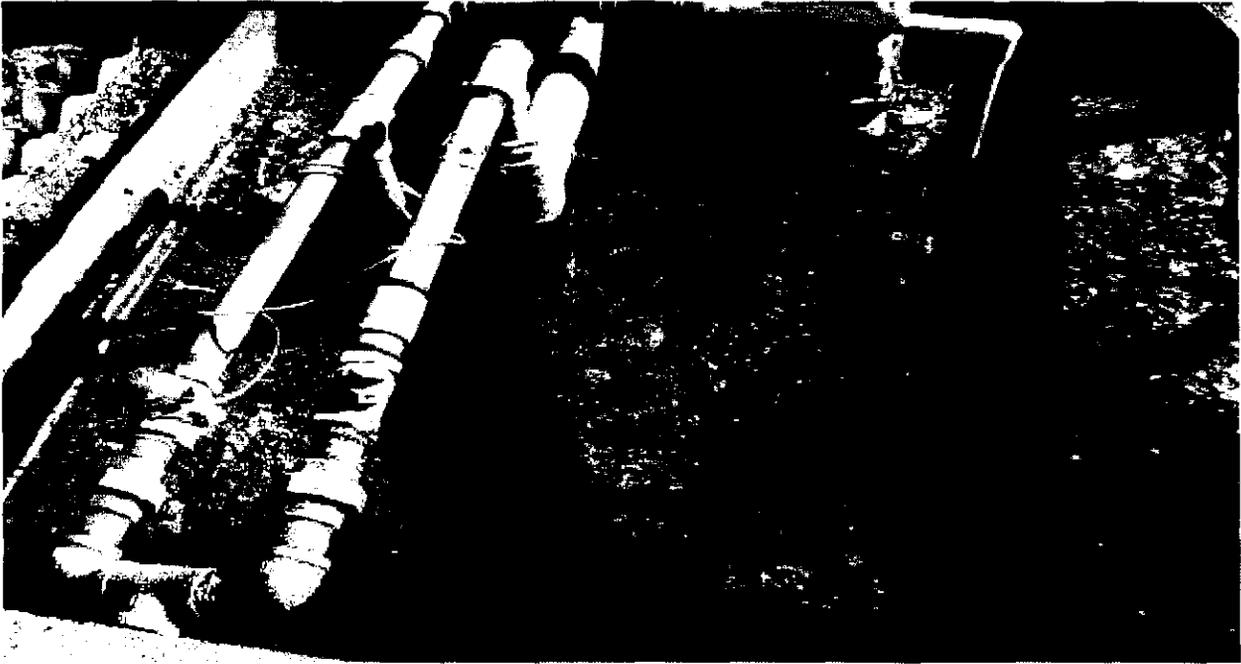
Photo 3 shows poor quality of clarifier, excessive solids, and skimmer plugged with solids.

4. The sludge return line was not operating and should be repaired.
5. The clarifier was covered with solids and the weir was full of solids. Solids were passing over the weir and being discharged onto the surface sand filters. The clarifier and weir should be cleaned. See Photos 1, 2 and 3.

6. The skimmer was not operating properly and should be repaired. See Photo 3.
7. The scum baffle was full of solids and should be cleaned.
8. The dosing chamber box contained solids and should be cleaned.

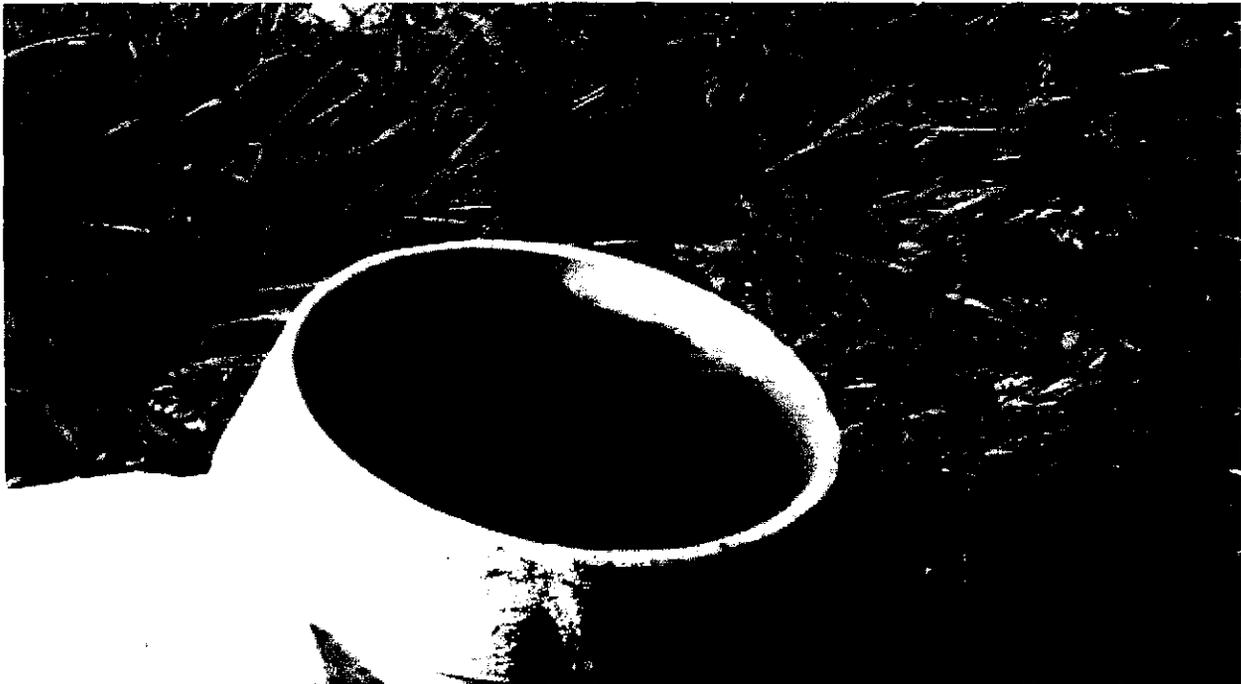
Photo 4 shows poor quality effluent containing solids discharging onto sand filter.

9. The sand filter beds were covered with vegetation. The effluent being discharged onto the sand filters contained visible solids. The sand filters need to be cleaned and raked. See Photos 4 and 5.
