**RE: MT. EATON LANDFILL
NOTICE OF VIOLATION/NOV
MSWL018846
MUNICIPAL SOLID WASTE
LANDFILL
WAYNE COUNTY**

On August 30, 2013, a site inspection was conducted at the closed Mt. Eaton Landfill, located at 8544 W. Lebanon Road, Mount Eaton, Wayne County, by John Hujar and Clarissa Gereby of the Division of Materials and Waste Management (DMWM), Ohio Environmental Protection Agency (Ohio EPA), and Ken Eng of the Wayne County Health Department. Rich Heier, representing the facility, was present during most of the inspection. Mt. Eaton Landfill is a closed municipal solid waste landfill undergoing post closure care.

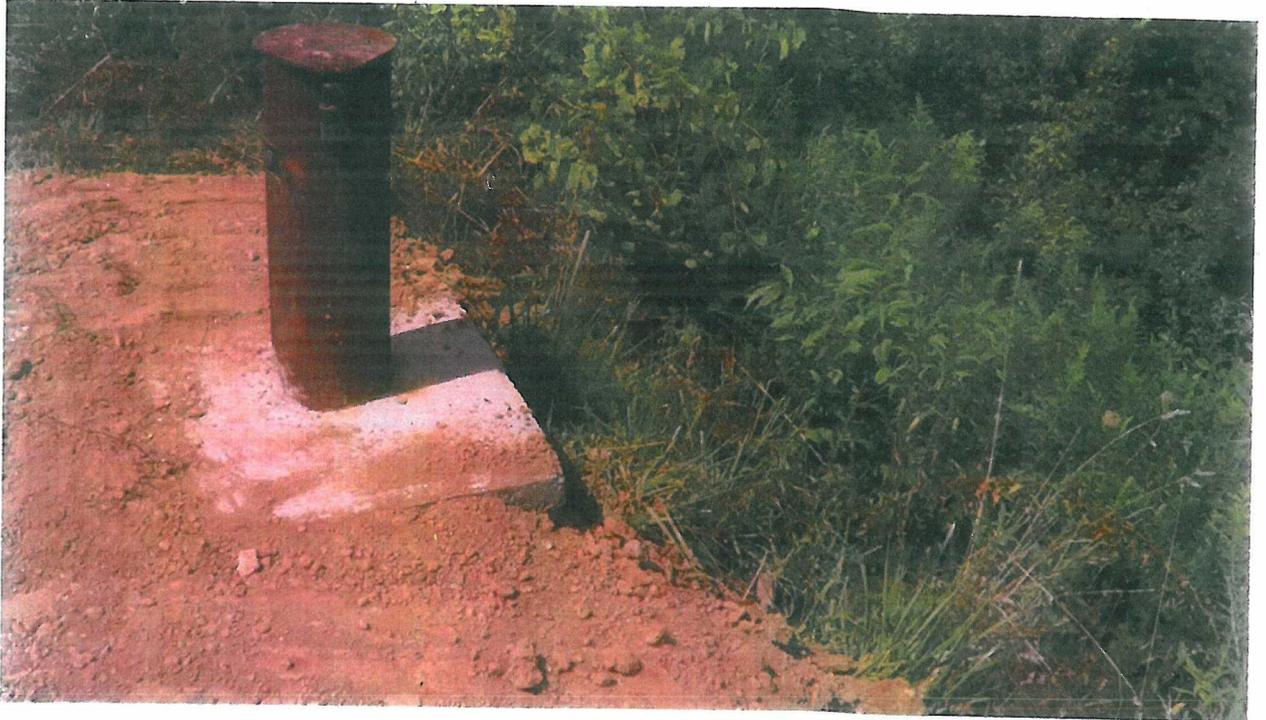
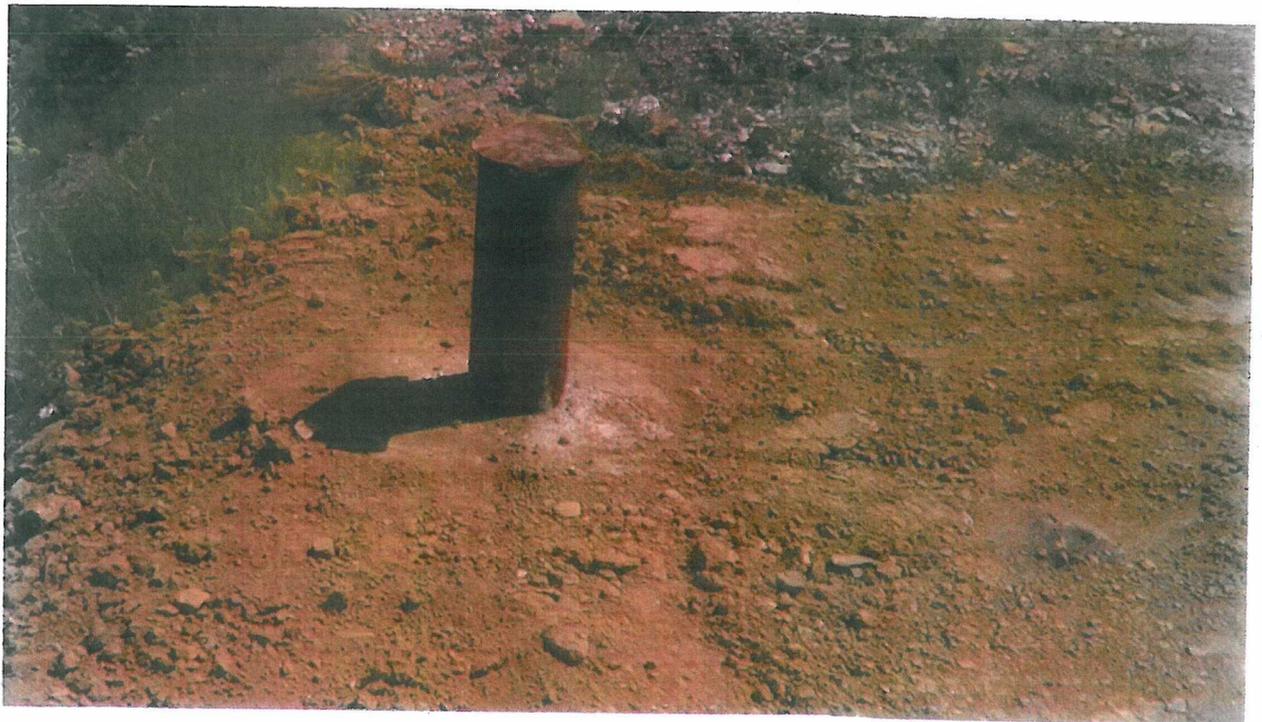
- Monitoring Well MW-17 and MW-18s well pad surrounding soils have been repaired inadequately; additional soils and berms/letdowns are required to prevent subsequent washout of soils around the wells.

- Erosion of the landfill cap in the vicinity of the flare

The owner/operator is in violation of this rule because the ground water monitoring system and the surface water management system have not been adequately maintained. MW-17 and MW-18 soils surrounding and supporting the concrete well pads have been washed out in the past and will continue to be compromised due to missing berms/letdowns and inadequate soils around the wells to support the concrete well pad. The surface water management system has not been maintained due to the presence of trees growing in surface water ditches; the surface water letdown culvert on the eastern slope of the “old cell” is broken/separated in several places and erosion is evident beneath the letdown culvert; erosion is present in the ditches near the C&DD landfill; extensive erosion in area leading down to sediment pond; no vegetation is growing on soils in the area leading down to sediment pond; the sediment pond has been filled in with soil/cattails which forms a “delta” at the mouth of the inlet, compromising the design capacity; and failing surface water ditches.

The owner/operator shall make repairs as needed to properly maintain and continually maintain the surface water and the ground water management systems immediately.

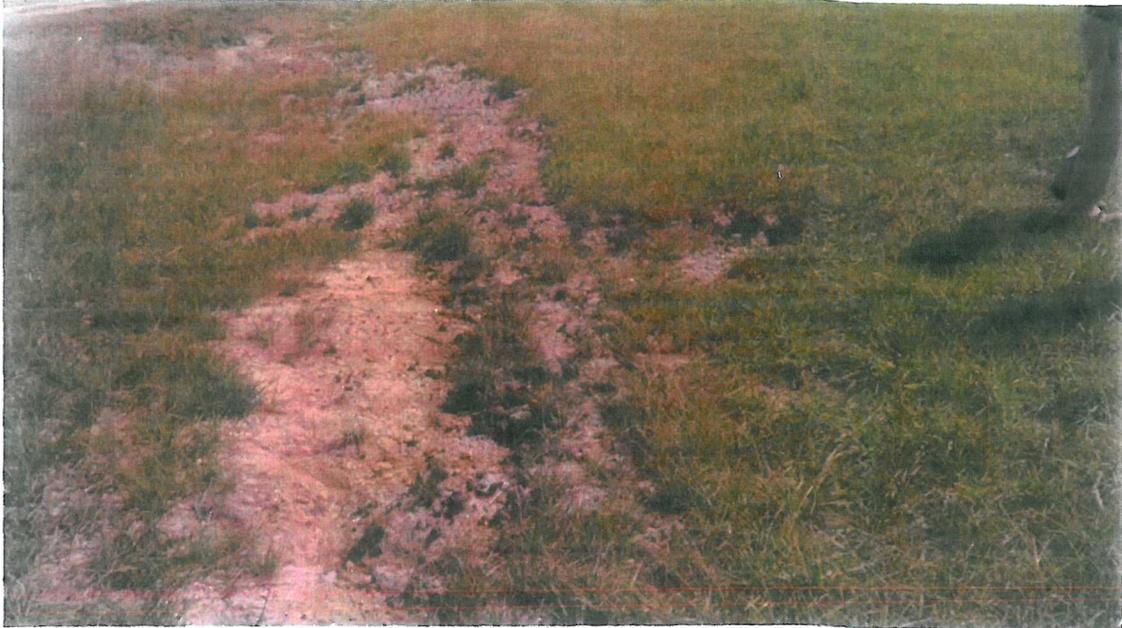
- Small trees were observed growing on the landfill cap and surface water ditches

The owner/operator is in violation of this rule because the integrity and effectiveness of the cap system has not been maintained due to the presence of dead vegetation on the landfill cap; large areas of no vegetation on the landfill cap, and the presence of considerable erosion on the landfill cap.

The owner/operator shall immediately make repairs of the cap system as necessary to correct the effects of dead vegetation, erosion, and preventing runon and runoff from eroding or otherwise damaging the cap system.

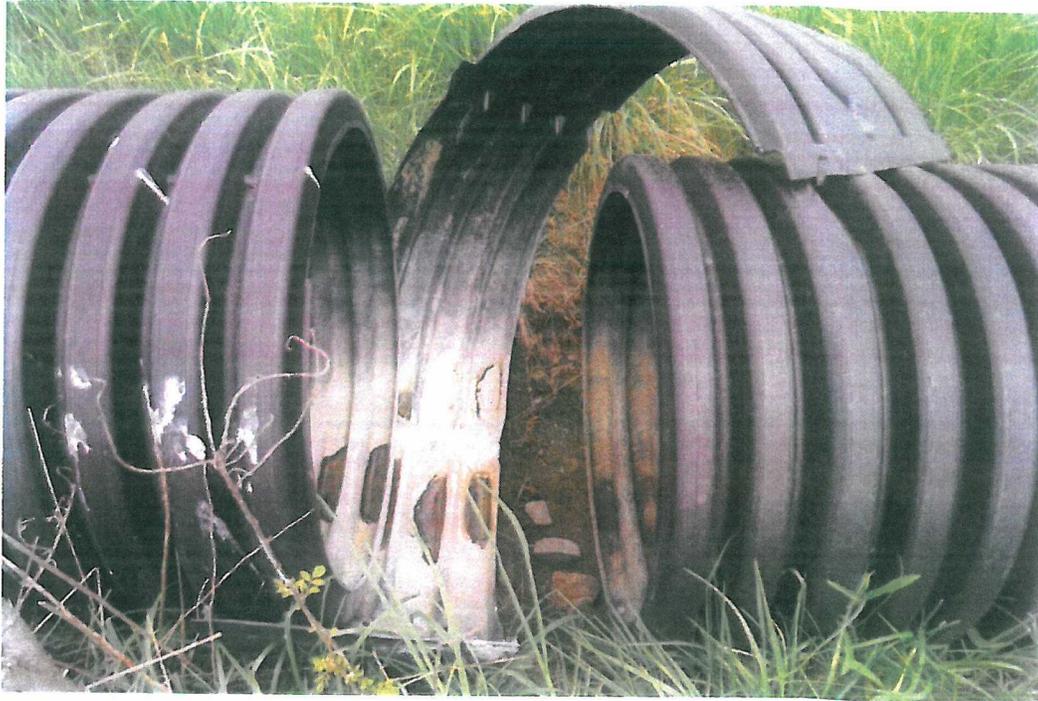
- Erosion was observed in the ditches near the construction and demolition debris landfill

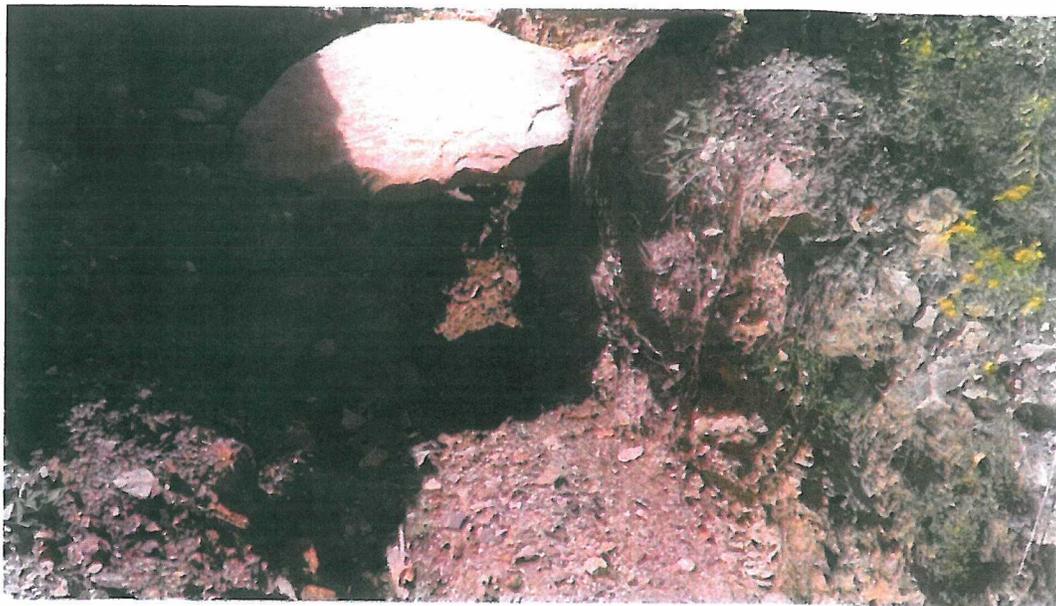
- Inadequate roadway maintenance in several areas

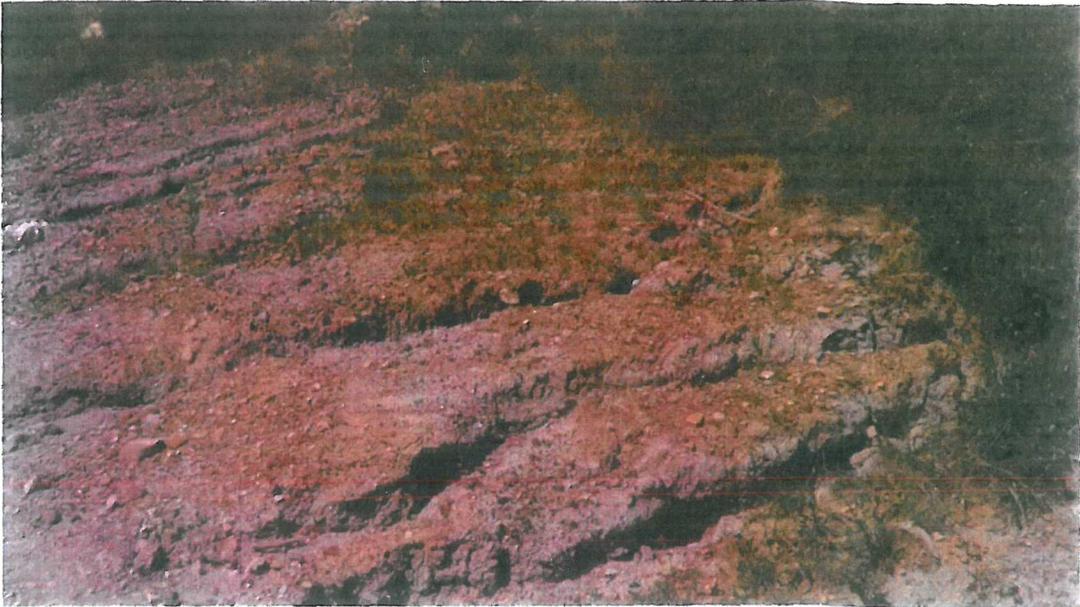
- Extensive erosion and lack of vegetation on the slopes in **the** area leading down to the sediment pond

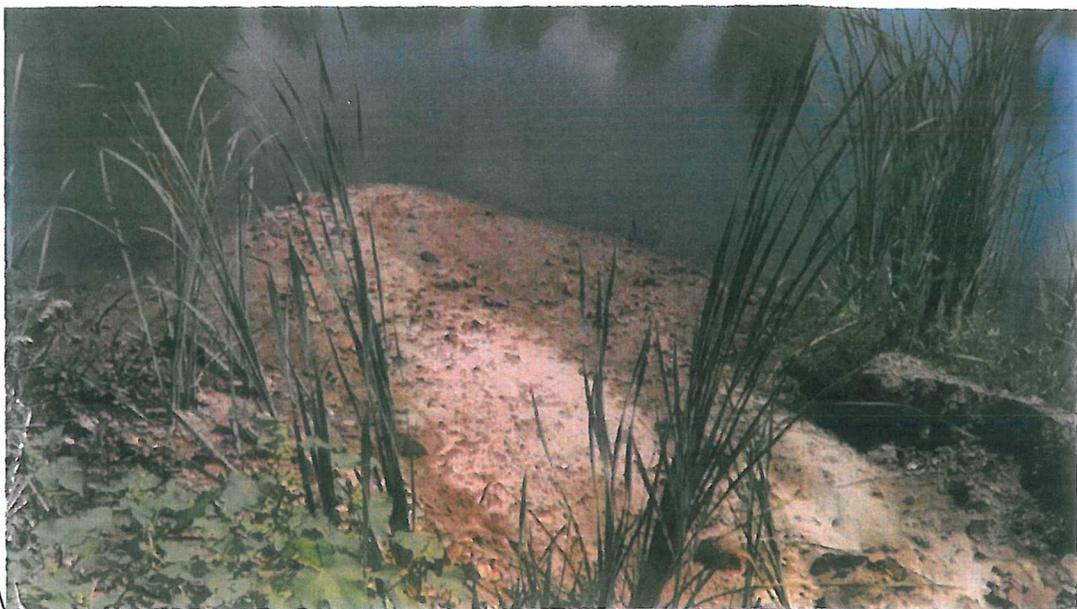
- The surface water sediment pond has established cattails and has a soils “delta” at the mouth of the inlet compromising the design capacity of the surface water sediment pond

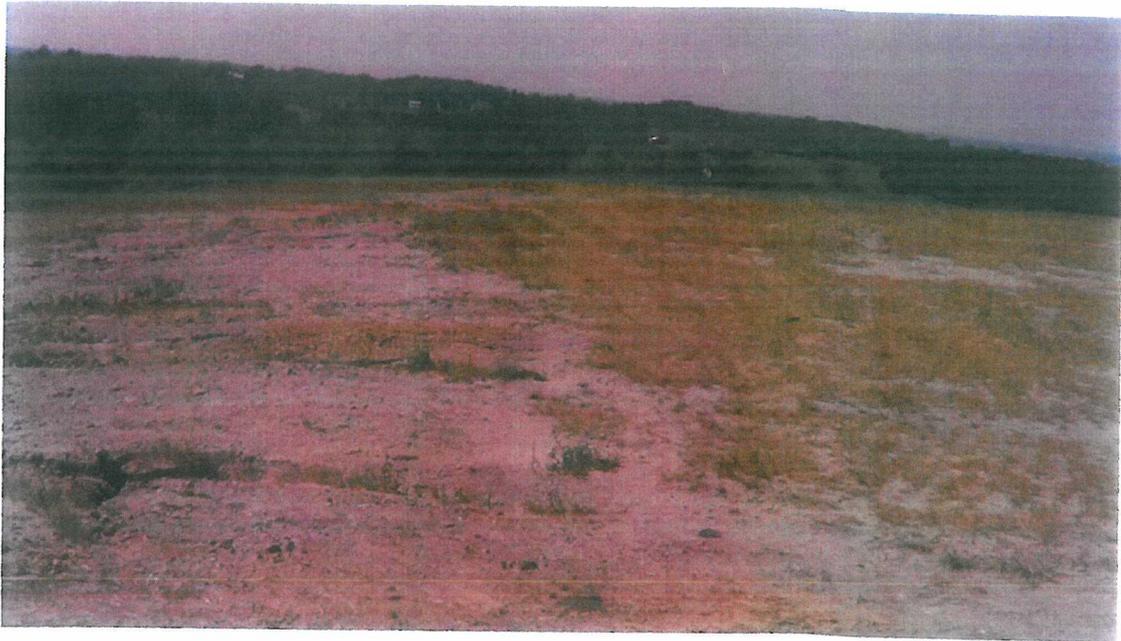
- Approximately seven acres with limited or no vegetative cover on top and sides of the "new cell" mound

The owner/operator is in violation of this rule because the landfill cap system does not have a complete and dense vegetative cover of healthy grasses or other vegetation within one year of placement of the cap system. Additionally, the Mt Eaton Landfill has been in post closure care for several years, and the vegetative cover is not yet established on either the “old cell” or the “new cell”.

The owner/operator of Mt. Eaton Landfill needs to immediately take the necessary measures to return to compliance with Ohio’s environmental laws. Within 14 days of receipt of this letter, the owner/operator of Mt. Eaton Landfill is requested to provide documentation to this office including the steps taken to abate the violations cited above.

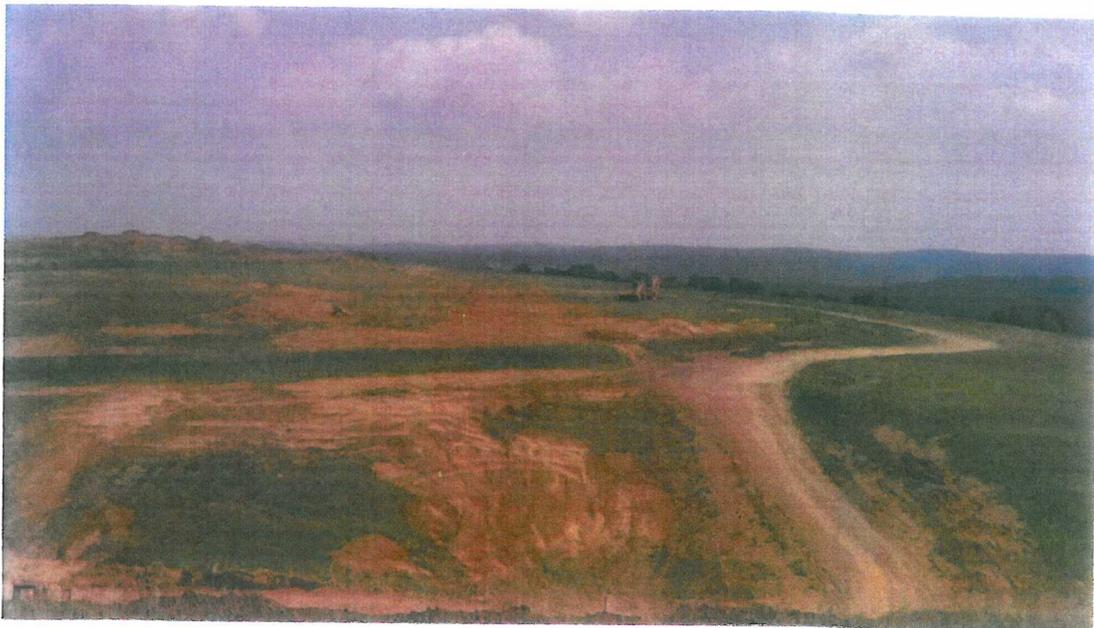
- Approximately eight acres with limited or no vegetative cover on the "old cell" mound
