**Environmental  
Protection Agency**

RE: Holmes County  
Miller-Hope Condominium Development  
NPDES Permit No. OHC000003  
Ohio EPA Permit No. 3GC05169\*AG  
Construction Storm Water Inspection

**Notice of Violation**

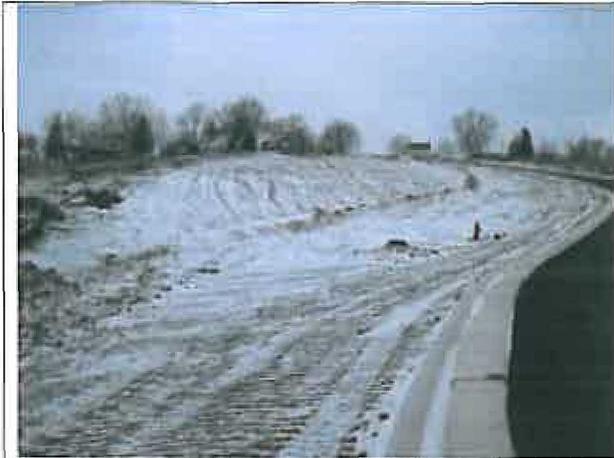
- No erosion and sediment best management practices (BMP) have been installed to prevent the discharge of sediment to the onsite stream. Diversion channels and erosion gullies discharge untreated sediment-laden storm water runoff to "waters of the State" (Figures 1 to 3). Sediment deposition was observed within the onsite stream (Figure 4). Properly designed sediment settling ponds must be installed on the western portion of the site.

- No stabilization of idle areas of the site has occurred prior to the onset of winter (Figures 1 to 3 and 7). Mulching must be implemented on the idle areas of the site.

**Figure 1** - Diversion channels and erosion gullies discharge untreated sediment-laden storm water runoff to "waters of the State."

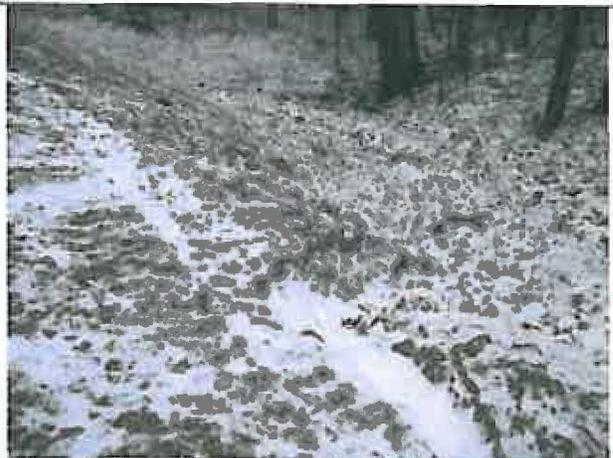
**Figure 2** - Diversion channels and erosion gullies discharge untreated sediment-laden storm water runoff to "waters of the State."

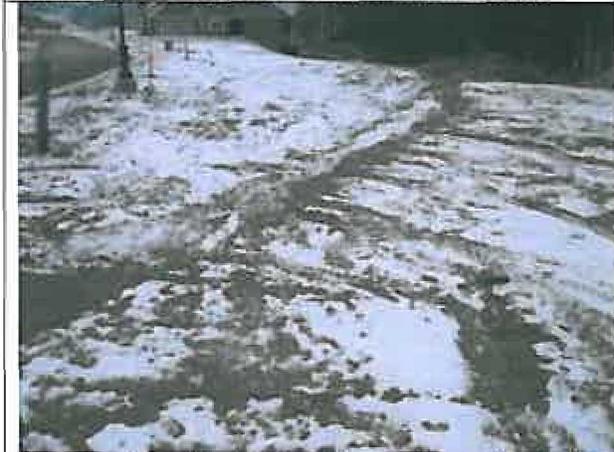
**Figure 3** - Diversion channels and erosion gullies discharge untreated sediment-laden storm water runoff to "waters of the State."

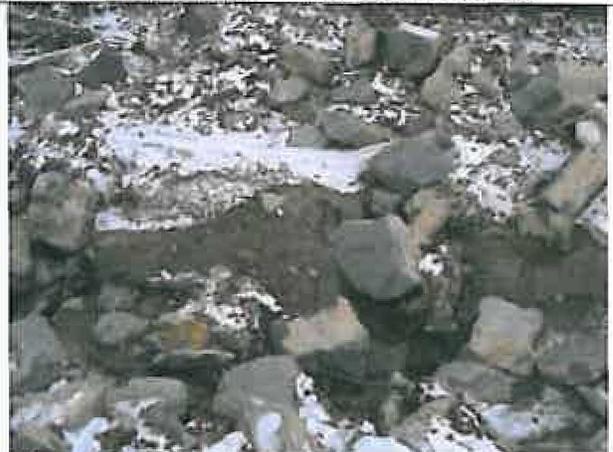
**Figure 4** - Sediment deposition was observed within the onsite stream.

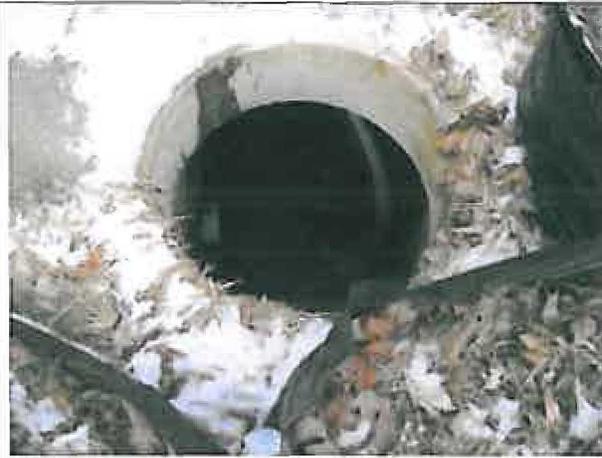
- A sediment detention basin has been constructed in the southeastern portion of the site that has not been modified for sediment removal (Figure 5). A properly designed dewatering skimmer must be installed on the outlet structure. In addition, a catch basin has been installed within the basin, which appears to drain the sediment detention basin directly into the culverted onsite stream (Figure 6).

**Figure 5** - The sediment detention basin outlet has not been modified for sediment removal

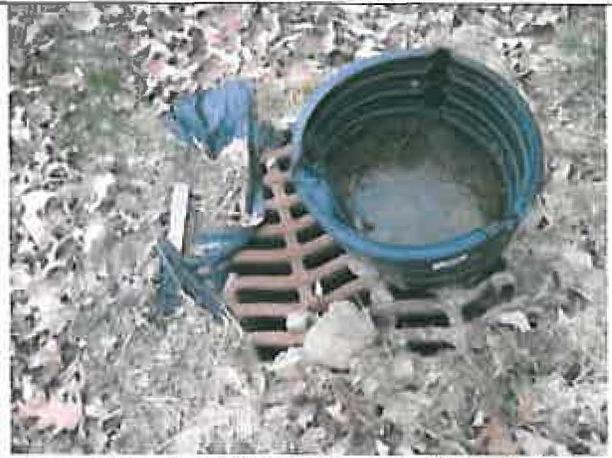
**Figure 6** - A catch basin has been installed within the basin, which appears to drain the sediment detention basin directly into the culverted onsite stream.

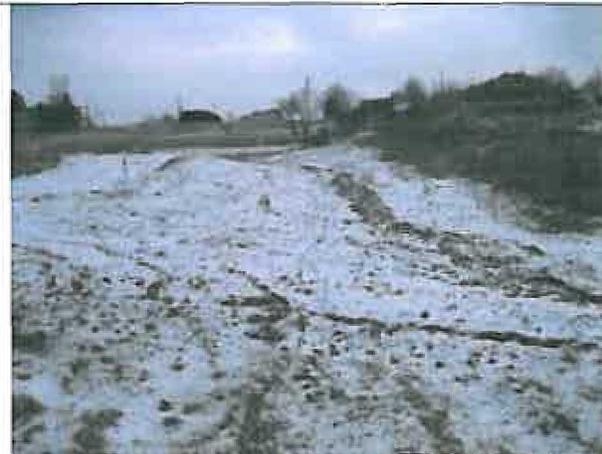
- Untreated sediment-laden storm water runoff is discharging directly into the undisturbed stream channel that has been bypassed via the stream culvert on the south eastern portion of the site (Figures 7 to 8). A properly designed sediment settling basin must be installed to treat sediment prior to a discharge to "waters of the State."

**Figure 7** - Untreated sediment-laden storm water runoff is discharging directly into the undisturbed stream channel.

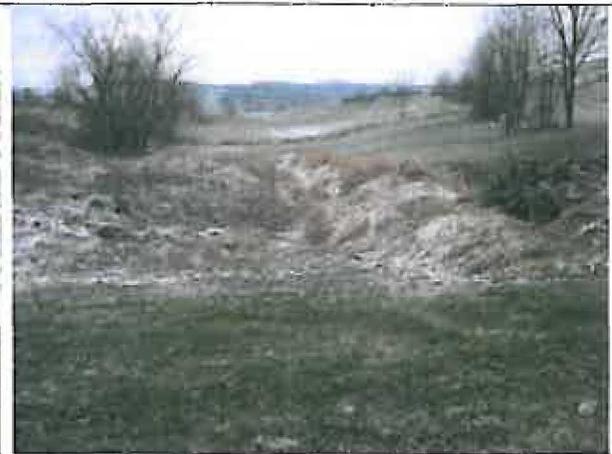
**Figure 8** - The undisturbed stream channel receiving untreated sediment-laden storm water runoff.

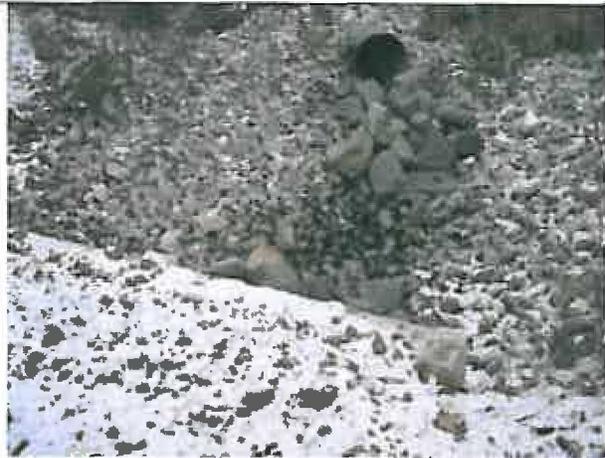
- An onsite stream has been culverted in two locations on the site and appears to exceed approximately one hundred fifty feet of impact (Figures 9 to 13). Upon questioning the project engineer, it does not appear that the site has received any 401/404 permit from the U.S. Army Corps of Engineers or Ohio EPA's 401 section. Please contact Tom Harcarik of Ohio EPA's 401 Section regarding the appropriate permitting that may be required for the stream impacts. For your convenience, Mr. Harcarik can be contacted at (614) 644-2139 or via e-mail at [tom.harcarik@epa.ohio.gov](mailto:tom.harcarik@epa.ohio.gov).

**Figure 9** - Upstream of the western culvert on the western portion of the site.

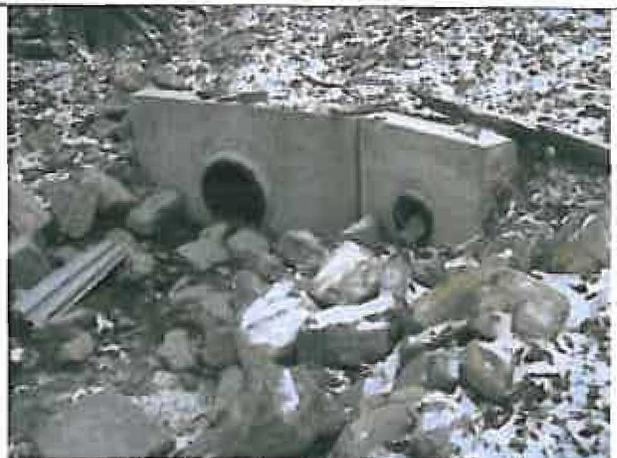
**Figure 10** - The culvert of the stream located on the western portion of the site.

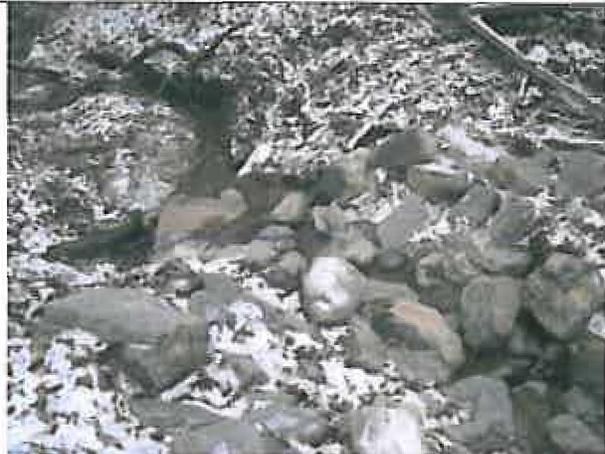
**Figure 11** - Downstream of the culvert located on the western portion of the site.

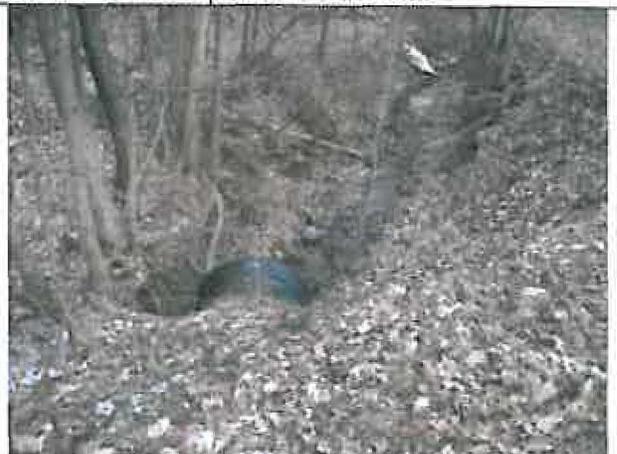
**Figure 12** - Upstream of the basin culvert located on the eastern portion of the site.

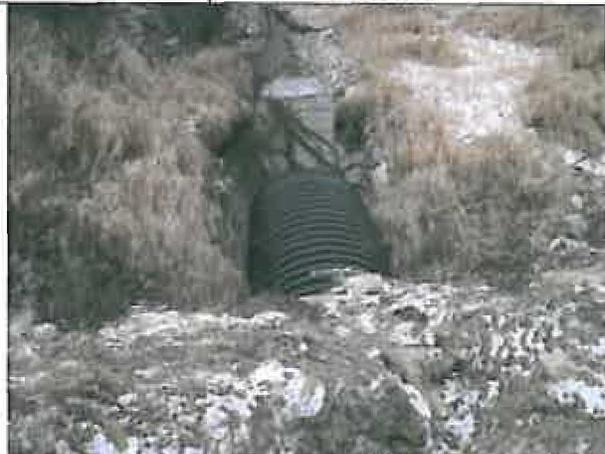
**Figure 13** - Downstream of the basin culvert located on the eastern portion of the site.
