RE: SUMMIT COUNTY
CITY OF GREEN
HERITAGE CROSSING OF GREEN
PERMIT NO.3GC05303*AG

On January 3, 2012, this office met with you at the above referenced construction site located at the northeast intersection of Graybill Road and Massillon Road in the City of Green, Summit County. The purpose of the inspection was to determine compliance with General Construction Permit No. 3GC05303*AG. Below you will find a list of violations (Pictures are attached for your reference) of the permit related to not implementing the Storm Water Pollution Prevention Plan (SWP3) approved for your site. These items were discussed with you during the inspection:

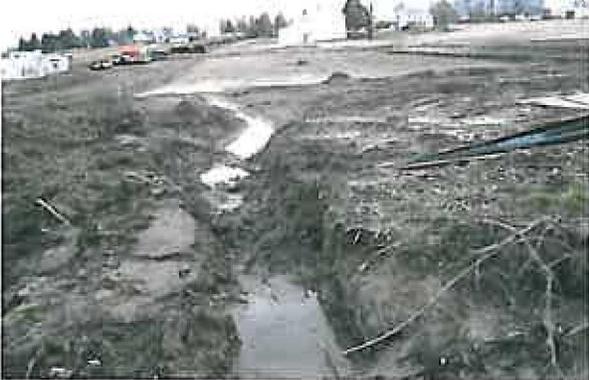
- 1) The West sedimentation basin was not installed as detailed in the construction sequence for the site. Uncontrolled runoff was observed leaving from the construction of Franks Parkway. This basin was to be constructed prior to any earth moving activities in the watershed known as Block B and Franks Parkway.

Uncontrolled runoff from Franks Parkway to U.T.

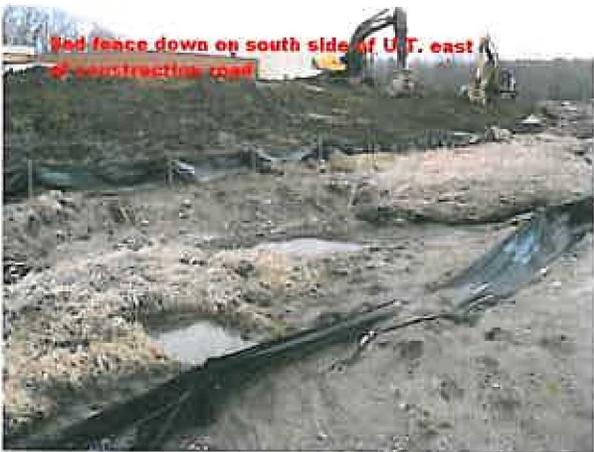
Sed fence down on south side of U.T. east of construction road

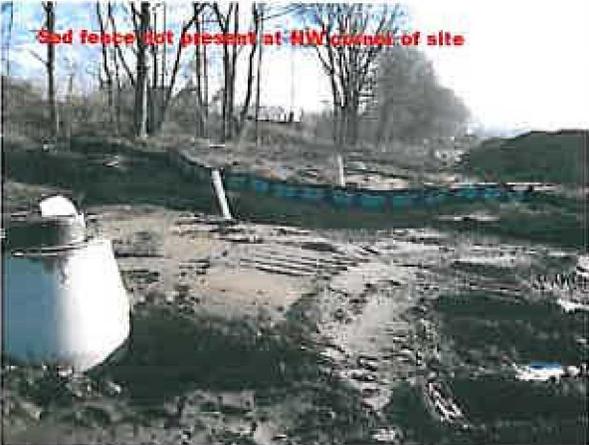
- 2) No sed fence was present along the west side of the unnamed tributary at the northwest corner of the site where a sanitary sewer had crossed the stream.

Sed fence not present at NW corner of site

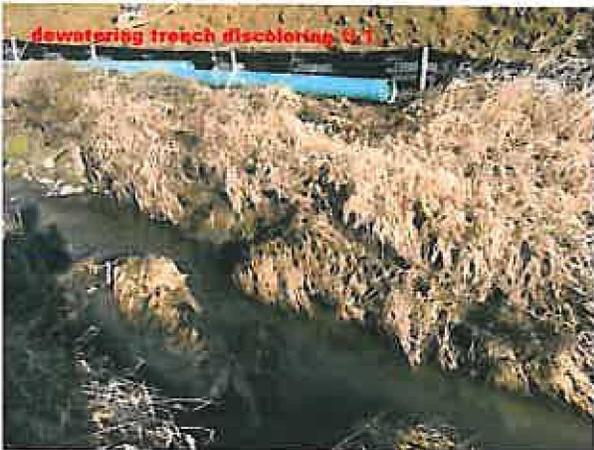
- 8) During the inspection, it was observed that the trench dewatering was being performed where muddy water was being discharged to the stream. The sed fence was not adequate, as the stream was visually impacted. A filter bag should be used to filter this water prior to discharge.

dewatering trench discoloring U.T.

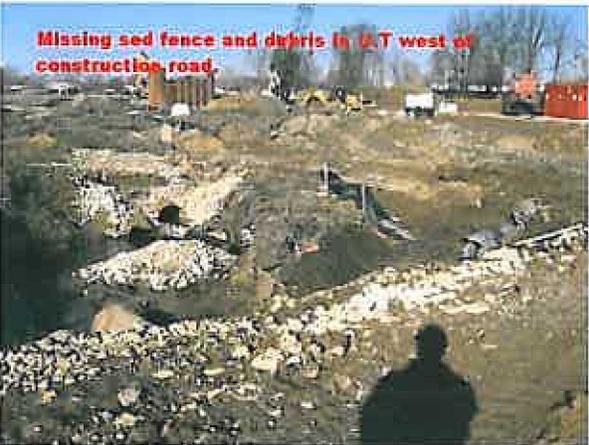
Missing sed fence and debris in U.T. west of construction road

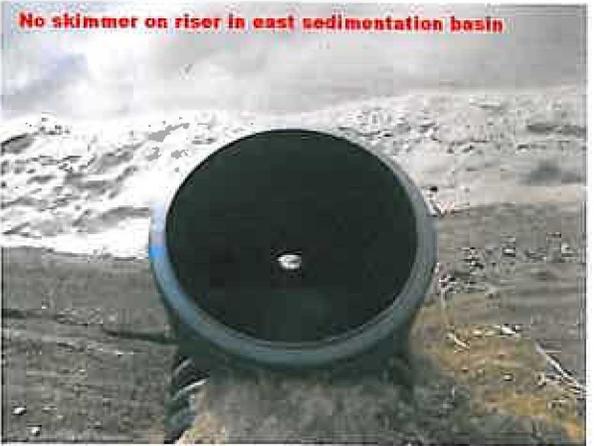
- 4) There was no skimmer on the south riser for the east temporary sedimentation basin.
- 5) There was no level spreader on the outlet from the east temporary sedimentation basin.

No skimmer on riser in east sedimentation basin
