**Environmental
Protection Agency**

RE: LORAIN COUNTY
CITY OF AVON
AVON CHESTER ROAD PROPERTY
CONSTRUCTION STORM WATER

NOTICE OF VIOLATION

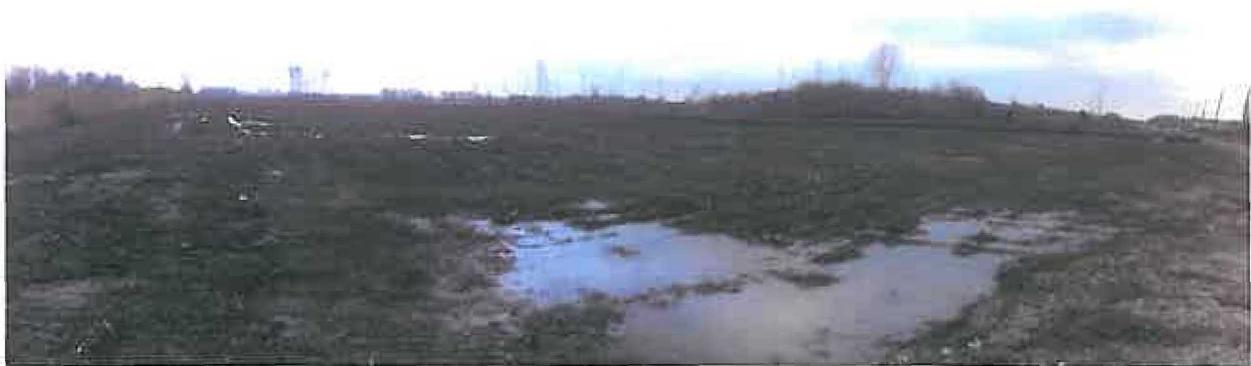
My inspection on December 12, 2011, revealed that a large portion of this property lies disturbed and idle with no attempts at temporary stabilization. Wood chips, stalks and other remnants of previous vegetation provide some soil cover, but there was no obvious attempt at seeding and mulching to reestablish vegetative cover to a 70% or greater growth density. A review of our files indicates that it was your intent to stabilize the site by establishing a cover crop over the disturbed areas prior to winter. This has not occurred. My inspection on February 2, 2012, indicated that these site conditions have not changed.

Fig 1. Panoramic view of the site from the SE corner at Jaycox Road. The site was previously completely forested. No vegetation has been established over disturbed areas.

- **Failure to initiate temporary stabilization within seven (7) days of last disturbance on all areas disturbed by construction, but where no additional construction activities will occur within the next 21 days or longer.** This is a violation of Part III.G.2.b.i of the NPDES permit and Ohio Revised Code (ORC) 6111.04 and 6111.07. To correct this violation, you must initiate temporary stabilization of all areas disturbed by construction activities (grading, grubbing, filling, clearing or excavating) immediately. At this time of year, temporary stabilization can be achieved through straw mulching (see attached specifications from *Rainwater and Land Development, Ohio's Standards for Land Development, Stormwater Management and Urban Stream Protection* (Ohio Department of Natural Resources, 2006)). If construction activities are not expected to resume within one (1) year of last disturbance, disturbed areas must be permanently stabilized. At this time of year, permanent stabilization can be achieved through dormant seeding (specifications also attached). You may also choose to temporarily stabilize these areas with straw mulch for now and then do permanent stabilization once the growing season resumes.

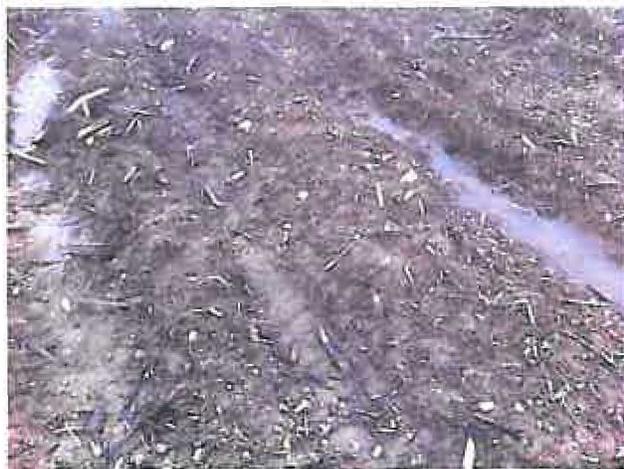
Fig 2 (ABOVE). Mulch left over from tree chipping operations provide some level of ground cover but vegetation has not been established.

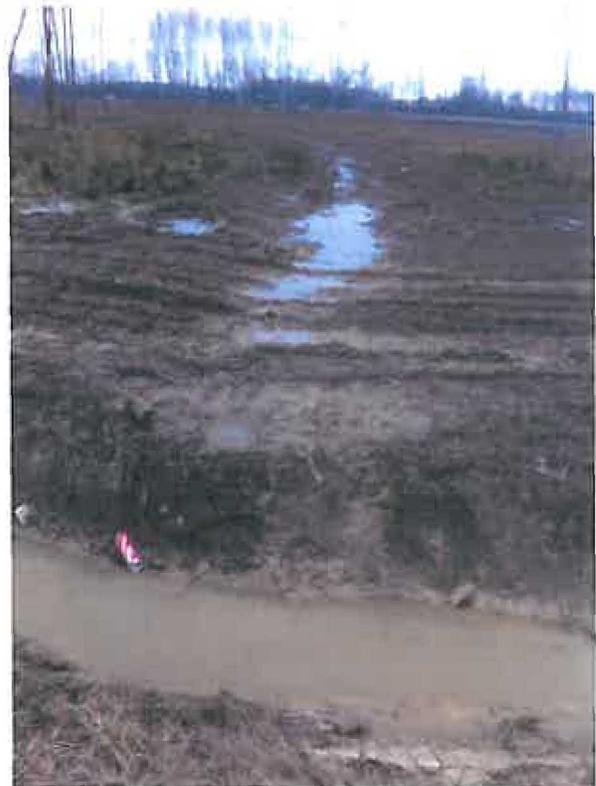
In addition, tire ruts and other surface roughening provide pockets to retain some storm water on-site; however, I observed swales that drain portions of the site to the Chester and Jaycox Road drainage channels as well as drainage channels that flow through the site (see photos). Although silt fence has been installed along some of these channels, it may not be providing adequate sediment control. There are areas where drainage swales flow under silt fence or sections where silt fence requires repair (see photos). Further, although silt fence has been

Fig 3 (RIGHT). There are a number of swales that drain disturbed areas to the road ditch along Chester Road (visible in the foreground of the photo). There are no sediment controls in place.

Ohio EPA believes that one or more of these conditions exists on this site and thus, one (1) or more sediment ponds should be part of the storm water pollution prevention plan (SWP3) for this project. Please review site drainage patterns and sizes and amend the SWP3 as necessary to comply with the requirements of the NPDES permit.

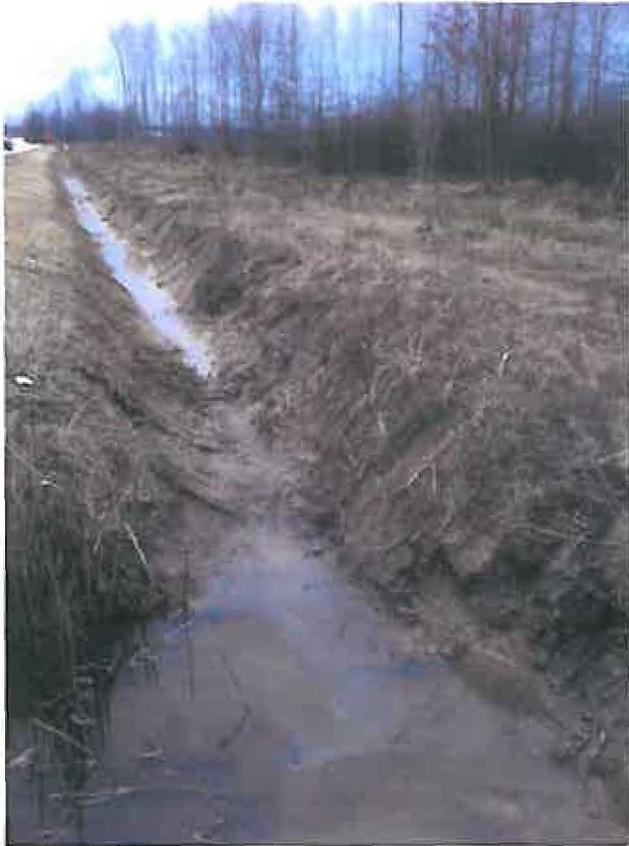
Fig 4 (LEFT). View of the ditch along Chester Road looking east from the Chester Road culvert. Note that the flow is visibly more sediment-laden than the flow in the stream coming from the east.

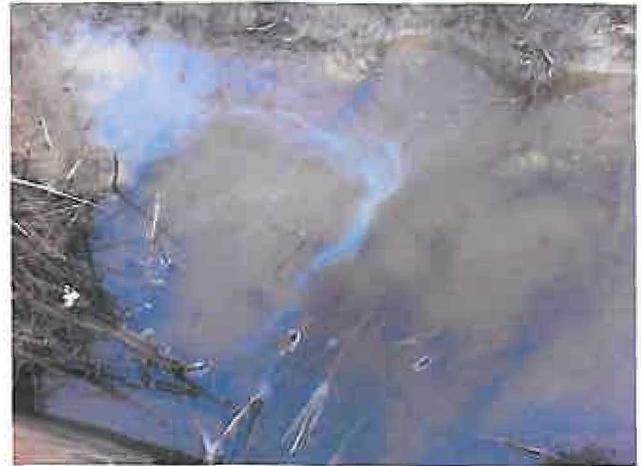
Fig 5 (ABOVE). Close-up of the sediment plume flowing from the ditch along Chester Road into the Chester Road culvert.

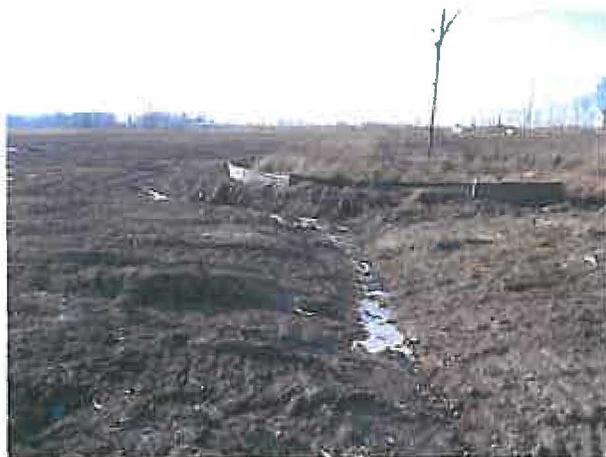
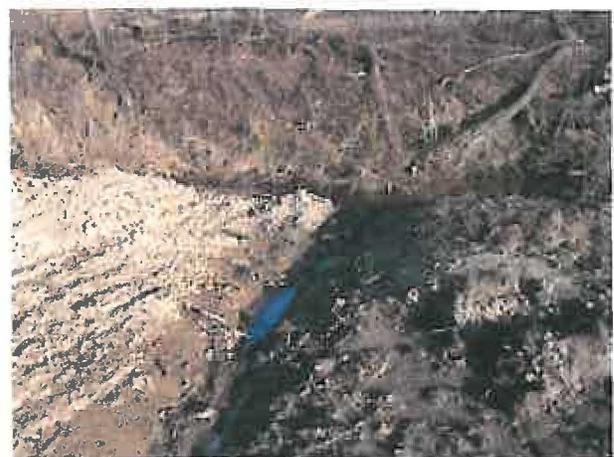
Fig 6 & 7. Swales collect runoff from disturbed areas and convey it to the stream that flows through the property. There are no sediment traps or basins in place to provide sediment control. These photos were taken December 12, 2011.

- **Failure to maintain silt fence installed along drainage channels which flow through the property.** This is a violation of Part III.G.2.i of the NPDES permit and ORC 6111.04 and 6111.07. The NPDES permit requires silt fence to be maintained in a functional condition, i.e., be capable of ponding runoff. There are several locations where flow has cut under the installed silt fence. Please repair as needed to ensure that runoff ponds along and seeps through the silt fence rather than flowing under it. Where silt fence is placed across a drainage swale, please be aware that silt fence may not be the appropriate sediment control. The size of the drainage area should be assessed to determine if a sediment pond, i.e., sediment trap or sediment basin, is more appropriate. As a reminder, the NPDES permit requires the use of a sediment pond for any one of the following conditions:

- o Concentrated storm water runoff (e.g., storm sewer or ditch).
- o Runoff from drainage areas which exceed the design capacity of silt fence and other sediment barriers (see Part III.G.2.d.iii of the NPDES permit for these limits).
- o Runoff from drainage areas that exceed the design capacity of inlet protection (see Part III.G.2.d.iv of the NPDES permit for these limits), or
- o Runoff from common drainage locations with 10 or more acres of disturbed land.

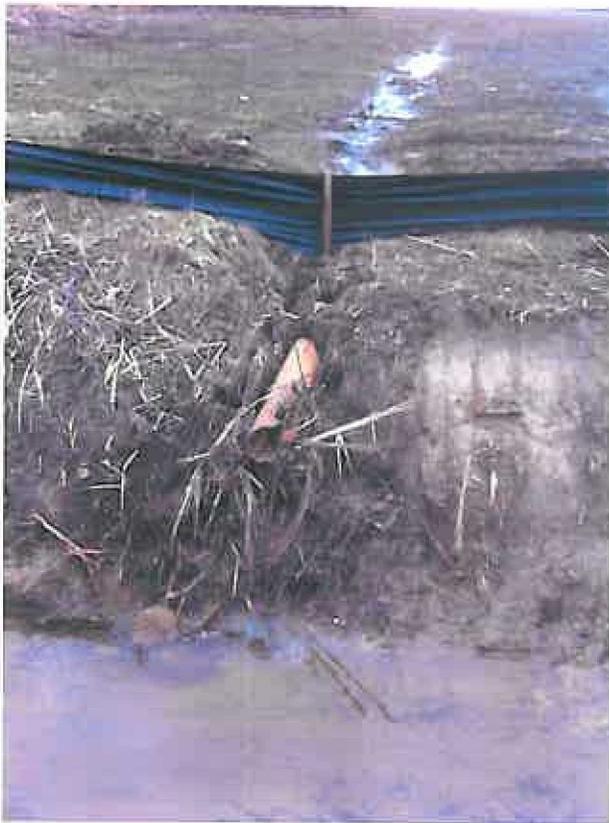
Fig 8 (LEFT). Silt fence has been placed across a drainage swale, but concentrated flows have created erosion. This allows sediment-laden runoff to pass underneath to the Chester Road ditch.

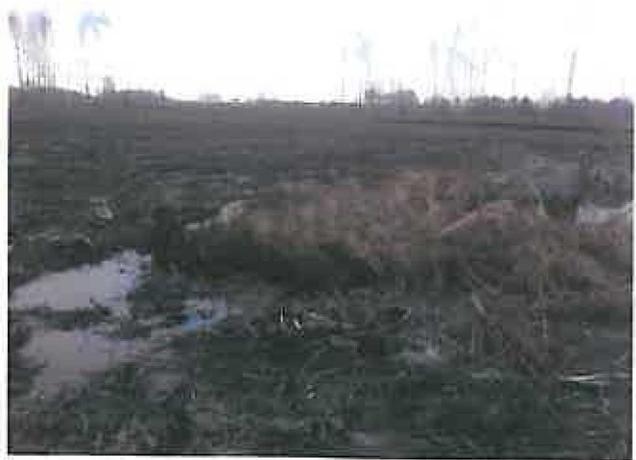
installed where shown on the Staking/Stumping Plan for Brown South submitted to Ohio EPA on August 15, 2011, some of the delineated wetlands on site are not protected with silt fence and susceptible to receiving sediment-laden runoff. Silt fence should be placed around all wetlands where runoff from disturbed areas flows to the wetlands.

Fig 9 (ABOVE). Silt fence has not been installed around all delineated wetlands. Note that flow from disturbed areas can be conveyed to this wetland (believed to be Wetland S-E).

- **Failure to install silt fence or other perimeter barriers to protect water resources from sediment transported via sheet flow.** This is a violation of Part III.G.2.d.iii of the NPDES permit and ORC 6111.04 and 6111.07. As indicated previously, some delineated wetlands are not protected with silt fence, yet accept runoff from disturbed areas. All delineated wetlands on the property should be protected from sheet flow runoff with silt fence, filter sock or compost berm (see attached specifications) to minimize the transport of sediment to these water resources.

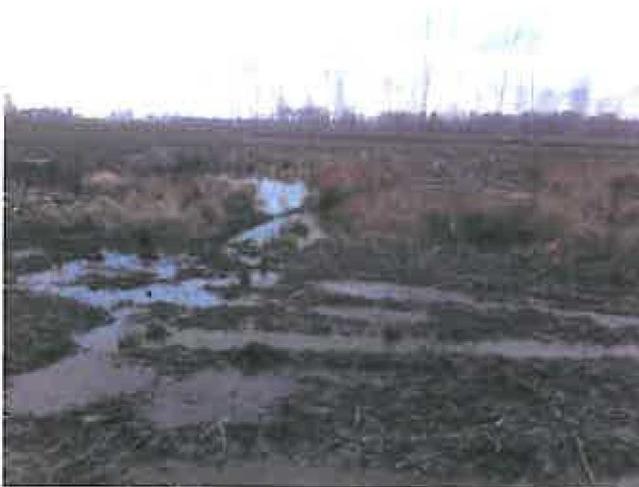
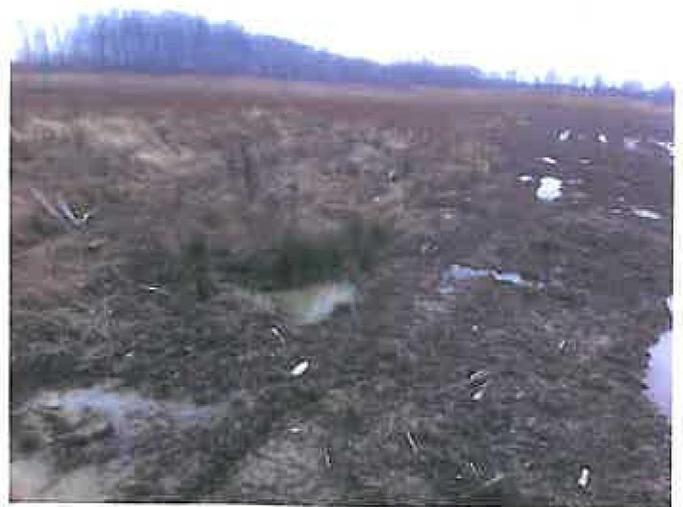
Fig 10 & 11. There is no silt fence around these wetlands, yet runoff from disturbed areas can convey sediment to them.
