**Environmental
Protection Agency**

RE: WATERLOO HIGH SCHOOL
PERMIT NO. 3PT00079*CD
PORTAGE COUNTY
ATWATER TOWNSHIP

On April 12, 2012, an inspection of the above referenced facility's wastewater treatment system was conducted. No one was present during my inspection to represent the facility. The purpose of the inspection was to evaluate the operation and maintenance of the treatment system along with the facility's compliance status with respect to the terms and conditions of the above referenced National Pollutant Discharge Elimination System (NPDES) permit.

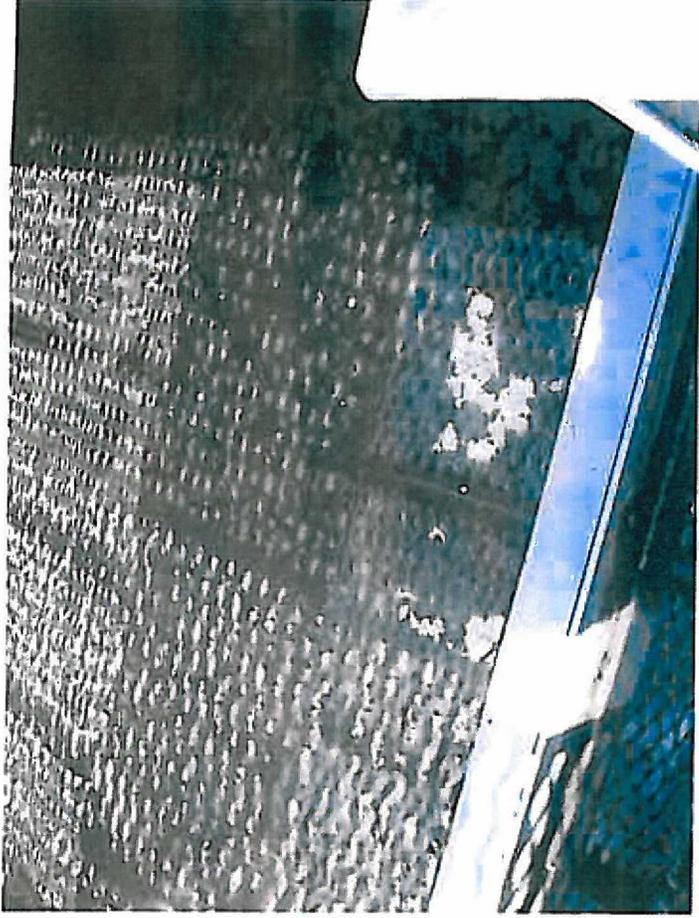
Figure 1

- 13) The surface of the settling tank was covered with a layer of solids and pin floc was observed flowing over the weir. See Figure 1. This is not typical of a properly operating plant.

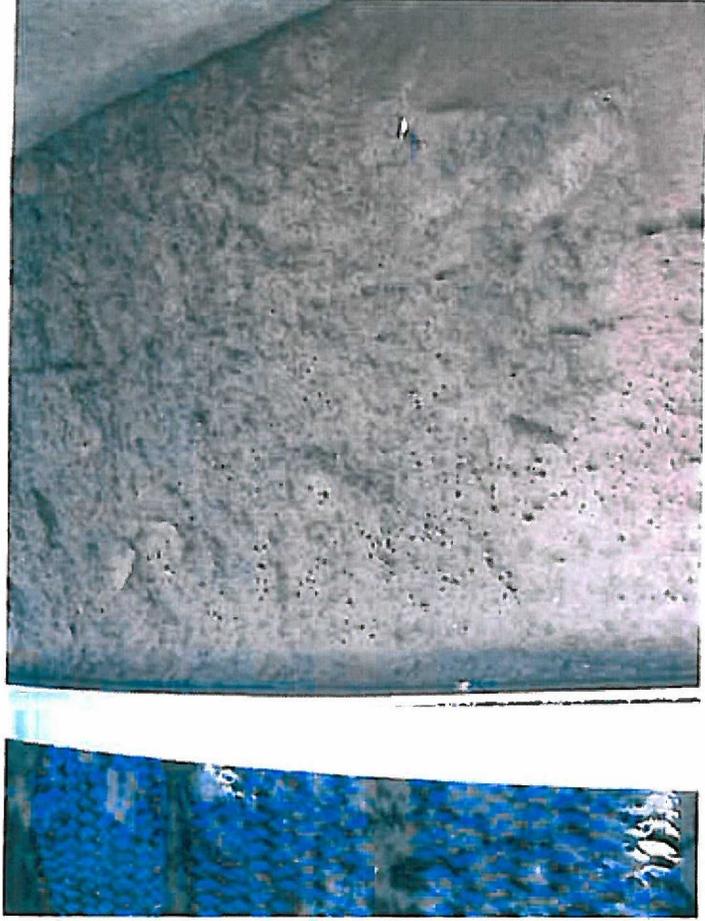
Figure 2

- 14) Scum build-up/ solids deposition was present behind the baffle in the settling tank. This material should be removed and properly disposed. See Figure 2.

Please notify this office in writing, within 14 days receipt of this letter, of your intentions to address items 12 through 19. This letter should include dates either actual or proposed. A follow-up inspection will be conducted subsequent to the completion date.

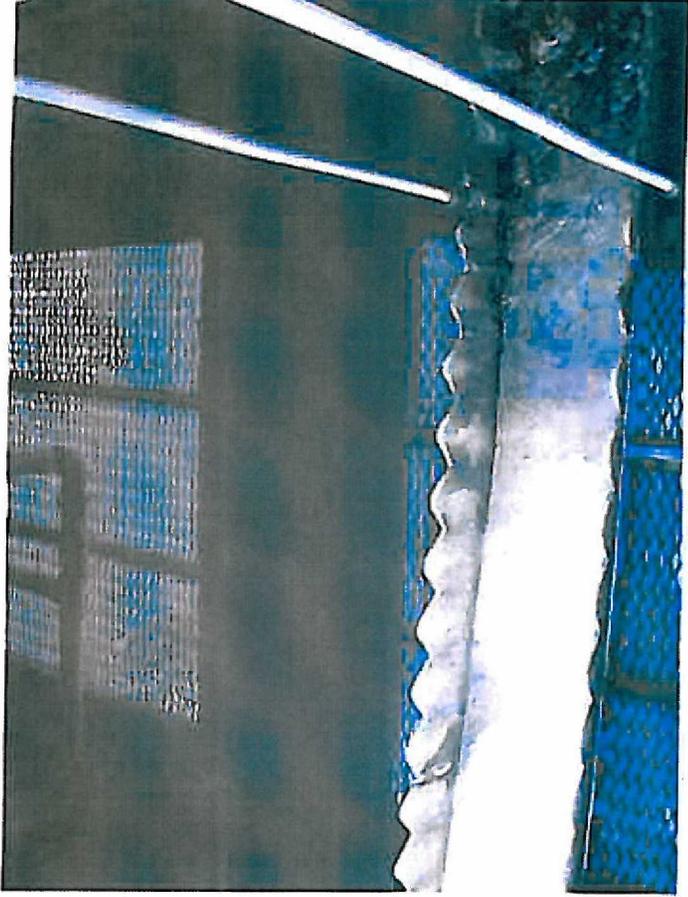
- 15) The weirs in the up flow fixed media clarifier need to be leveled. Currently the effluent is only flowing over the weir on one end. See Figure 3
- 16) The surface sand filter beds consisted of two cells. One surface sand filter bed appeared to be plugged and had floating solids. See Figure 4. A pump was being used to transfer the effluent to the other sand bed. See Figures 4 & 5. This bed should be immediately taken off-line to allow the bed to drain and the sludge to dry. Once the bed dries, the sludge layer should be raked from the bed. The sludge should be properly disposed at a licensed solid waste landfill. The other sand filter bed was draining properly. Minimal vegetation was present in this bed. The surface sand filter beds should be maintained free of vegetation at all times.
