RE: LORAIN COUNTY  
CITY OF AVON  
FIRMINT CHEVROLET  
CONSTRUCTION STORM WATER

**INSPECTION PHOTOS**  
**Firment Chevrolet**

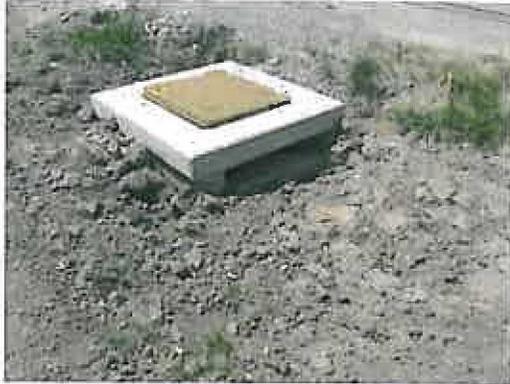
2. One of the catch basins along Chester Road serves as a secondary outlet for the retention pond system (see Fig 1). This catch basin discharges to an unnamed tributary of Powdermaker Ditch rather than back to the retention pond system. Storm drain inlet protection is needed around this catch basin.

**Figure 1:** Overflow inlet on Chester Road

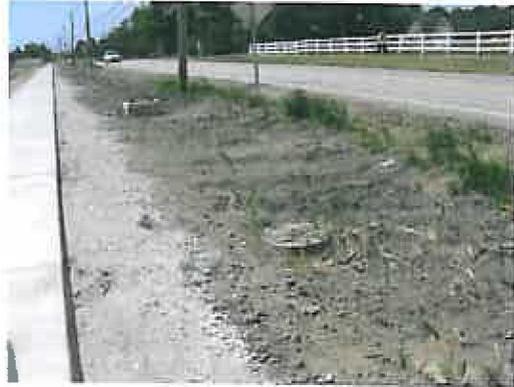
3. The ditch on Chester Road needs to either be temporarily stabilized or reach its final gradation with permanent seeding.
4. Looking at the gradation of the land, a silt fence or grass diversion ridge is needed on the northern side of the topsoil pile to protect the wetlands to the north.

**Figure 2:** Road Ditch along Chester Road

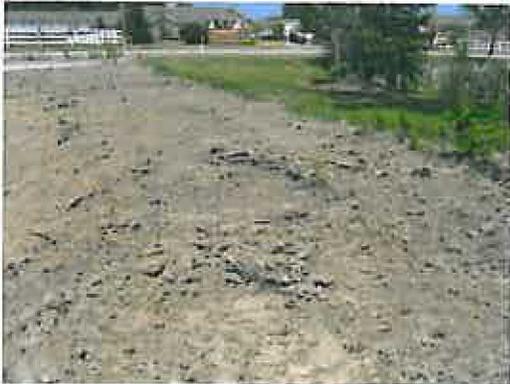
1. The retention basin walls have been hydro-seeded, but the seed has not germinated. Mr. Powers indicated that hydroseeding had occurred three weeks prior to my visit, thus we would expect that grass should have started to grow. Measures such as watering must be taken to ensure germination. If germination has not yet occurred, seeding may need to be redone. The basin walls will not be considered stable until vegetation reaches 70% growth density. In addition, it was noted that stabilization did not extend beyond the immediate basin sidewalls, yet there are disturbed soils around the basin that have not been stabilized, but will remain unworked for more than 21 days. These areas must also be stabilized immediately.

**Figure 3:** Area surrounding sediment basin
